**CITY OF CANTON POLICE DEPARTMENT
151 ELIZABETH ST
CANTON, GA 30114**

FOLLOW-UP ROOF LEAK EVALUATION REPORT

**Re: Building Exterior Consulting Services
Roof Consulting Services
City of Canton Police Department
Canton, GA 30114
(W&A Project #: 24-01329-2)**

Follow-up Roof Leak Evaluation Report
City of Canton Police Department
Canton, GA
(W&A: 24-01329-2)

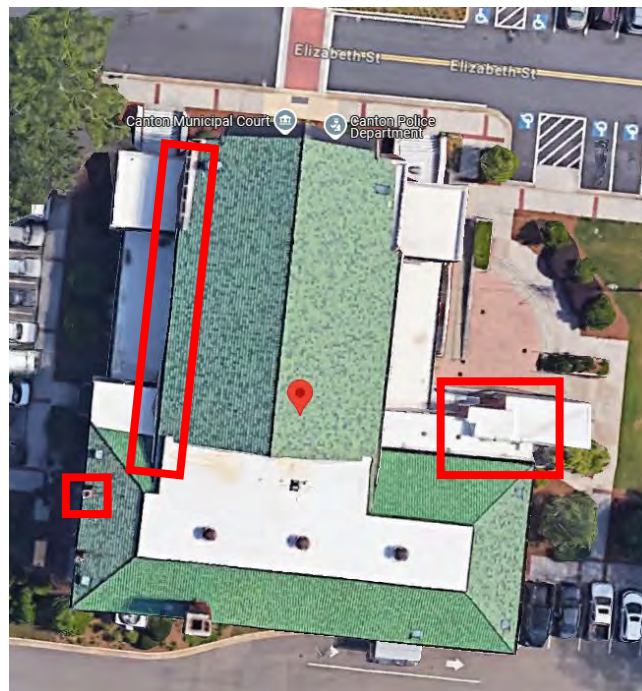
Diagram 1

City of Canton personnel reported multiple leaks, which had grown in severity since our previous condition evaluation, general locations marked below in **Diagram 1**. The primary focus of the evaluation was to identify potential sources of leakage.

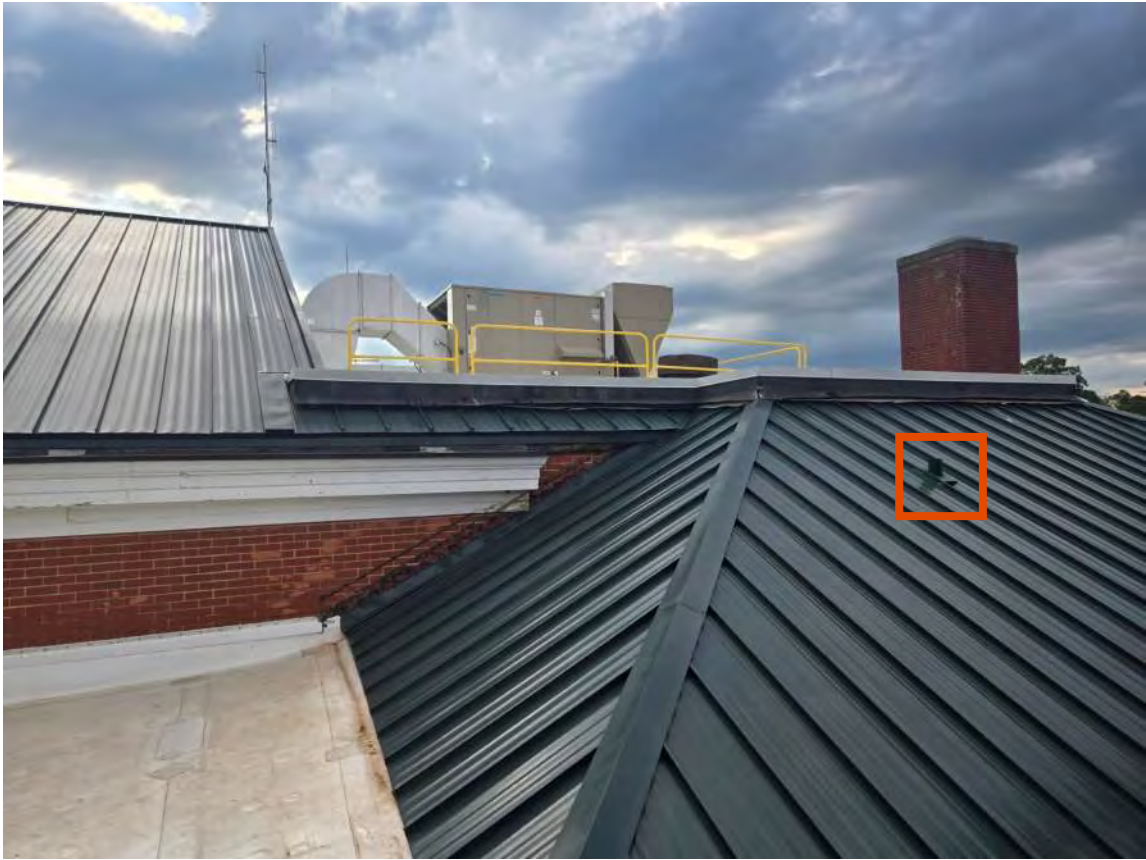
Photo 1

Photos 1 - 8 show that vent stack penetration flashing had been altered. Alterations were not in general accordance with published SMI details, as provided in our previous report. The sealant appeared to be clear silicone and not a professional grade sealant. These conditions are anticipated to be a source of leakage soon if left uncorrected.

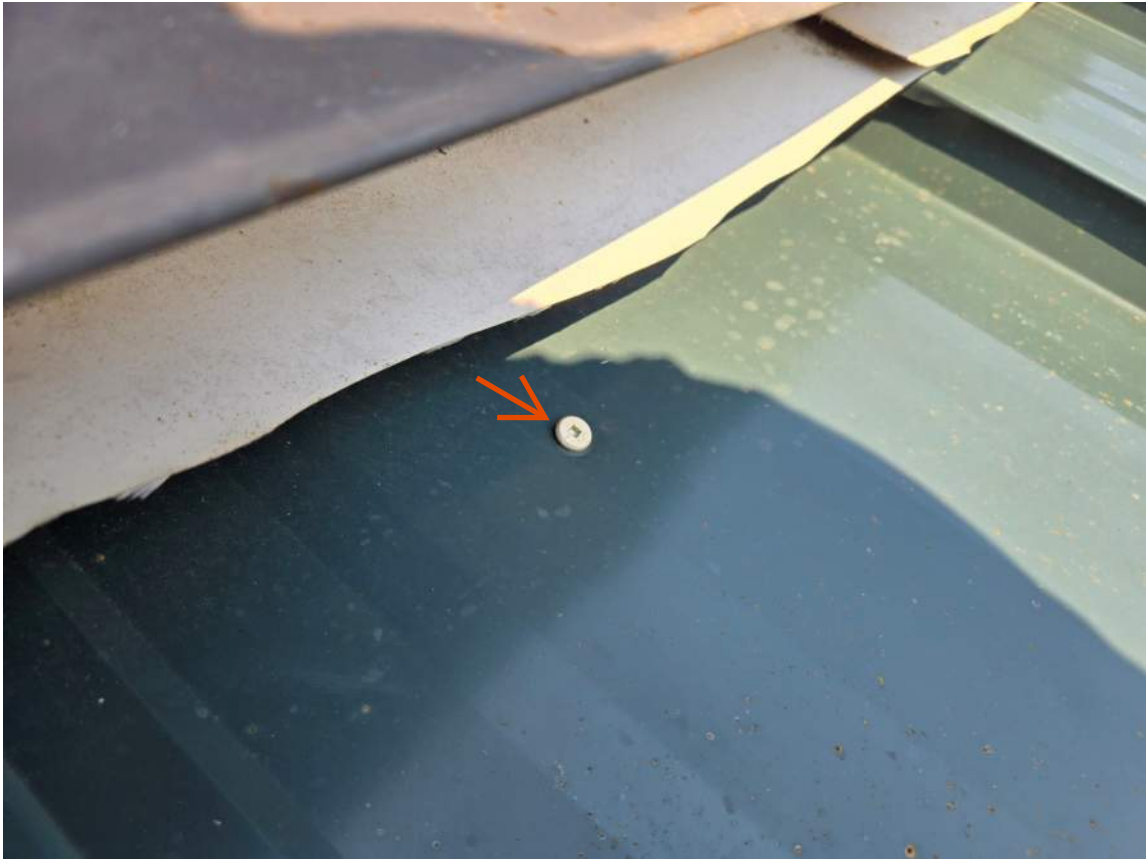
Photo 9

Photos 9 & 10 show several examples of exposed panel fasteners at the head of the panel that were not driven flush, potentially allowing water to get underneath the fasteners and panels.

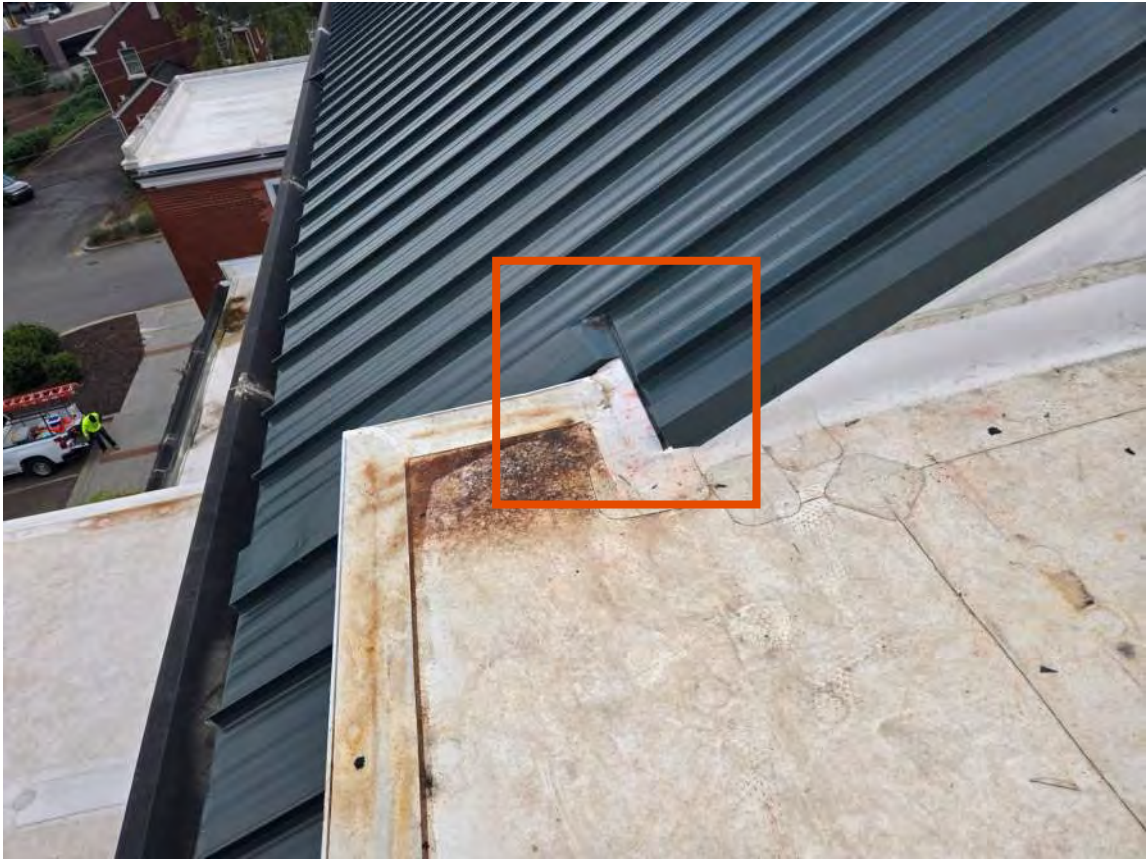
Photo 11

Photos 11 – 14 show transition detailing that appeared to be a change from our previous evaluation. Previous observations contained exposed panel edges that left the underlayment and adjacent single ply membrane exposed. The corrective works appears to be a field fabricated box that covered the condition. The box does conceal some of the previous concerns but is unlikely to have eliminated the potential for future roof leakage.

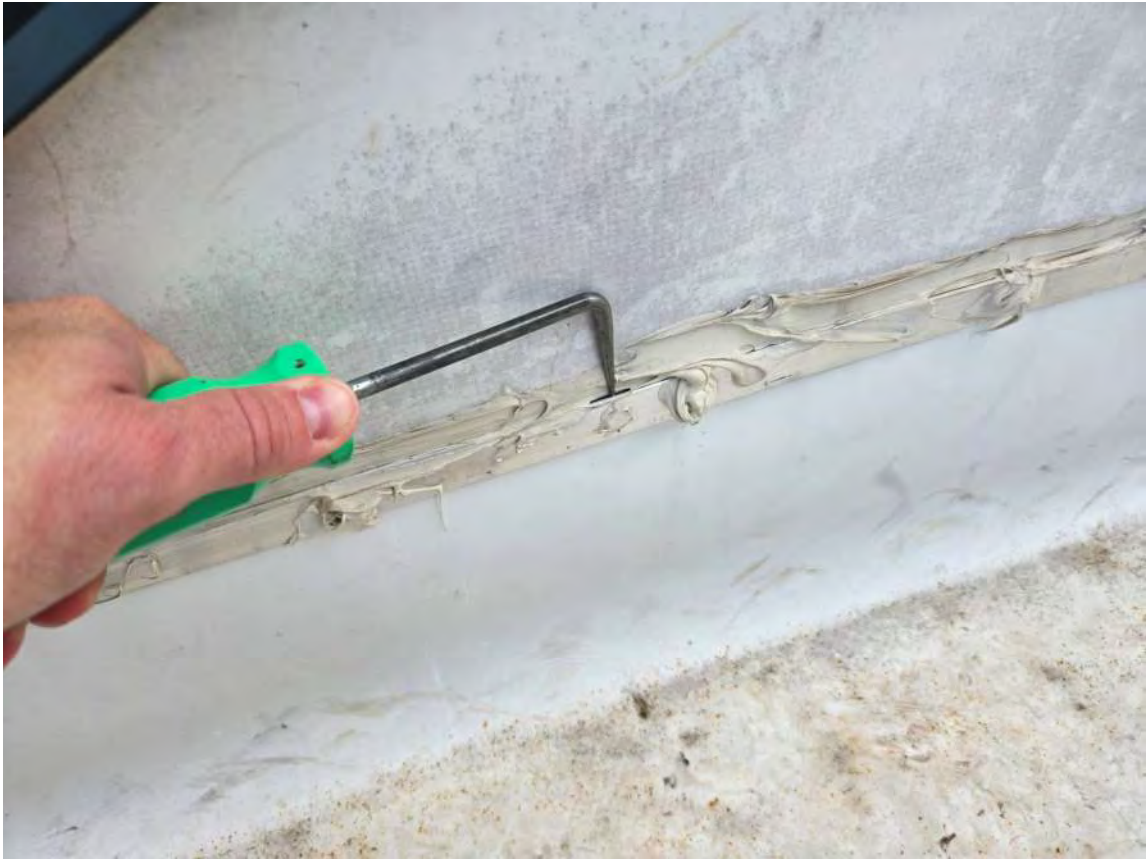
Photo 15

Photos 15 – 17 show that termination bar sealant contained voids and abandoned fastener penetrations had not been sealed. Both of these items are anticipated to contribute to leakage inside the building.

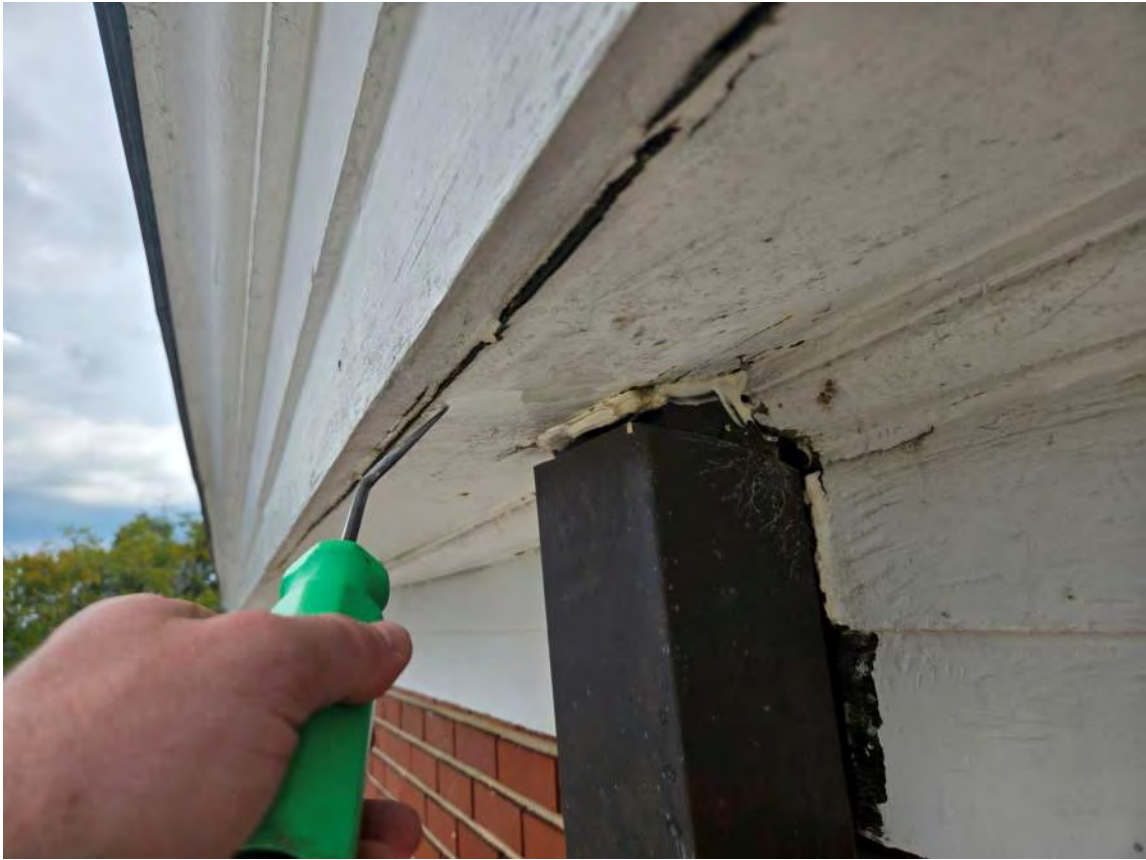
Photo 19

Photos 18 – 20 show that the gutter solder joints are cracked and allowing water into the wood soffit/cover. While this is not anticipated to be a cause of interior leakage, the uncontrolled water may lead to future problems, including but not limited to wood rot of the decorative gutter covers.

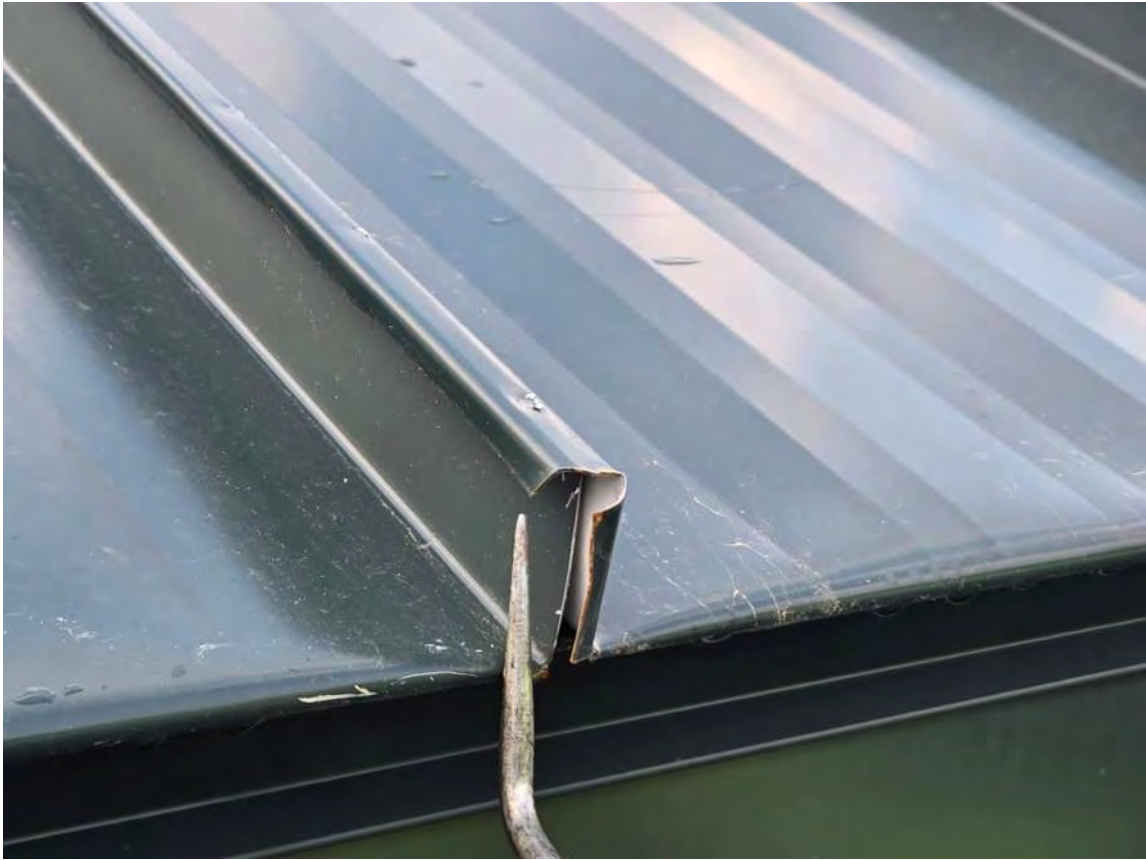
Photo 21

Photos 21 – 24 show that panel seams had not been corrected from our last evaluation and report. The level of seaming observed is consistent with what SMI considered to be Step 2 of 4 of the seaming process. Anchor clips were exposed sporadically across the roof area. These observations were present in areas that Canton reported to have been worked on by the roofer.

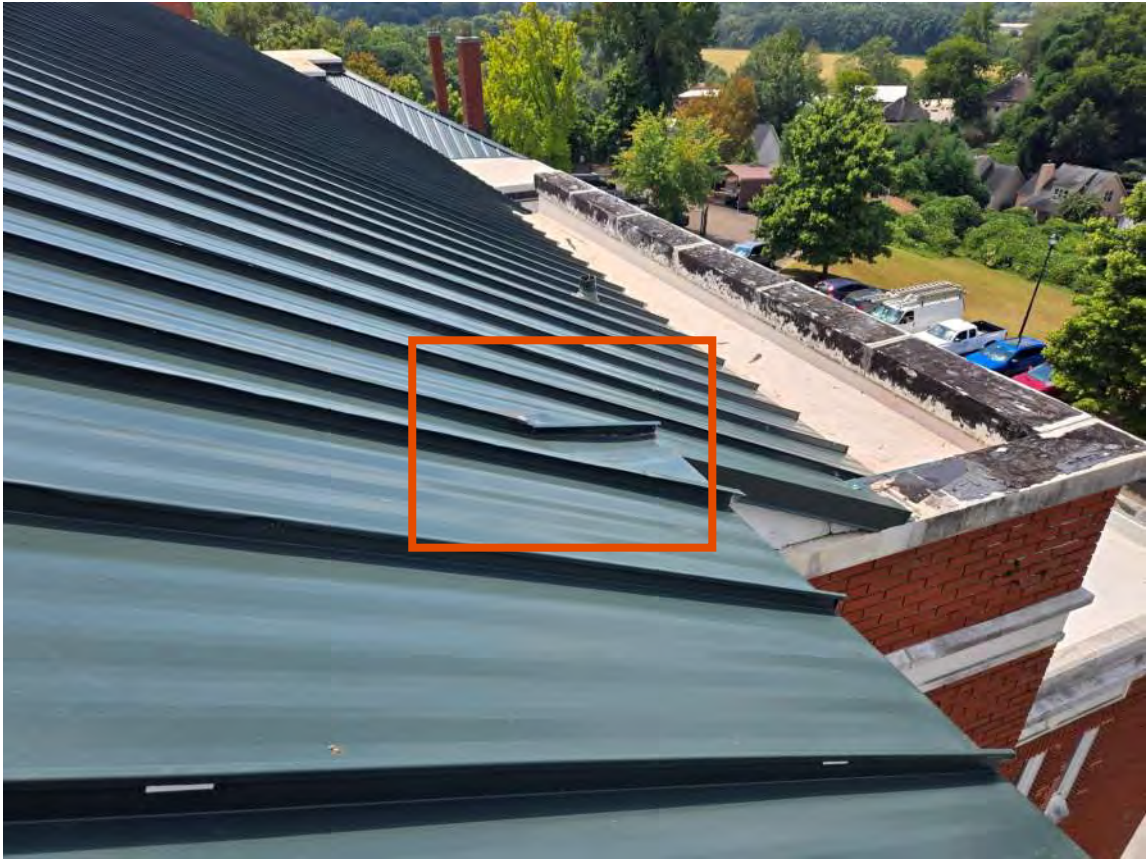
Photo 25

Photos 25 – 28 show a detail area within the reported area of corrective work. Panels were field bent to better follow the contour of the roof deck but the detailing of the bent panel and flashing with clear silicone sealant was improper and contained voids. The method of corrective work in this location does not appear to conform with what we would consider best practices.

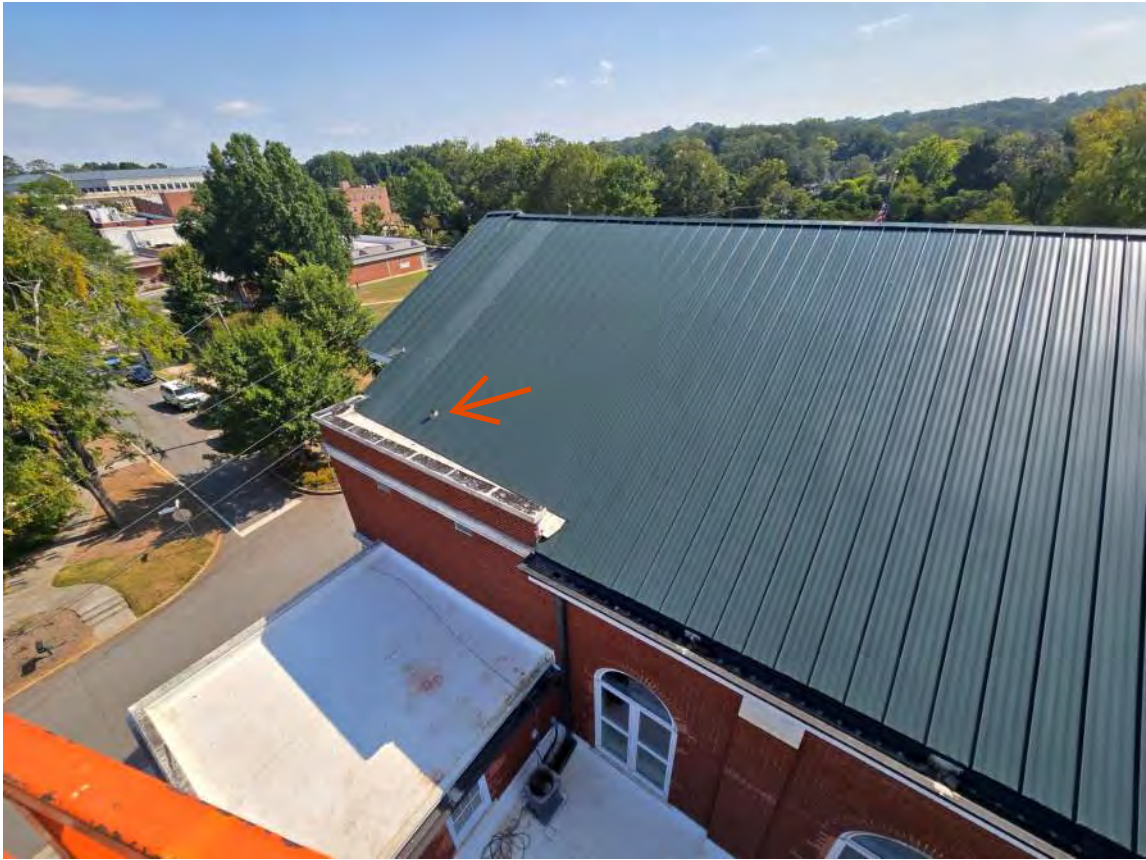
Photo 29

Photos 29 – 31 show an added penetration boot. The previously observed painted underlayment was left exposed and contained voids. The boot was detailed to the metal panel with clear silicone, indicating that butyl tape, as called for by SMI, was not likely underneath the penetration boot. The clear silicone was not well adhered to the panel.

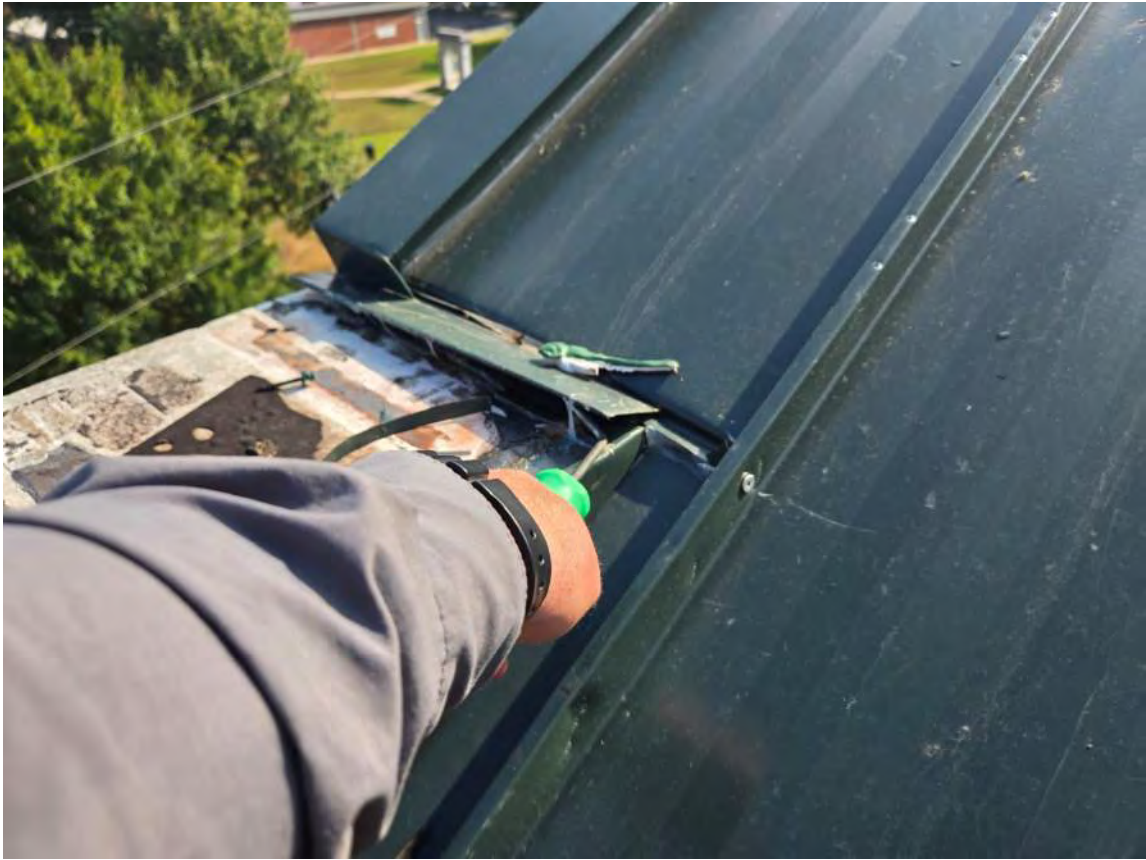
Photo 33

Photos 32 – 36 show that some correct work had been attempted at the north parapet transition area between Areas 3 & 4. Metal flashings were loosely held in place with clear silicone and screws through the stone coping. An open TPO seam was observed in the area. This area appears to be one of several contributing factors to interior leakage.

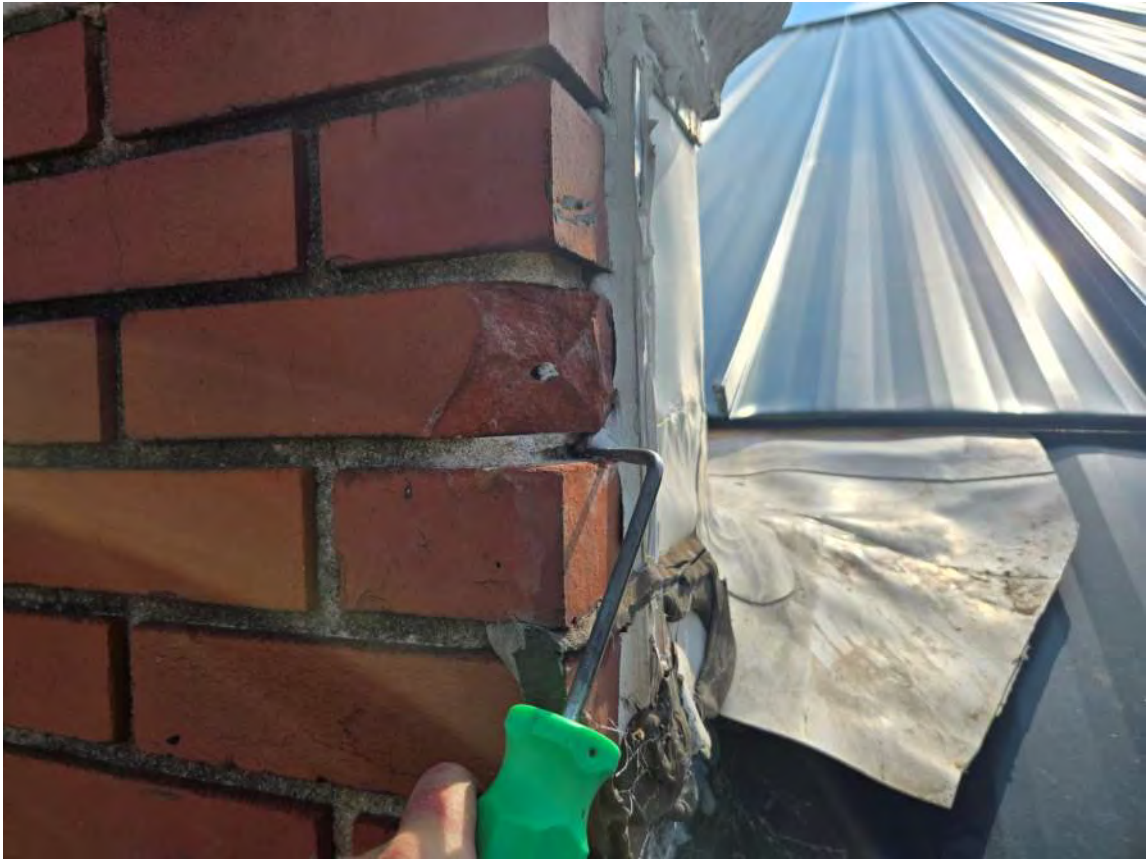
Photo 37

Photos 37 – 41 show that the corrective work performed on the Area 4 to Area 3 transition, in the Area 4 drainage path was limited primarily to clear silicone that was not well applied and was not well adhered. Wind driven rains and high volumes of water drainage are anticipated to be able to bypass the detailing in this location and enter the building.

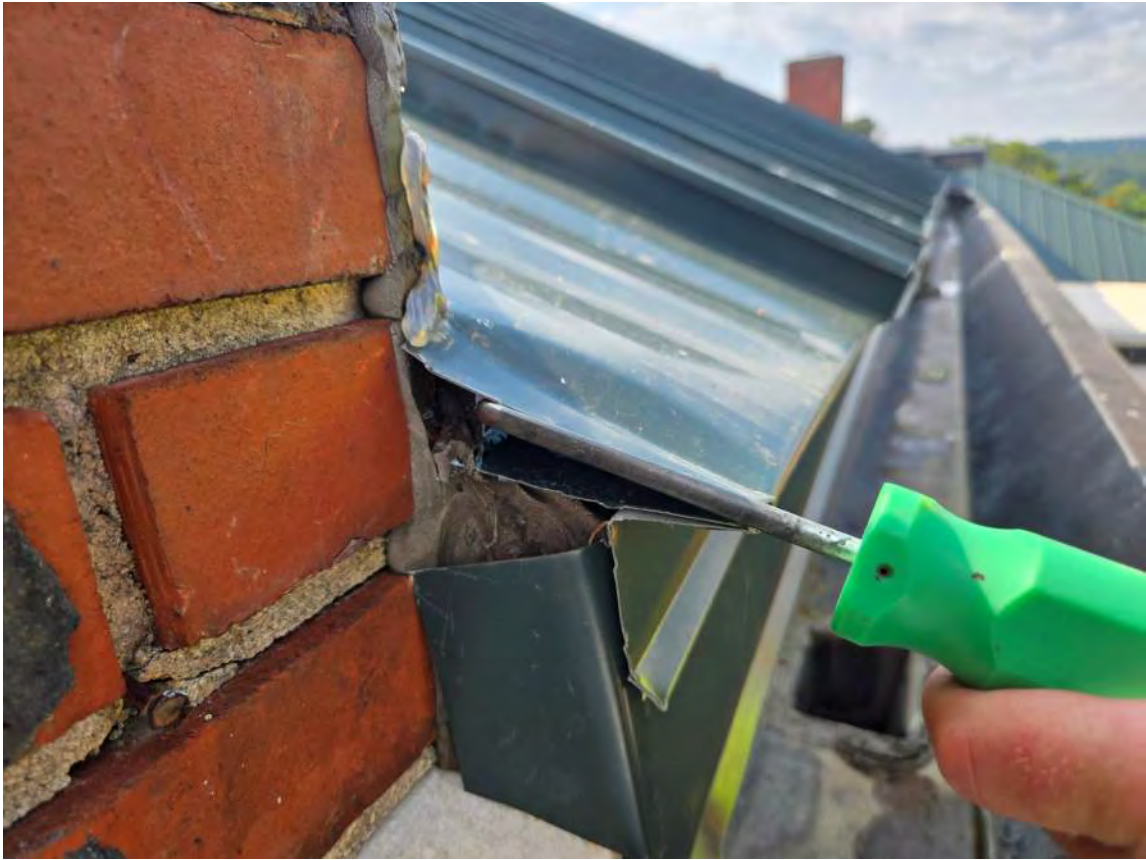
Photo 43

Photos 42 – 44 show that the edge panel bypassing the Area 4 parapet contained a large open void that provided direct access to water. Once water entered the void, it could likely travel and may be able to enter the building. The counter flashing over the gutter was also poorly attached and easily manipulated by hand. Existing sealants had not been replaced with new.

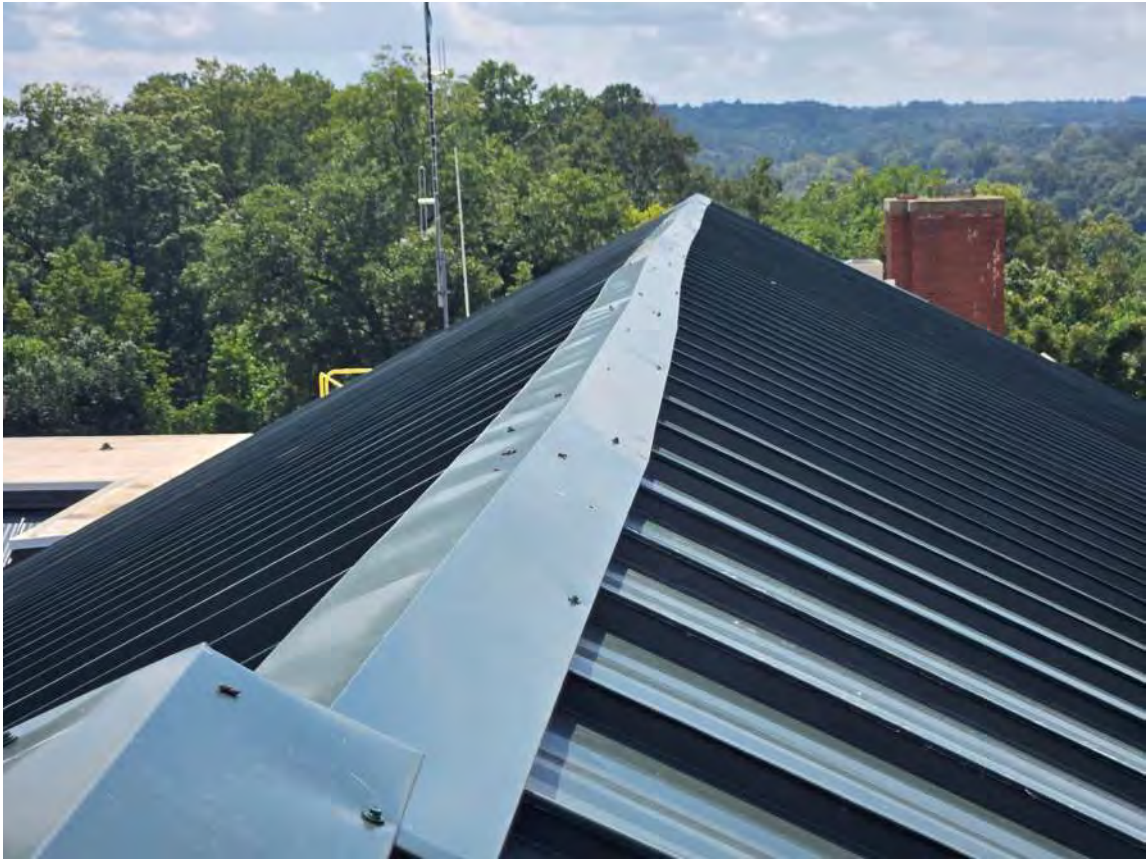
Photo 45 shows that the ridge cap was not well aligned at the ridge and contained sporadically placed fasteners in lieu of pop rivets placed 18" OC as required by SMI.

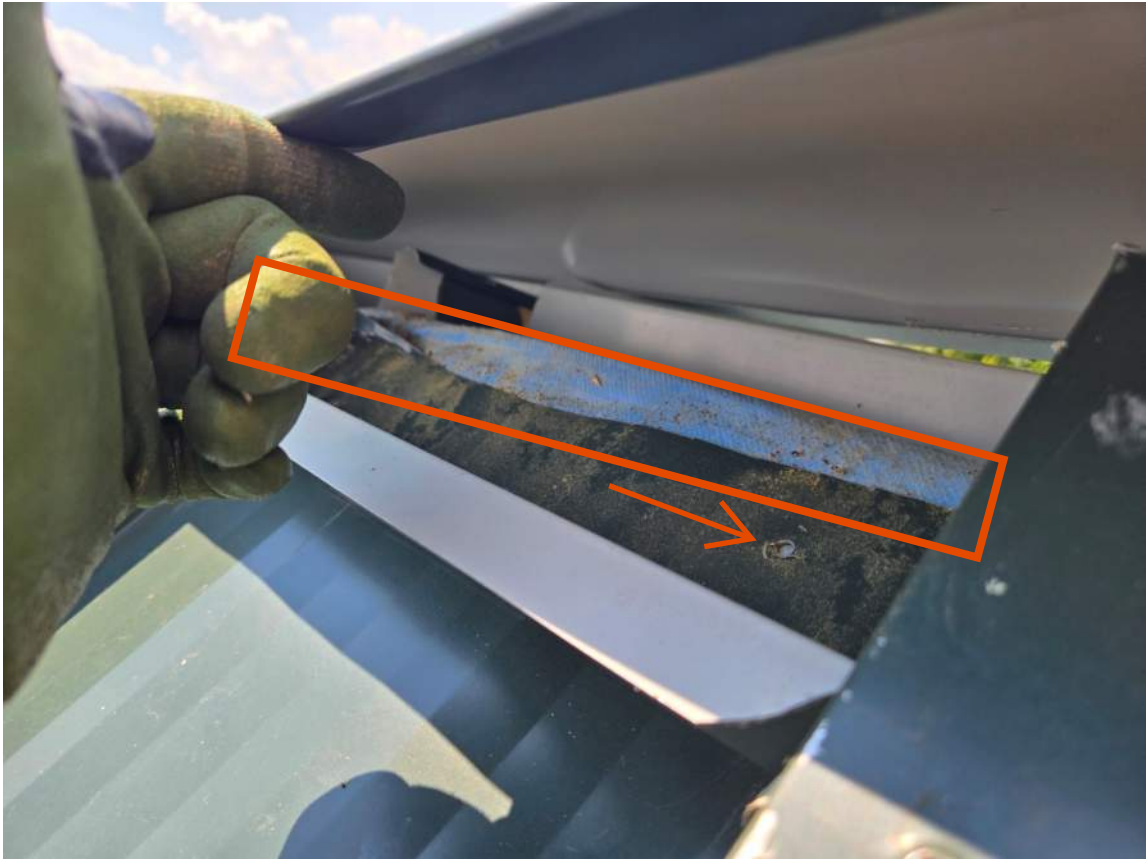
Photo 47

Photos 46 & 47 show that the panels did not contain boxed ends at the ridge, under the ridge cap, which was not in accordance with SMI required detailing.

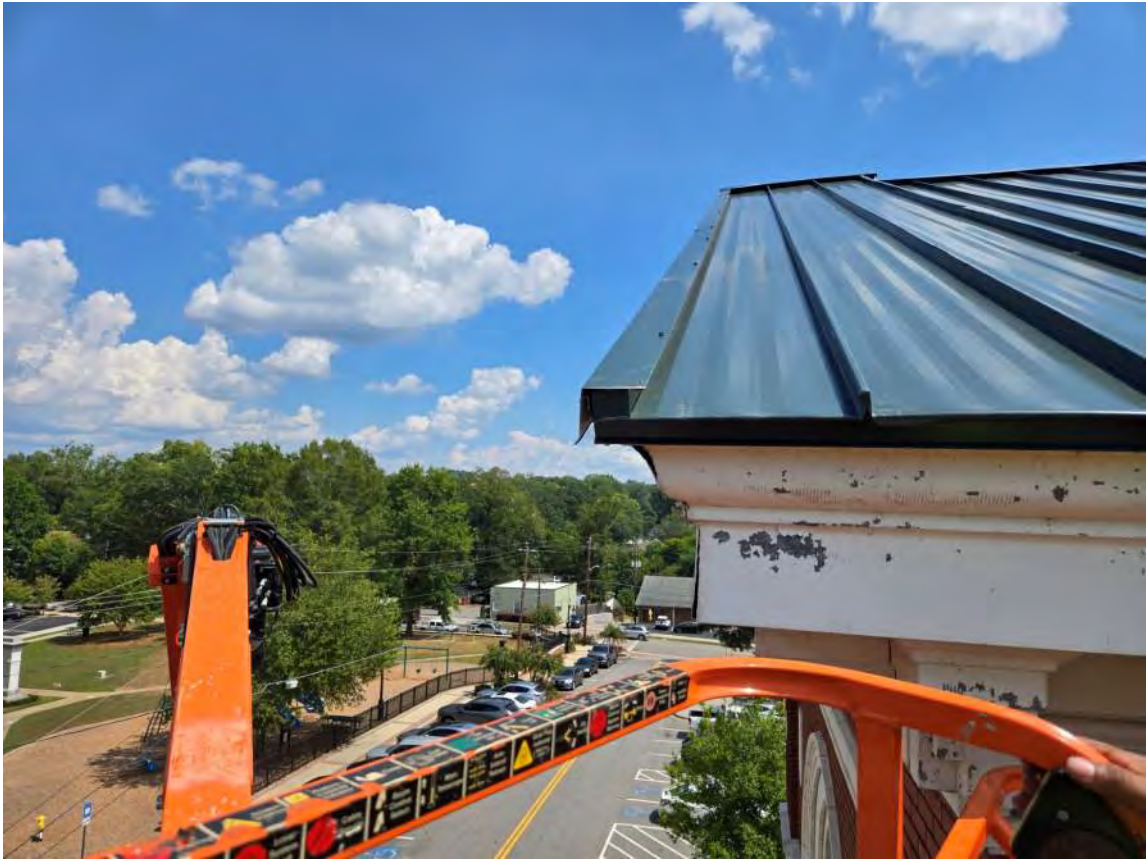
Photo 49

Photos 48 – 51 show that the rake flashing at the north gable was not engaged with a cleat and was easily manipulated by hand. Voids were also present that had not been addressed.

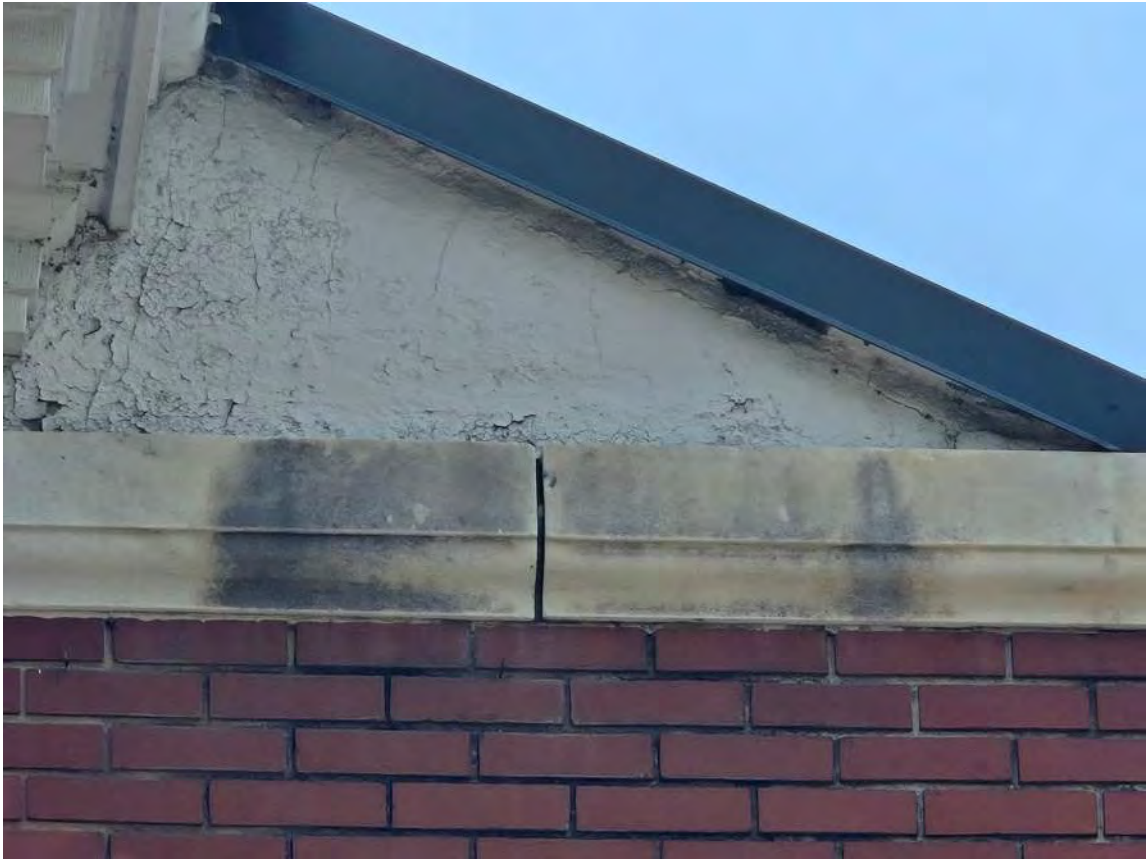
Photo 53

Photos 52 – 54 show some exterior wall components that are likely also contributing to leakage. Missing stone coping mortar and open joints between vertical cementitious panel and stone coping were observed and provide potential pathways for water to enter the building.

- Tuck point areas of wall with missing/degraded mortar above roofing terminations and within areas of exterior wall above leakage. See **Photos 71 – 73, 92, 93, 123, 124, 126 – 128** as examples.
- Repair areas of cracked masonry/masonry distress. See **Photos 95, 101** as examples.
- At rising masonry walls, consider the application of a clear silicone coating after the tuck pointing has been completed. Clear silicone coatings, such as GE Optic, allow the wall system to continue to function as originally intended while limiting bulk water entry into the wall system.
- Remediate cementitious panels at gable ends of roof. See **Photos 52 – 54** for example areas.
- Re-solder copper gutters

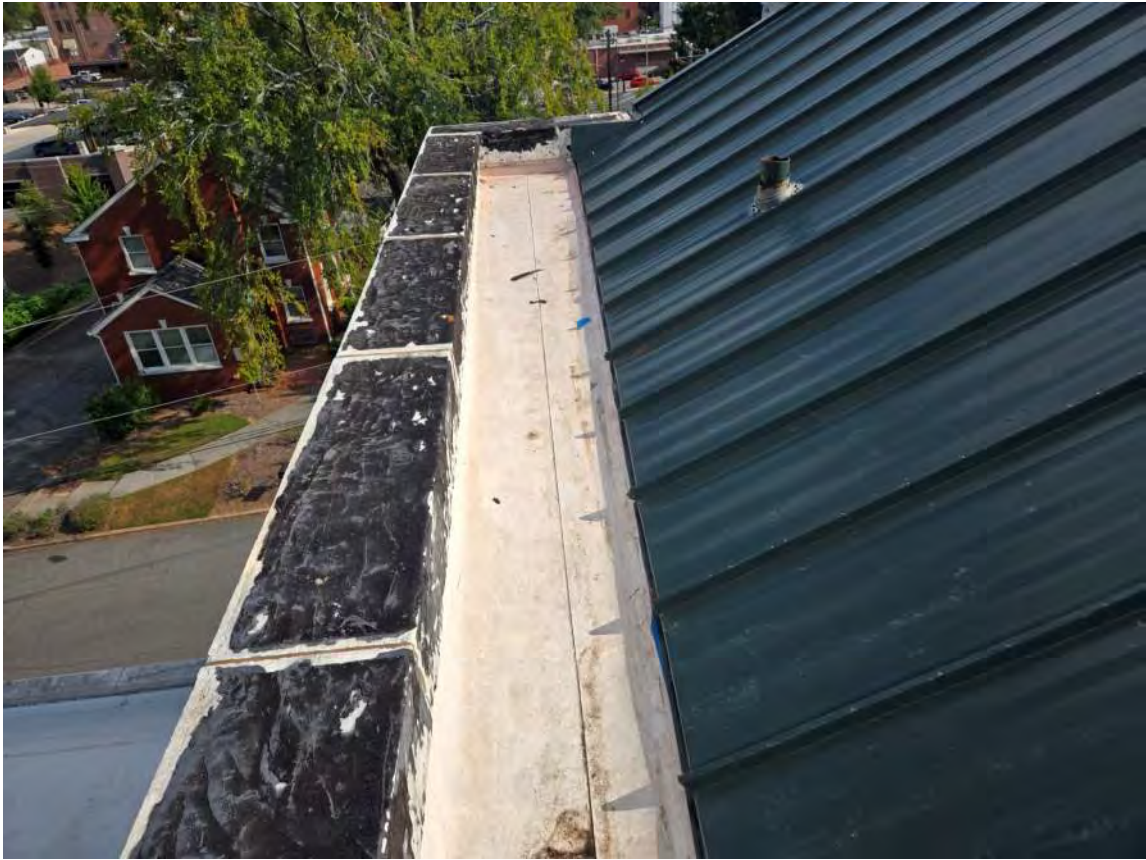
Photo 55

Photos 55 – 63 show that multiple damages were in the single ply roofing membrane that had not been replaced. Also observed were coping sealants that were no longer adhered to the stone coping. Both of these items likely allow water to bypass the roofing system and enter the building.

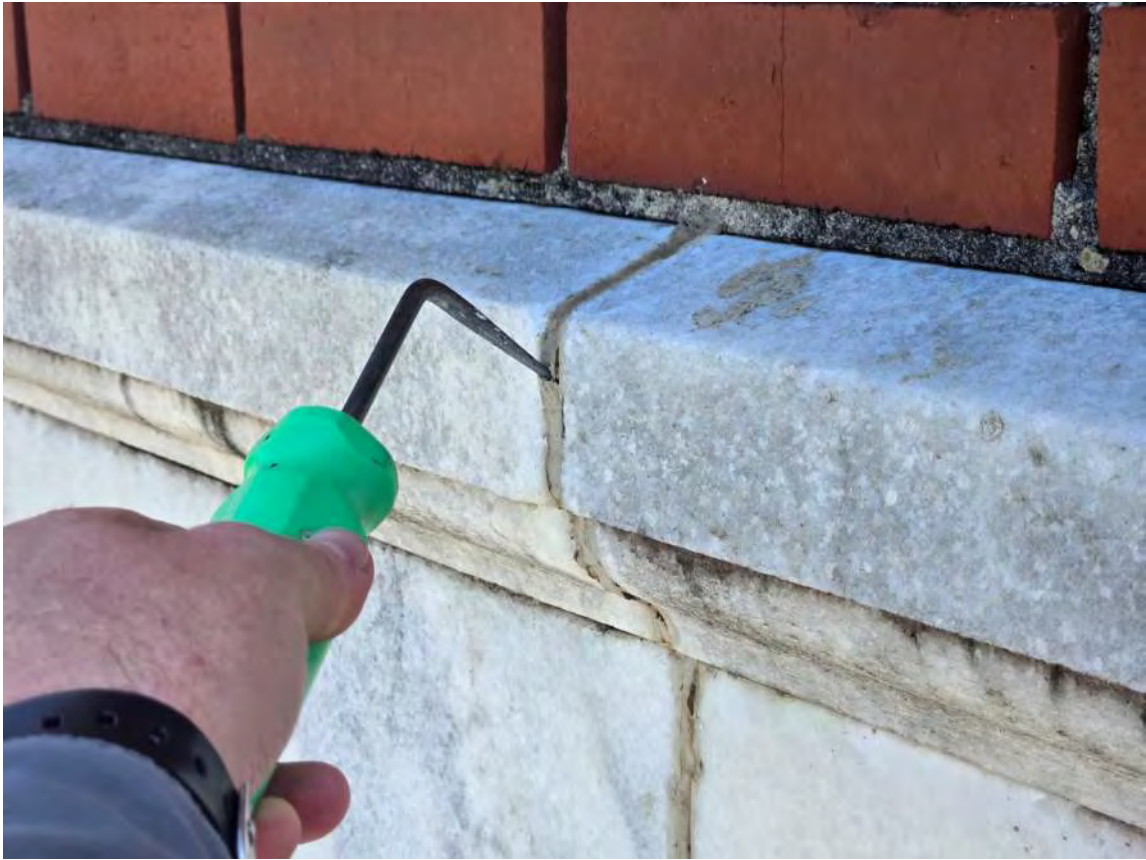
Photo 65

Photos 64 & 65 show that the decorative band at the approximate height of the Area 4 roof decking contained voids in the sealant between pieces of the decorative band.

- At stone copings, exterior accent bands and transitions, remove and replace degraded sealants, at a minimum. Consider the application of an elastomeric coating at the skyward facing portion of the stone coping that ties into the roof termination flashings to provide continuity. See **Photos 60 – 65, 116, 117** for example areas.

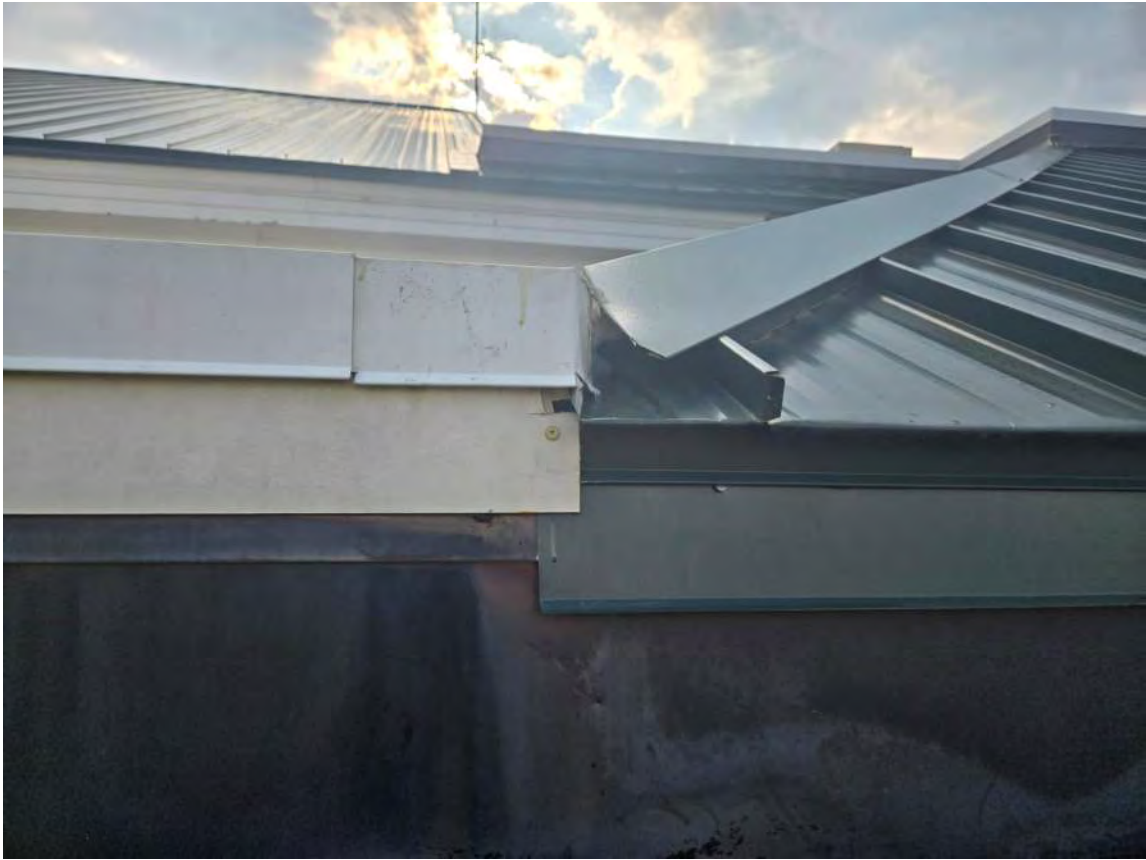
Photo 67

Photos 67 & 68 show a large void in the fascia flashing at the Area 1 hip to Area 5 perimeter transition.

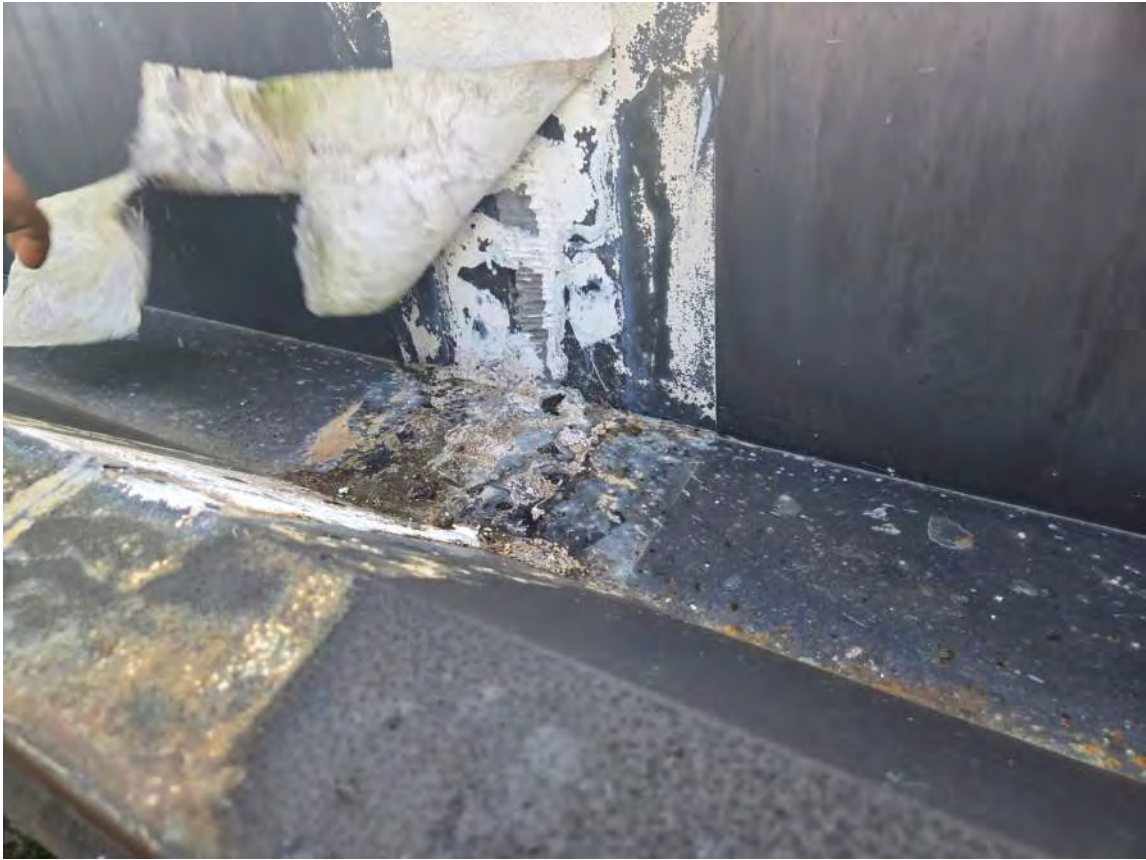
Photo 69

Photos 69 & 70 show that the gutter solder joints were cracked and not adhered to the gutter. This was a common observation.

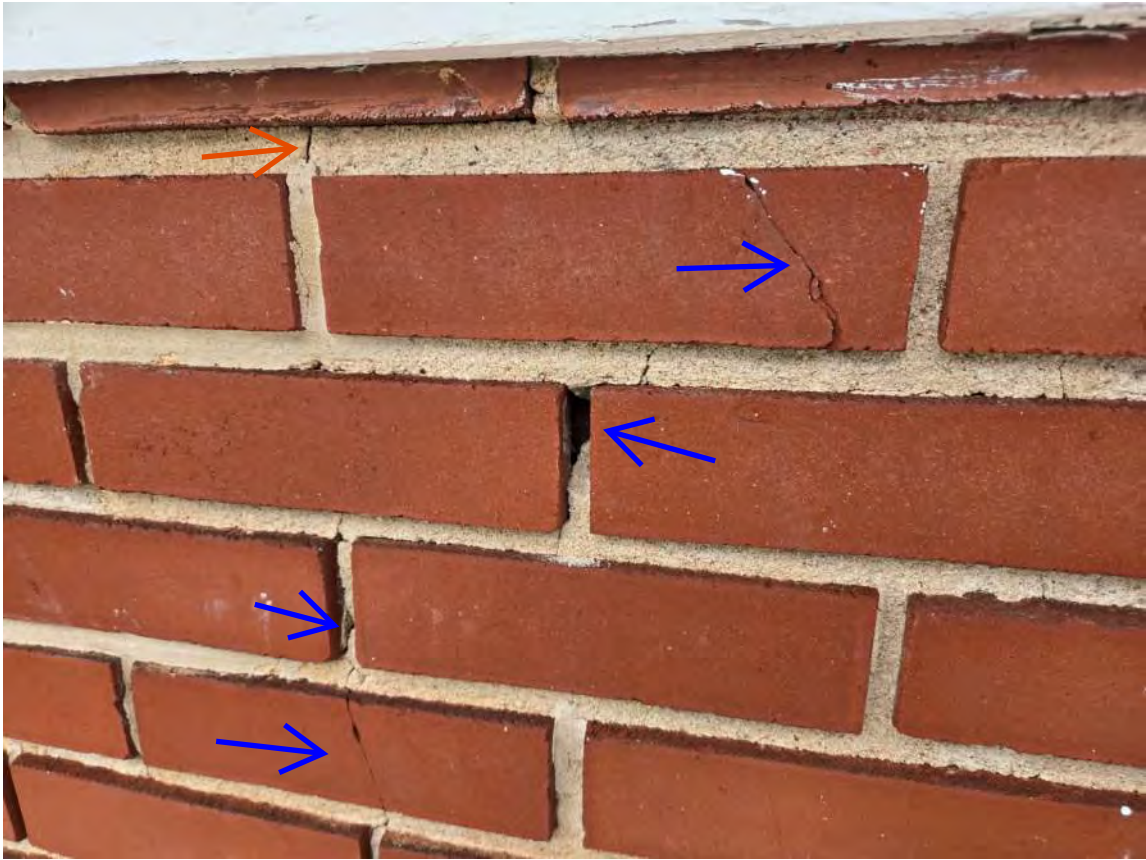
Photo 71

Photos 71 – 73 show masonry distress above the roof flashing. This masonry distress would likely allow bulk water to enter the wall system and bypass the roof flashing.
