**CITY OF CANTON POLICE DEPARTMENT
151 ELIZABETH ST
CANTON, GA 30114**

FOLLOW-UP ROOF LEAK EVALUATION REPORT

**Re: Building Exterior Consulting Services
Roof Consulting Services
City of Canton Police Department
Canton, GA 30114
(W&A Project #: 24-01329-2)**

Follow-up Roof Leak Evaluation Report
City of Canton Police Department
Canton, GA
(W&A: 24-01329-2)

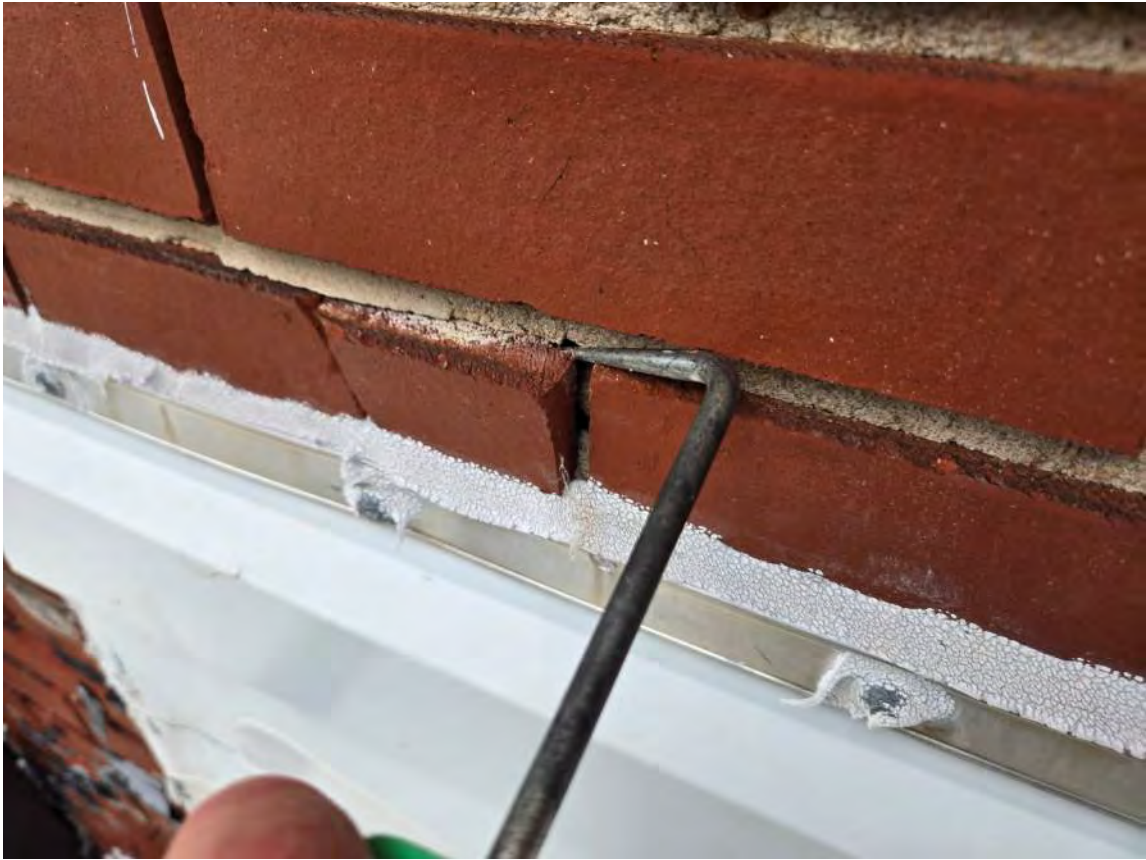
Photo 73

Photos 71 – 73 show masonry distress above the roof flashing. This masonry distress would likely allow bulk water to enter the wall system and bypass the roof flashing.

- Tuck point areas of wall with missing/degraded mortar above roofing terminations and within areas of exterior wall above leakage. See **Photos 71 – 73, 92, 93, 123, 124, 126 – 128** as examples.
- Repair areas of cracked masonry/masonry distress. See **Photos 95, 101** as examples.
- At rising masonry walls, consider the application of a clear silicone coating after the tuck pointing has been completed. Clear silicone coatings, such as GE Optic, allow the wall system to continue to function as originally intended while limiting bulk water entry into the wall system.
- Remediate cementitious panels at gable ends of roof. See **Photos 52 – 54** for example areas.
- Re-solder copper gutters

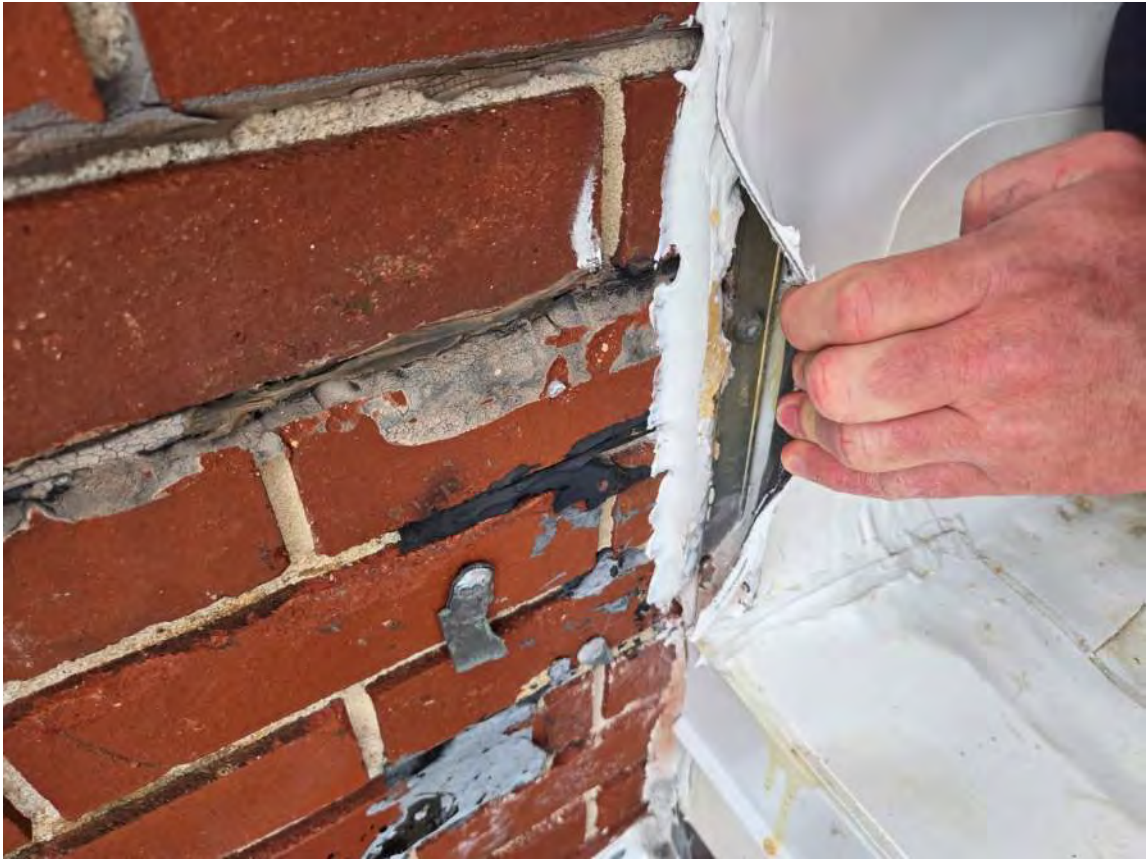
Photo 75

Photos 74 & 75 show that the new roof flashing membrane was not well terminated over the top of the existing roof flashing at the rising wall. This would likely allow water to enter the roof assembly and leak into the building. Existing sealants had not been replaced and were past their service lives. The degraded sealant would also likely allow water to bypass the surface mounted counter flashing.

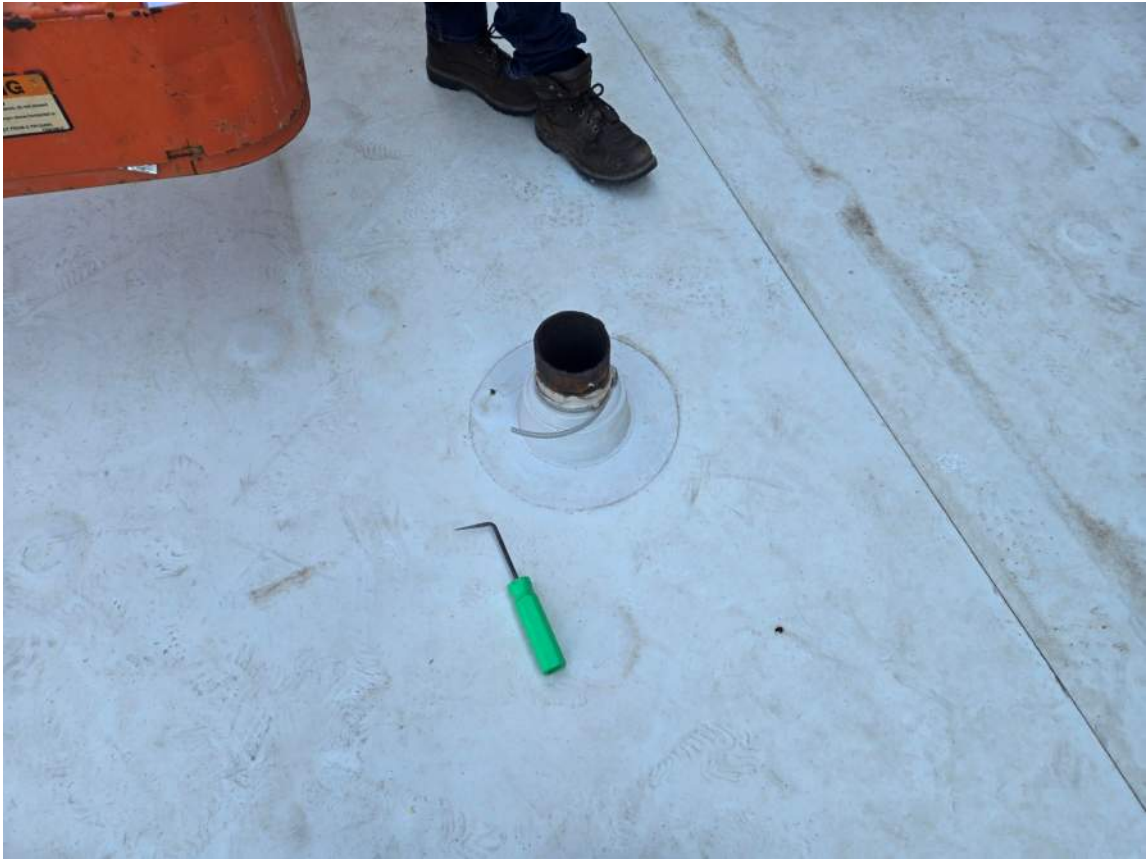
Photo 77

Photos 77 & 78 show a vent penetration in the roof area. The penetration flashing was visually watertight and did not contain obvious voids. We could not confirm if butyl mastic was present between the iron pipe and the penetration boot. The iron pipe did transition to PVC several feet below the roof surface. These connections can leak and can be easily damaged.

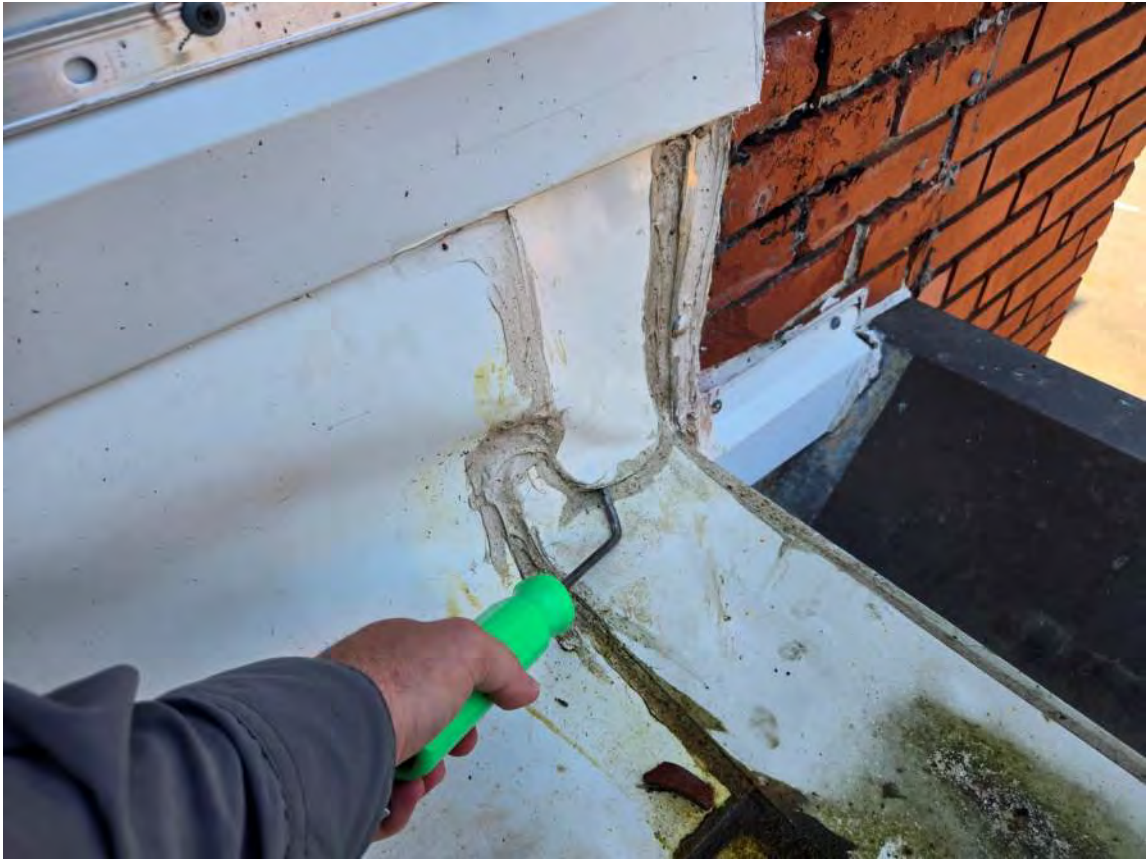
Photo 79

Photos 79 & 80 show that the vertical edge flashing at the outside edge of the roof was not well adhered and contained voids in the flashing.

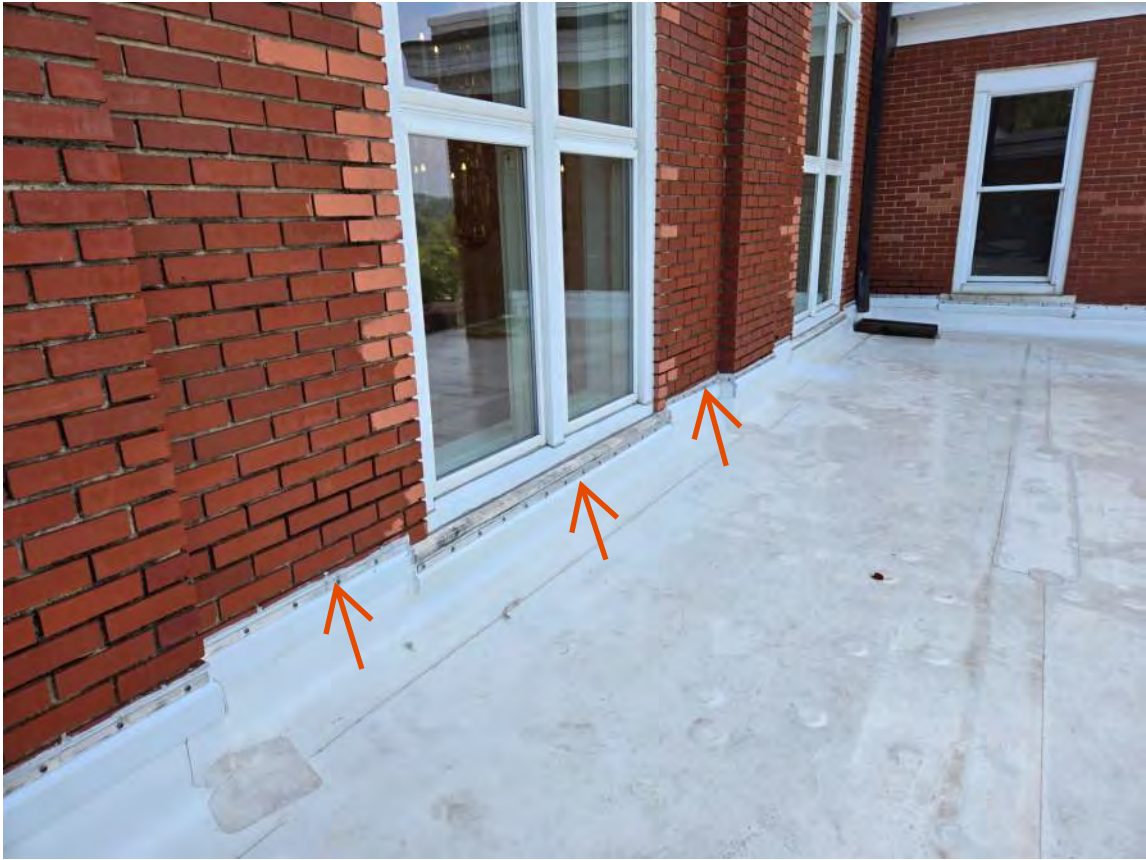
Photo 81

Photos 81 – 91 show that the roof flashing from the older roof was still in place and that termination sealants had failed in many areas. The new roof flashing was not adhered to the wall and was not properly terminated. The roof flashing could be pulled out from under the older roof counter flashing and when it was, water was observed beneath the flashing. We removed roofing membrane and discovered that roofing coverboard and insulation in the area was wet. We also observed that the old roof flashing had been left in place.

- Perform moisture survey to locate areas of wet roofing materials, as present, and remove and replace those materials.
- At stone windowsills, remove existing coatings, sealants, etc down to bare stone/metal and install a liquid flashing system by Elevate. Lap liquid flashing onto the newly applied termination detailing sealant to provide continuity of the system. See **Photos 81, 88 & 89** for example locations.

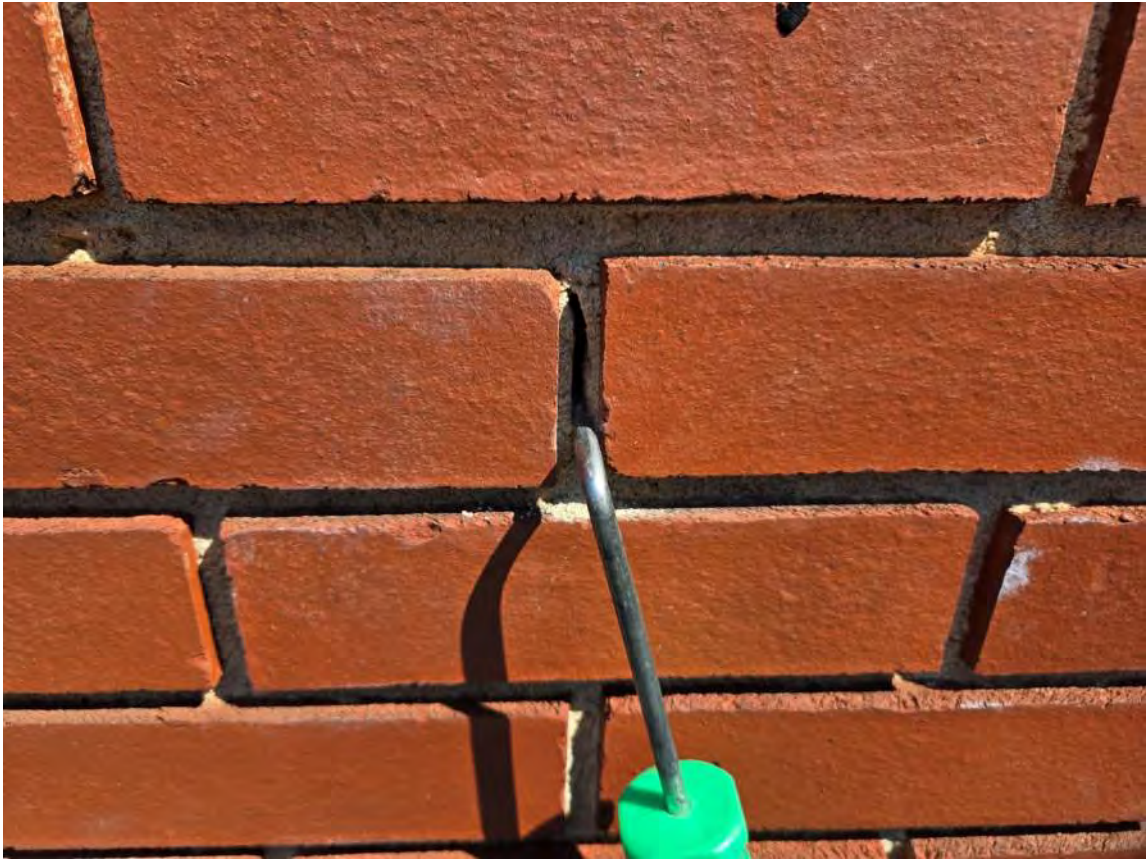
Photo 93

Photos 92 & 93 show missing mortar joints above the roof flashing. With the flashing installation observed below, it is likely that once bulk water enters the wall it can easily bypass the roof flashing and enter the building.

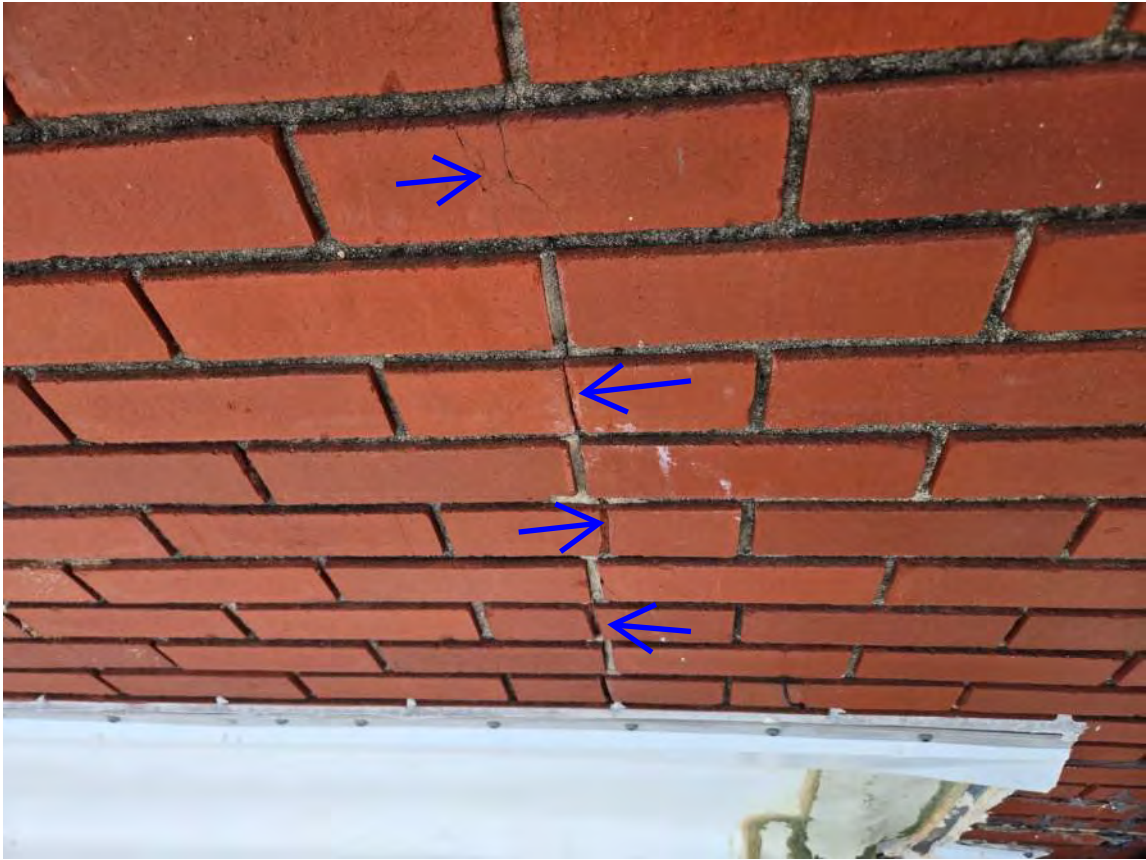
Photo 95 shows additional examples of masonry distress, as has been observed elsewhere.

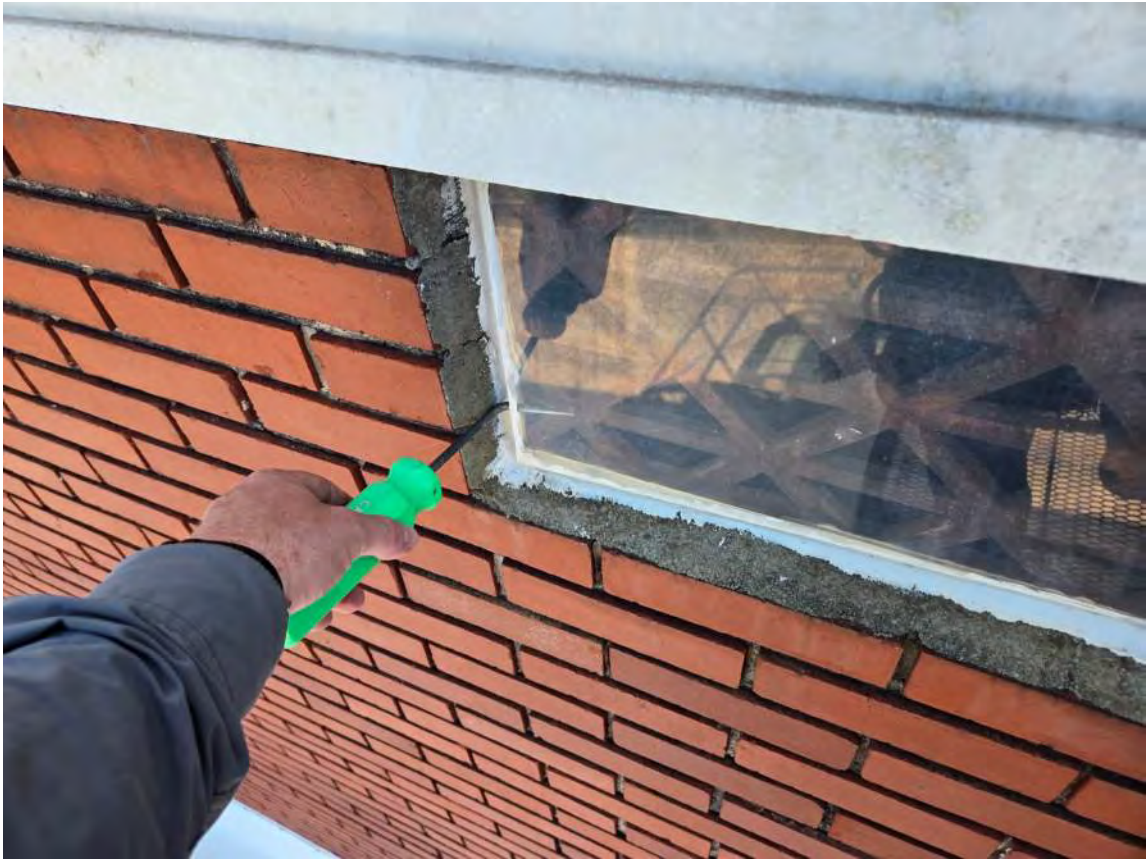
Photo 97

Photos 96 & 97 show that a wall vent cover contained voids in the perimeter sealant that may allow water leakage.

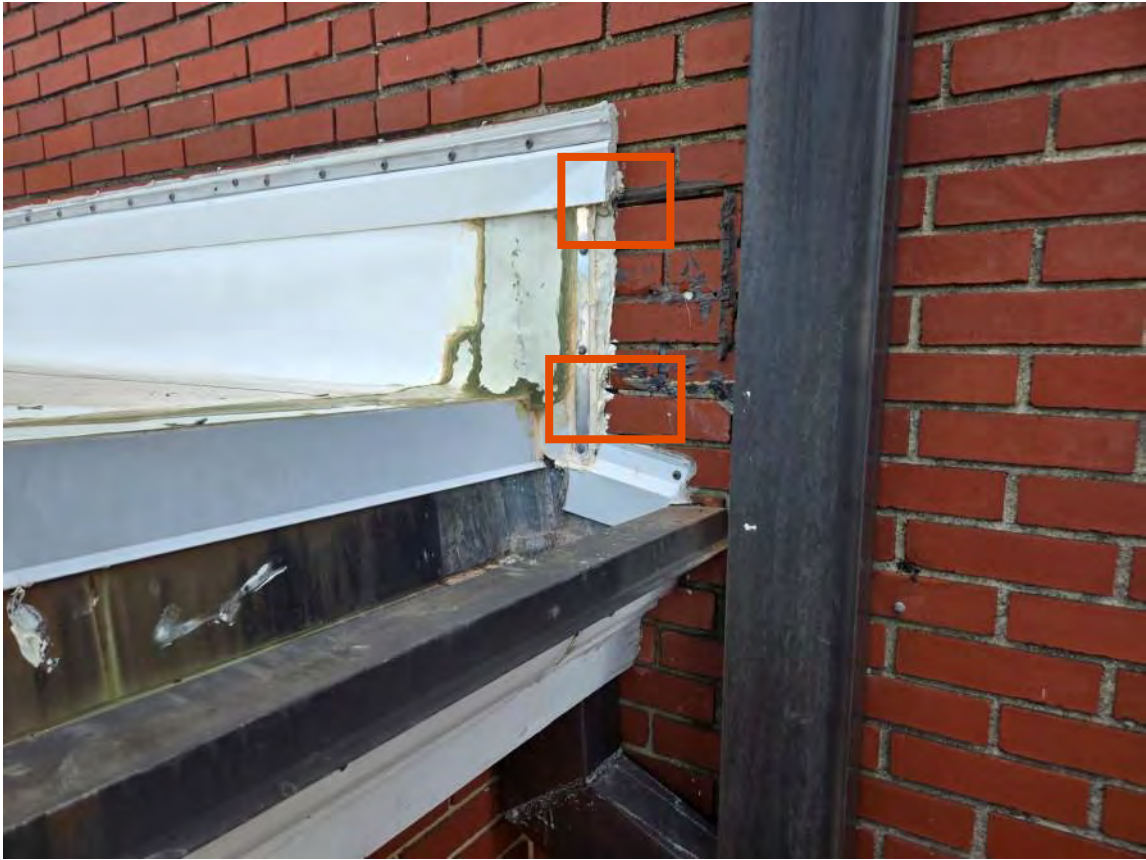
Photo 99

Photos 98 – 101 show perimeter flashing termination deficiencies that may allow water to enter the building.

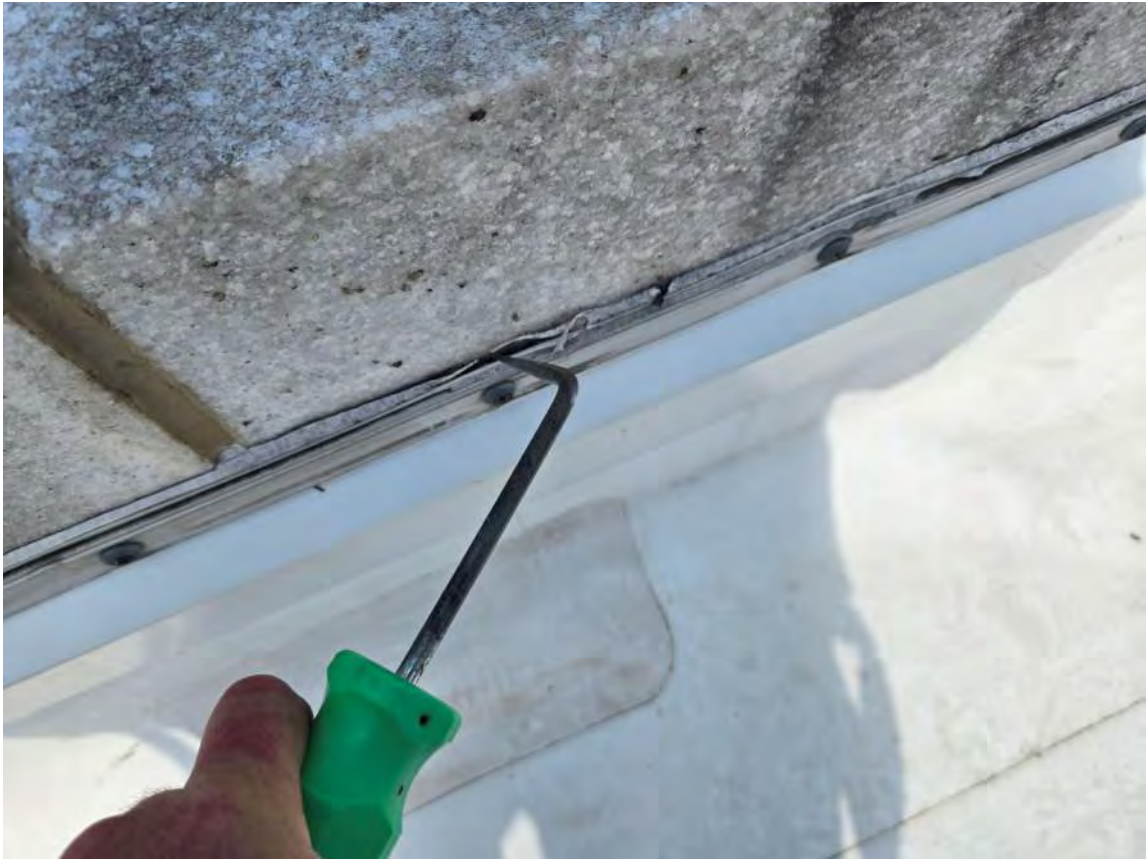
Photo 103

Photos 102 – 105 show additional views of degraded sealant at the older/reused surface mounted counter flashing and coping stone to rising wall termination.

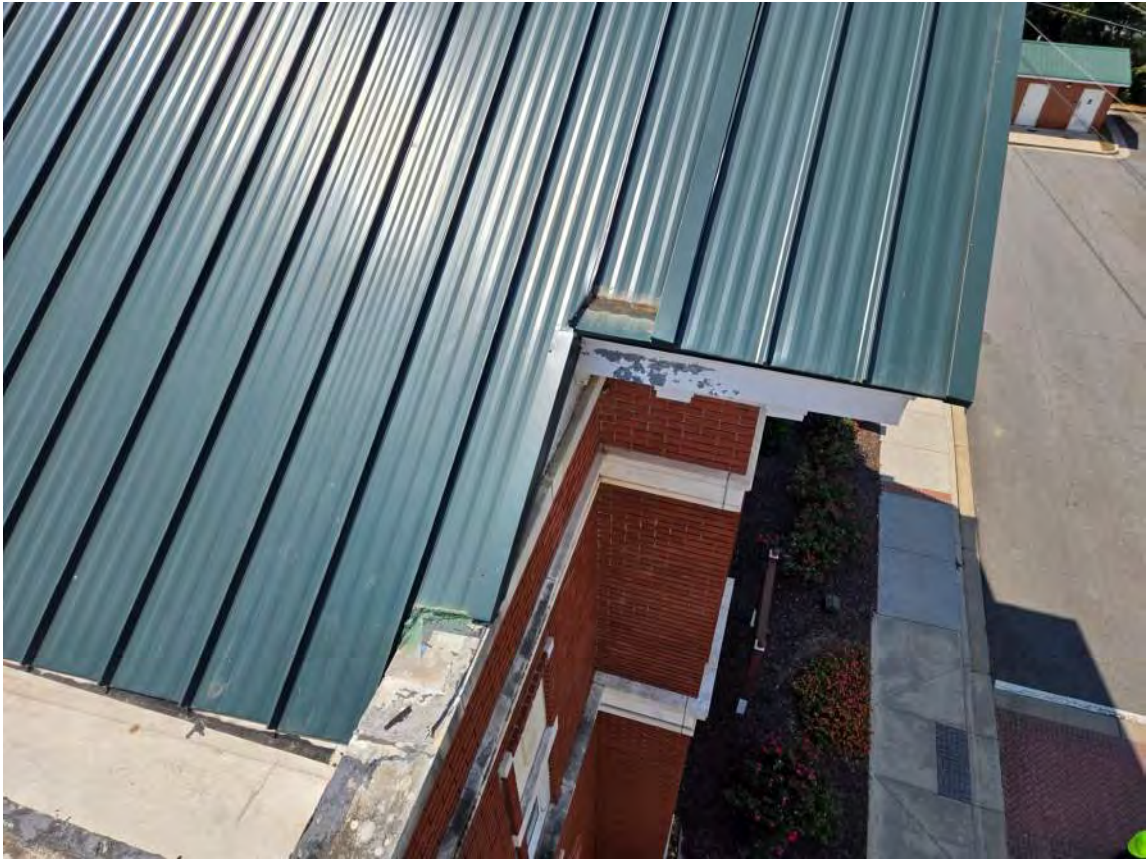
Photo 107

Photos 106 & 107 show the general condition of the roofing system during our evaluation. A lesser amount of leakage was reported on the east side of the gable, compared to the west side of the gable. Some exterior wall concerns were observed, similar to what was observed on the west side.

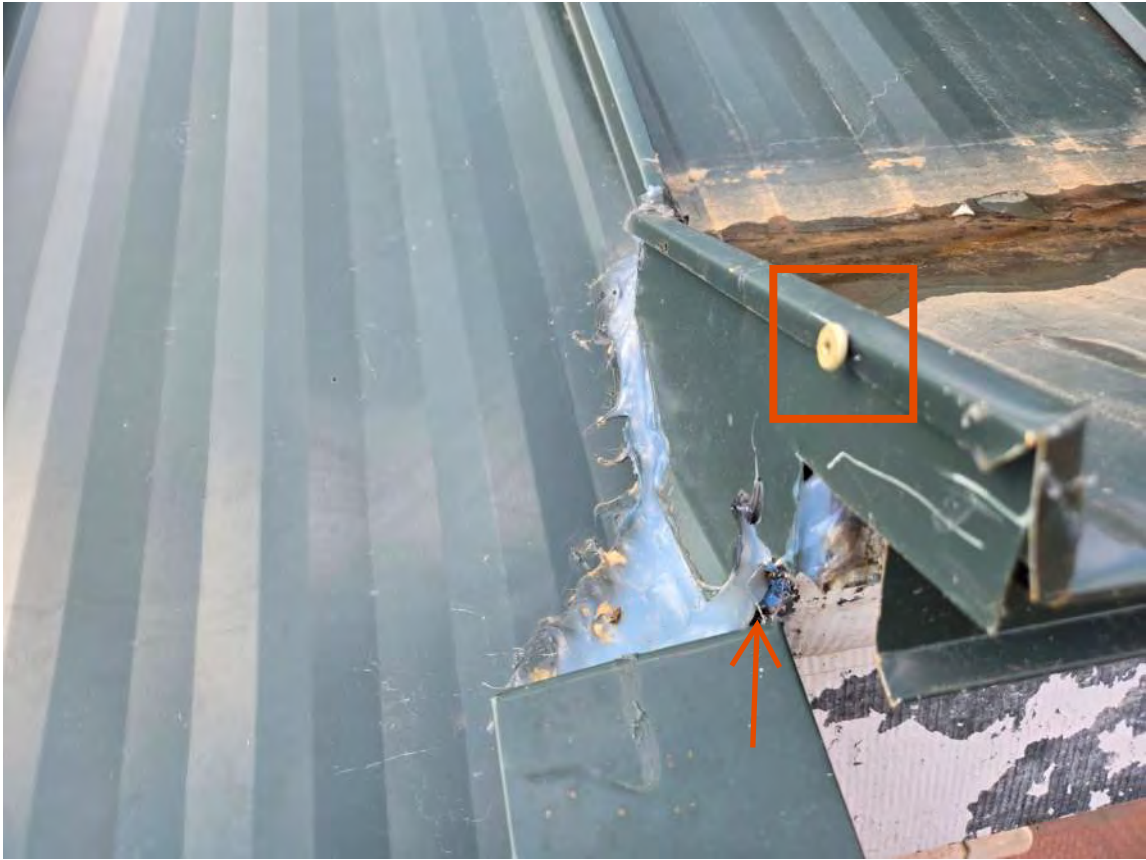
Photo 109

Photos 108 – 119 show similar level of detailing to what was observed on the west side of the roof. Voids had been left at transition areas and changes of plane. Sealant voids were present in new and older sealants. Flashings were not well secured to the roof.

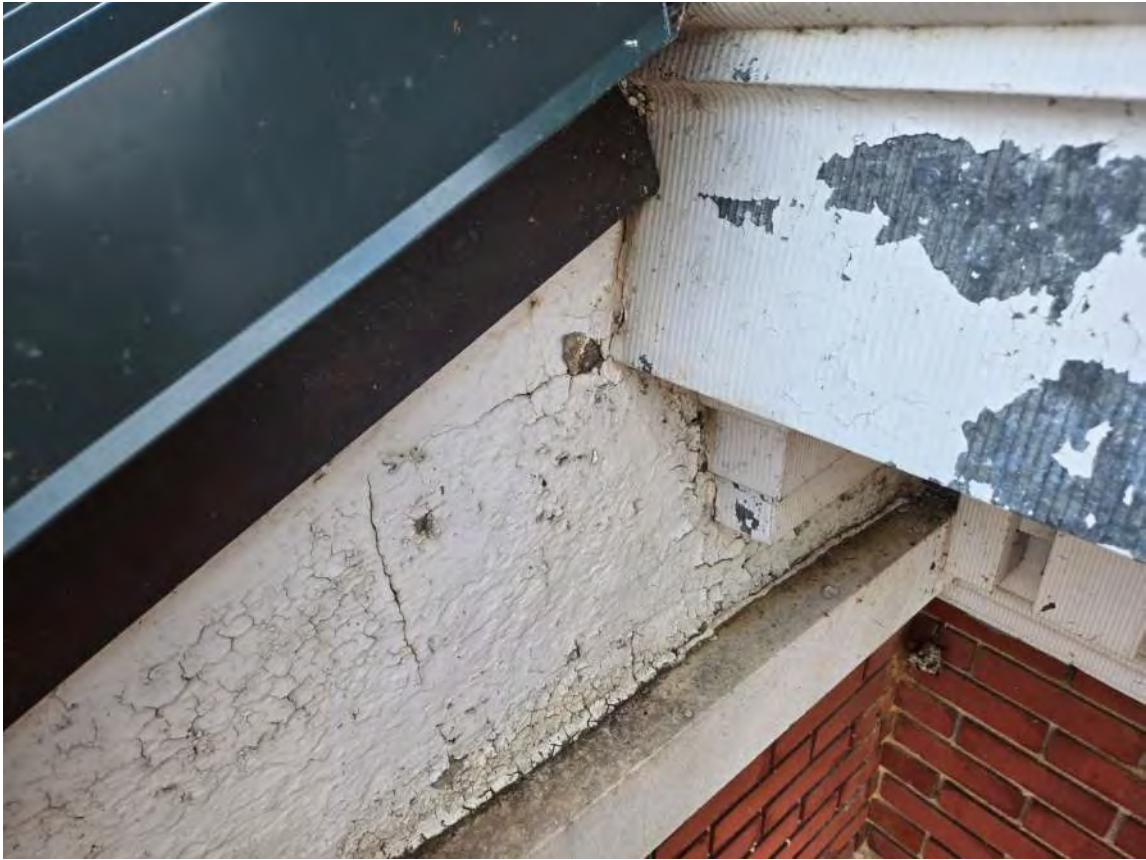
Photo 121

Photos 121 – 133 show failing and missing sealants and mortar on the exterior wall of the roof area, above the window. Reported leakage by the City of Canton and observed by W&A indicate some level of leakage to the interior in this general area.
