**CITY OF CANTON POLICE DEPARTMENT
151 ELIZABETH ST
CANTON, GA 30114**

FOLLOW-UP ROOF LEAK EVALUATION REPORT

**Re: Building Exterior Consulting Services
Roof Consulting Services
City of Canton Police Department
Canton, GA 30114
(W&A Project #: 24-01329-2)**

Follow-up Roof Leak Evaluation Report
City of Canton Police Department
Canton, GA
(W&A: 24-01329-2)

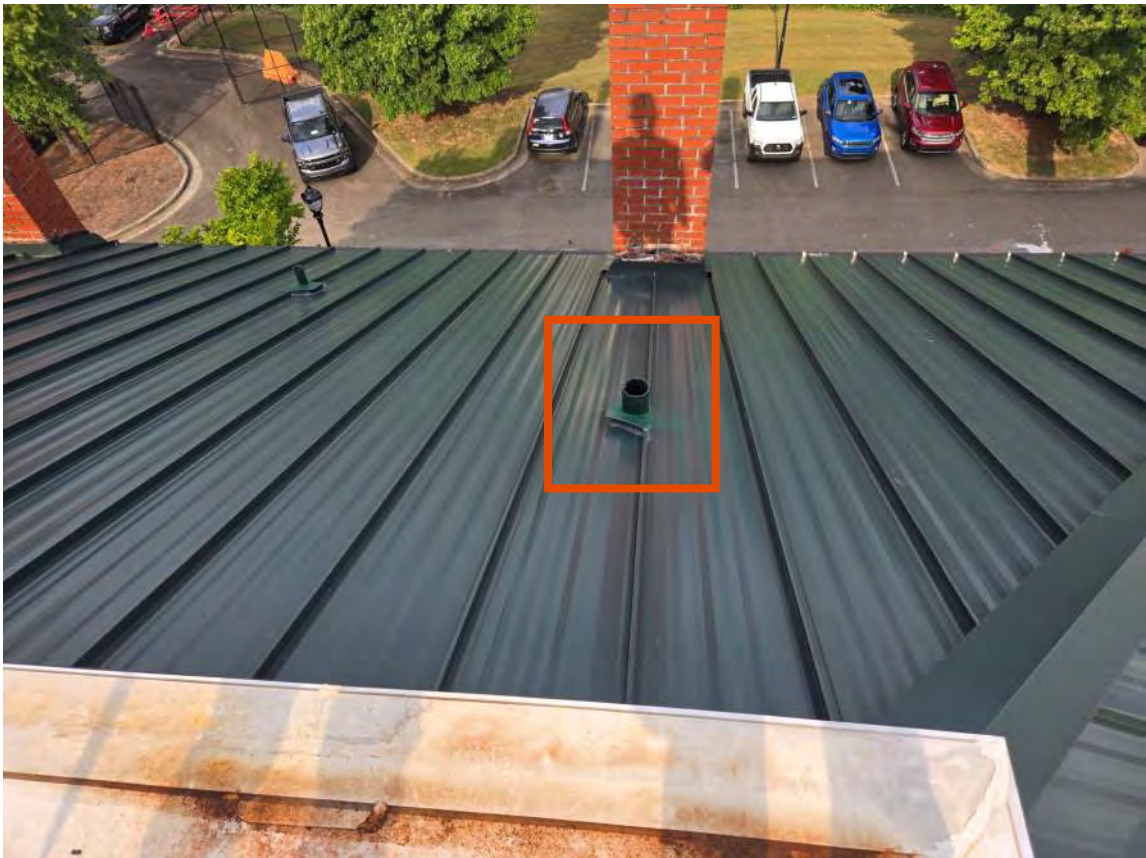
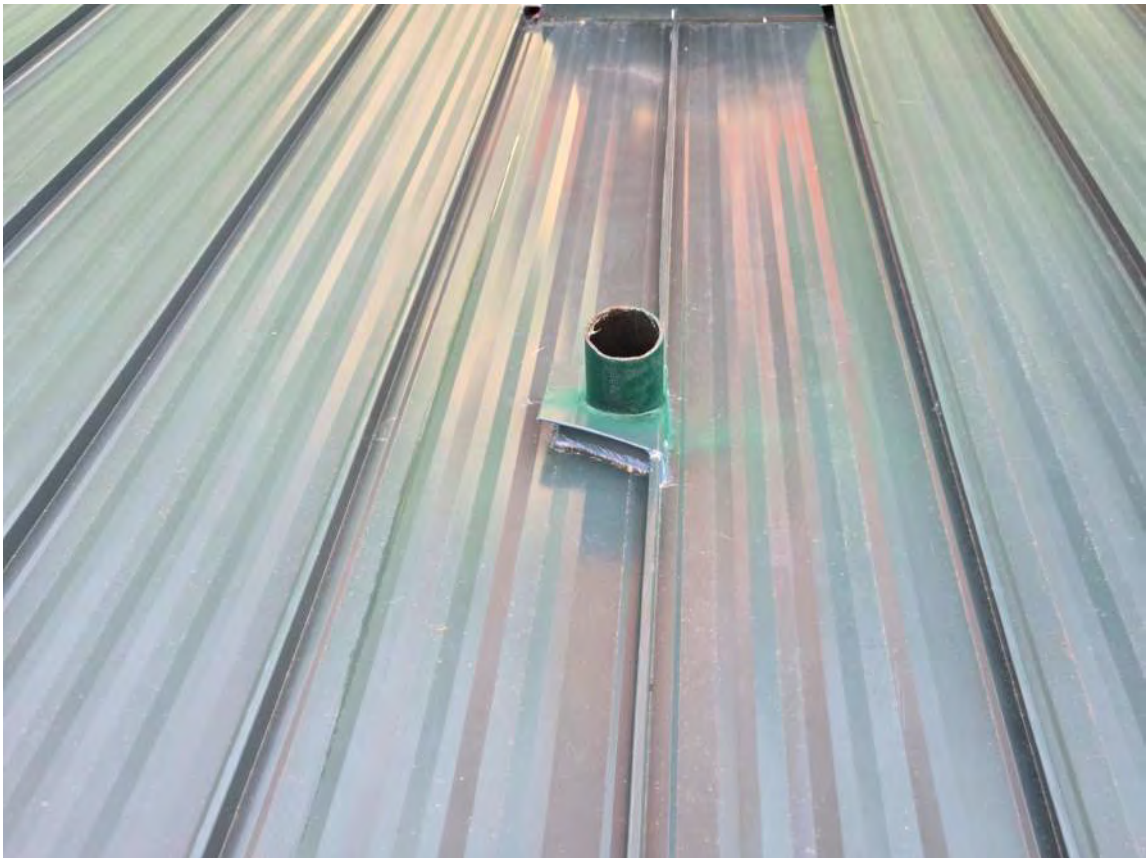
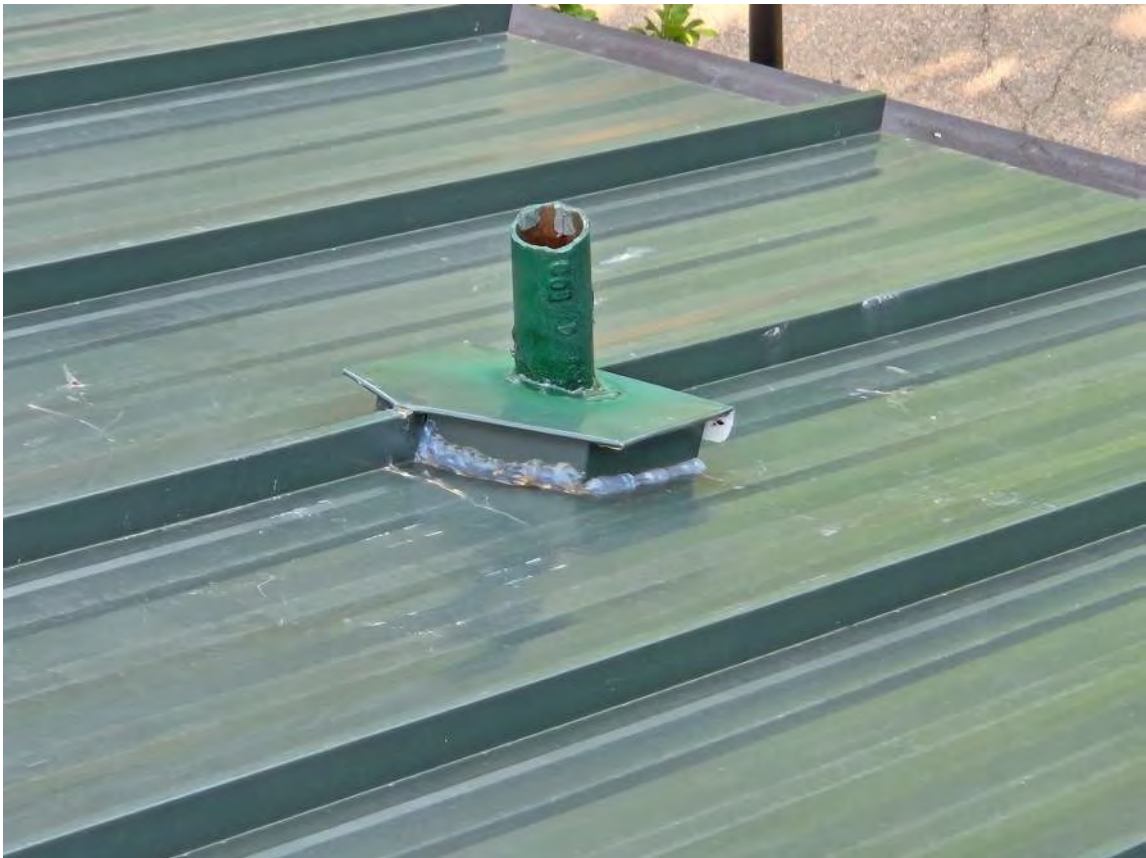
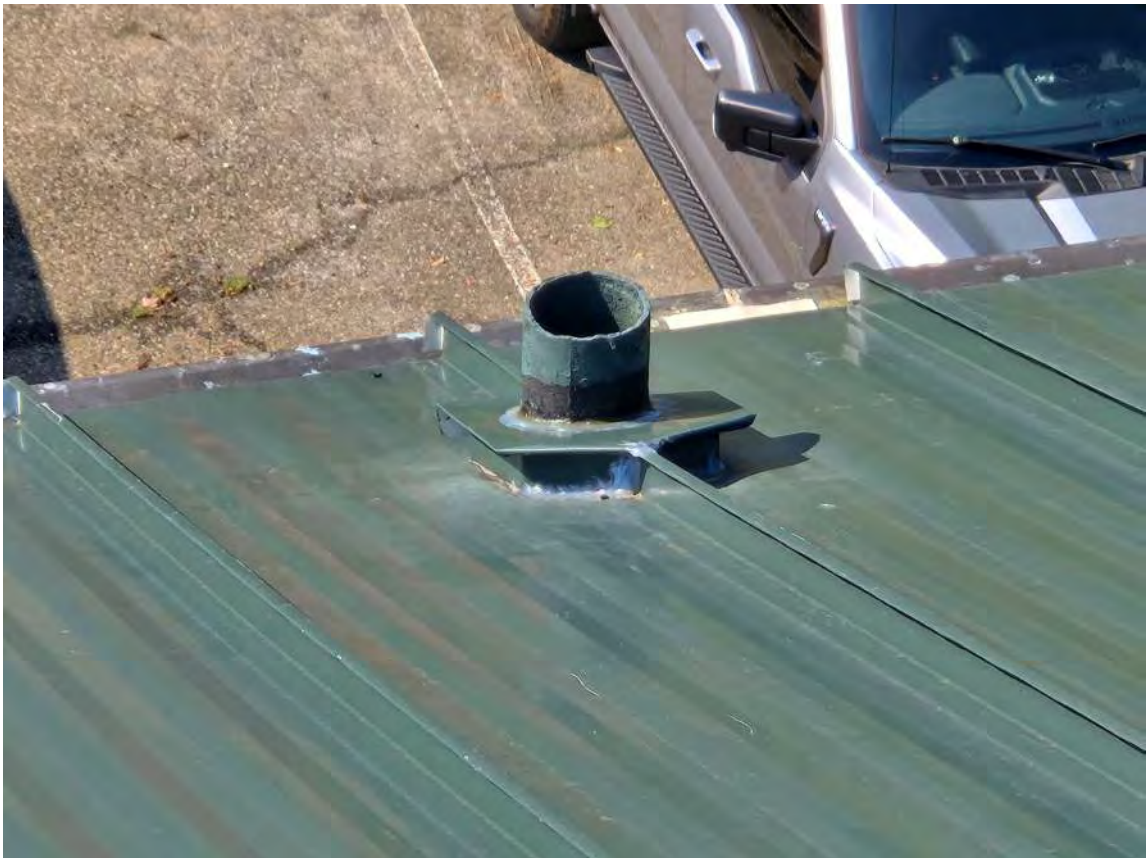
Photos 1 - 8 show that vent stack penetration flashing had been altered. Alterations were not in general accordance with published SMI details, as provided in our previous report. The sealant appeared to be clear silicone and not a professional grade sealant. These conditions are anticipated to be a source of leakage soon if left uncorrected.

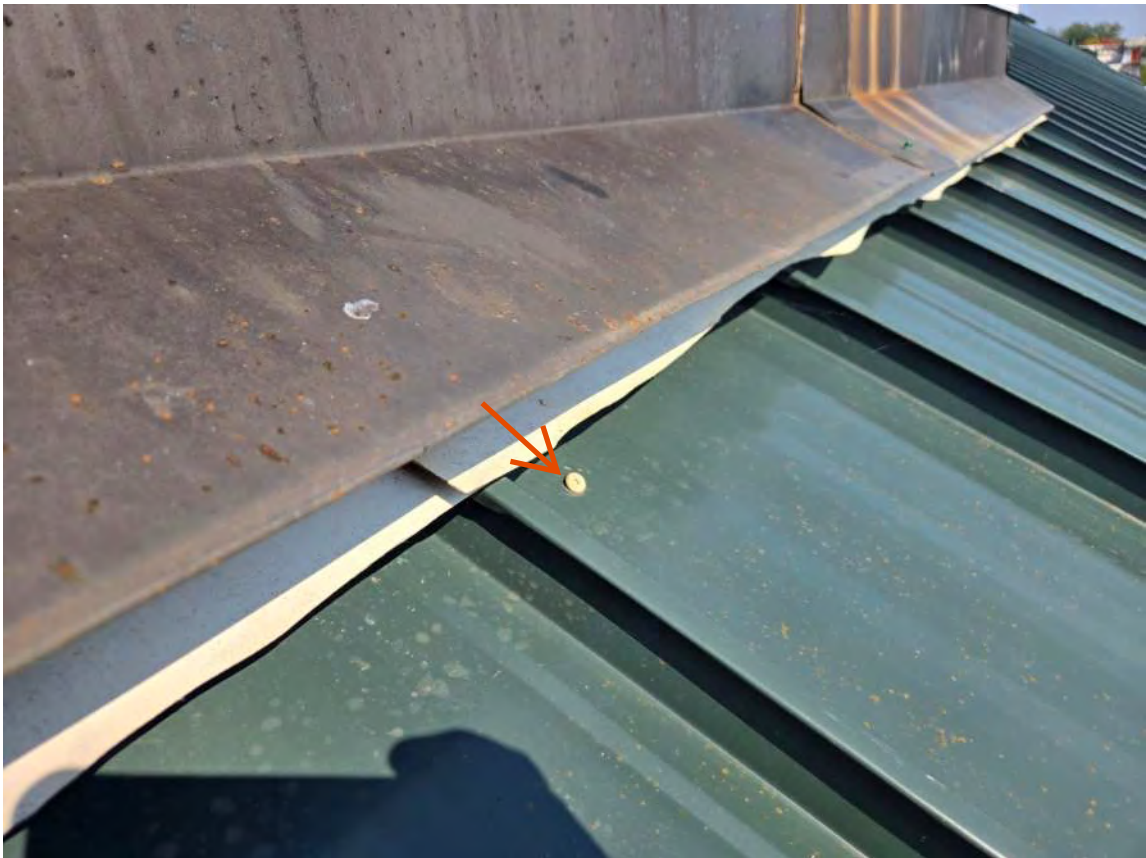
Photo 10

Photos 9 & 10 show several examples of exposed panel fasteners at the head of the panel that were not driven flush, potentially allowing water to get underneath the fasteners and panels.

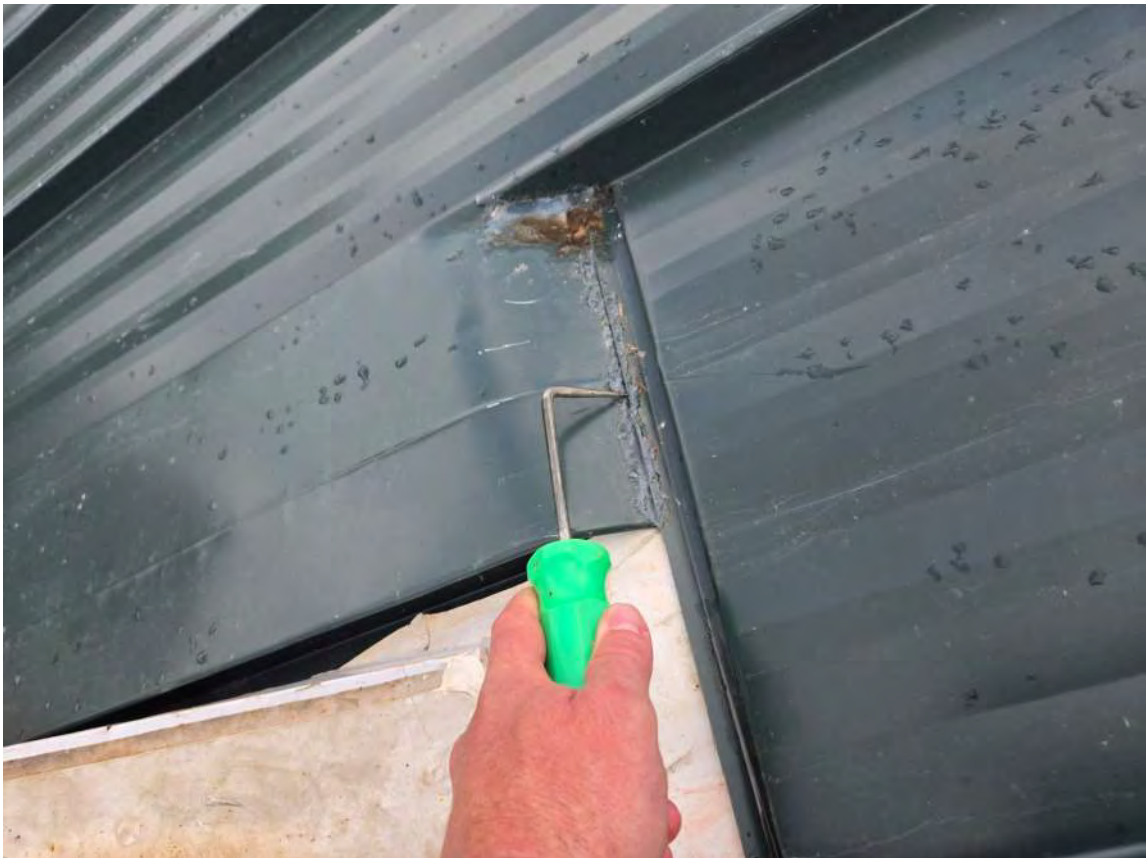
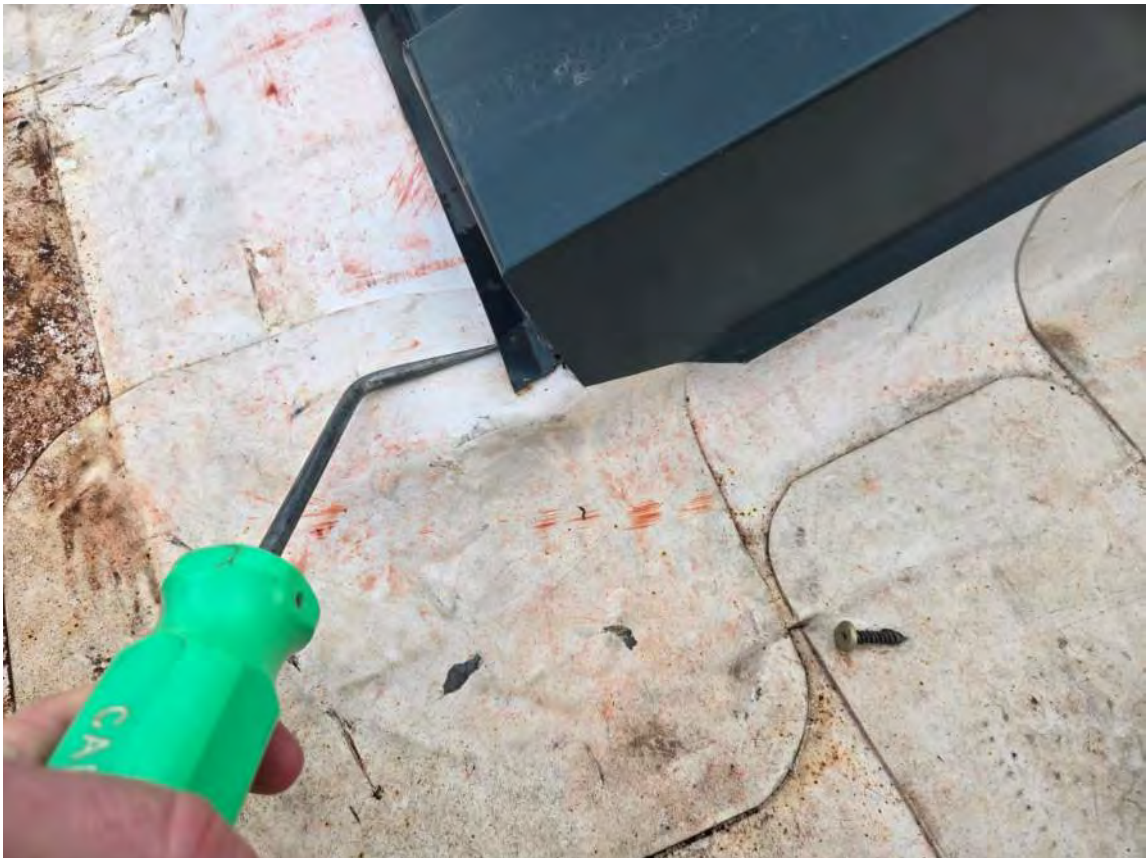
Photos 11 – 14 show transition detailing that appeared to be a change from our previous evaluation. Previous observations contained exposed panel edges that left the underlayment and adjacent single ply membrane exposed. The corrective works appears to be a field fabricated box that covered the condition. The box does conceal some of the previous concerns but is unlikely to have eliminated the potential for future roof leakage.

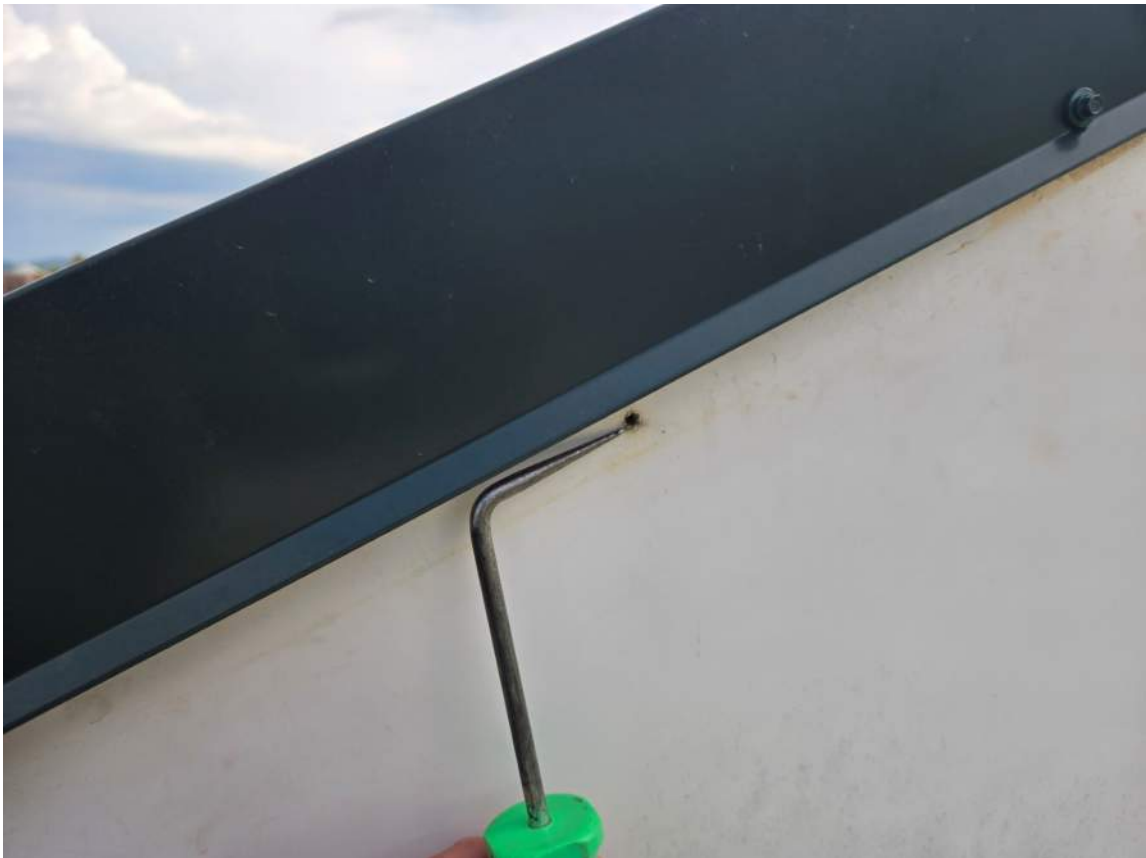
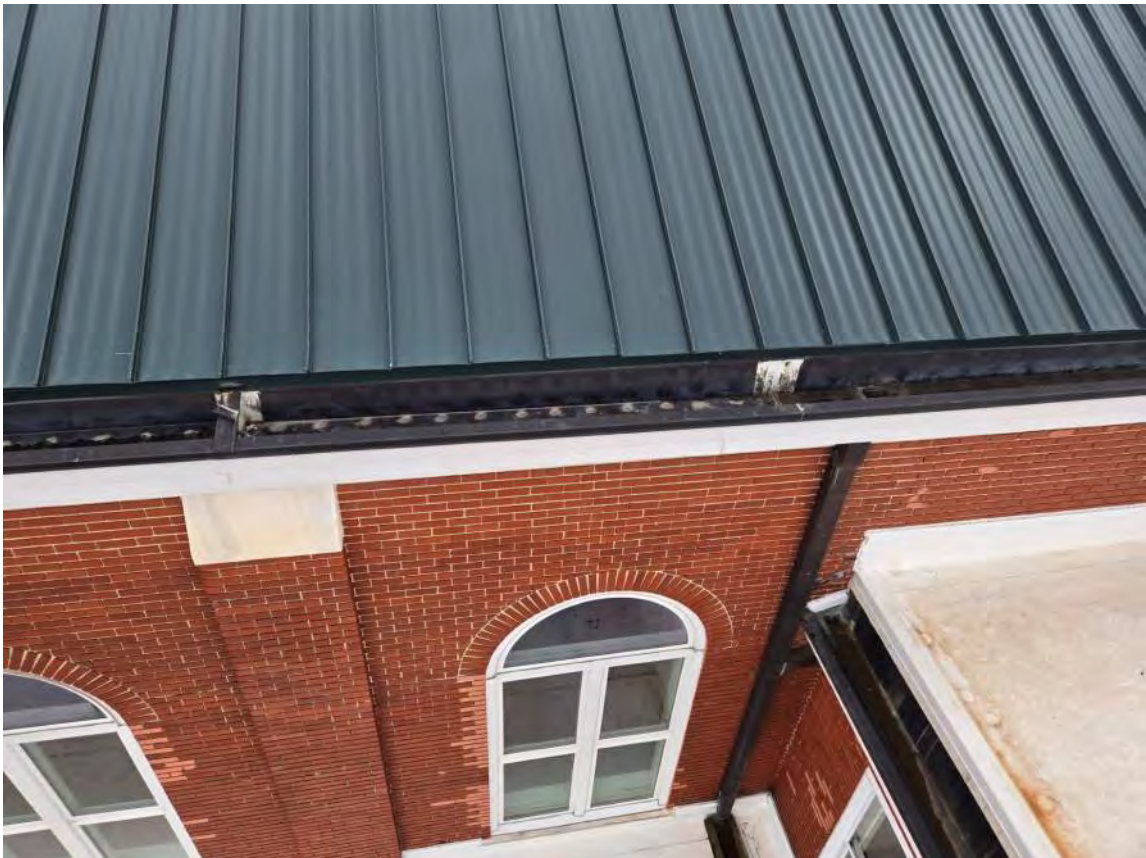
Photos 15 – 17 show that termination bar sealant contained voids and abandoned fastener penetrations had not been sealed. Both of these items are anticipated to contribute to leakage inside the building.

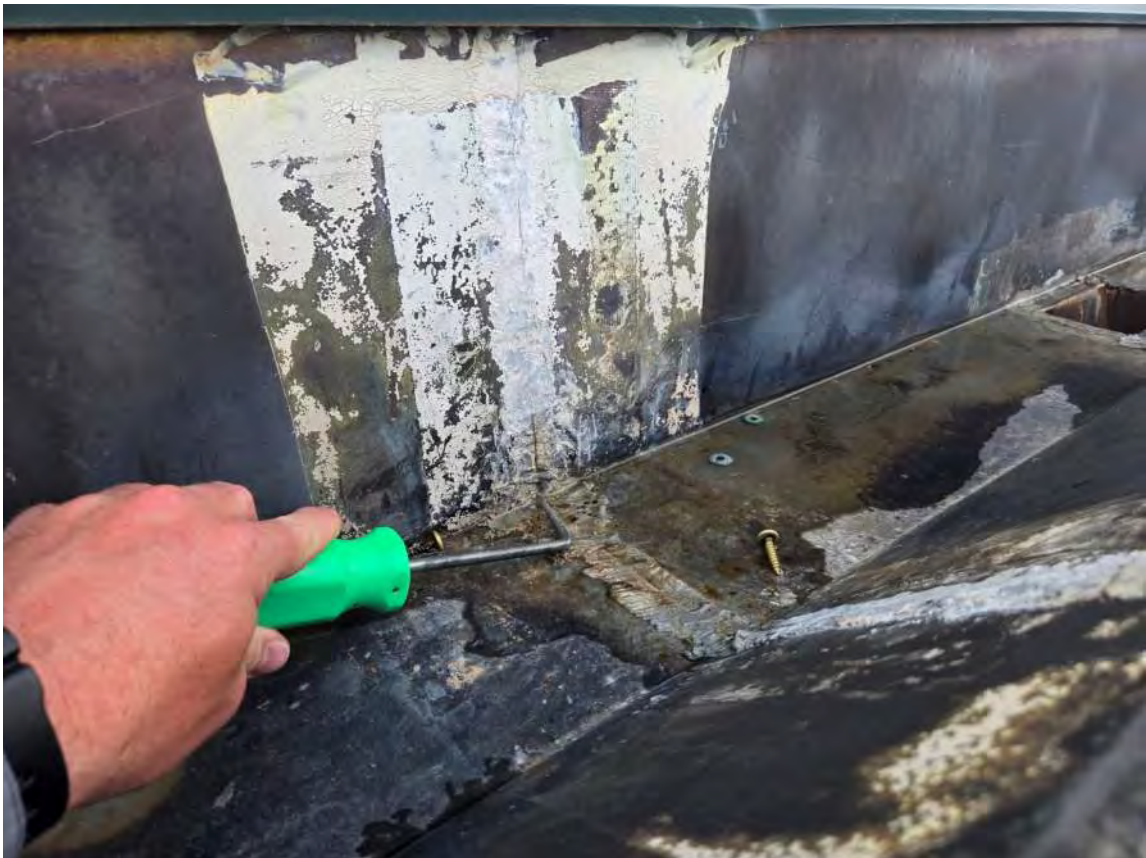
Photos 18 – 20 show that the gutter solder joints are cracked and allowing water into the wood soffit/cover. While this is not anticipated to be a cause of interior leakage, the uncontrolled water may lead to future problems, including but not limited to wood rot of the decorative gutter covers.

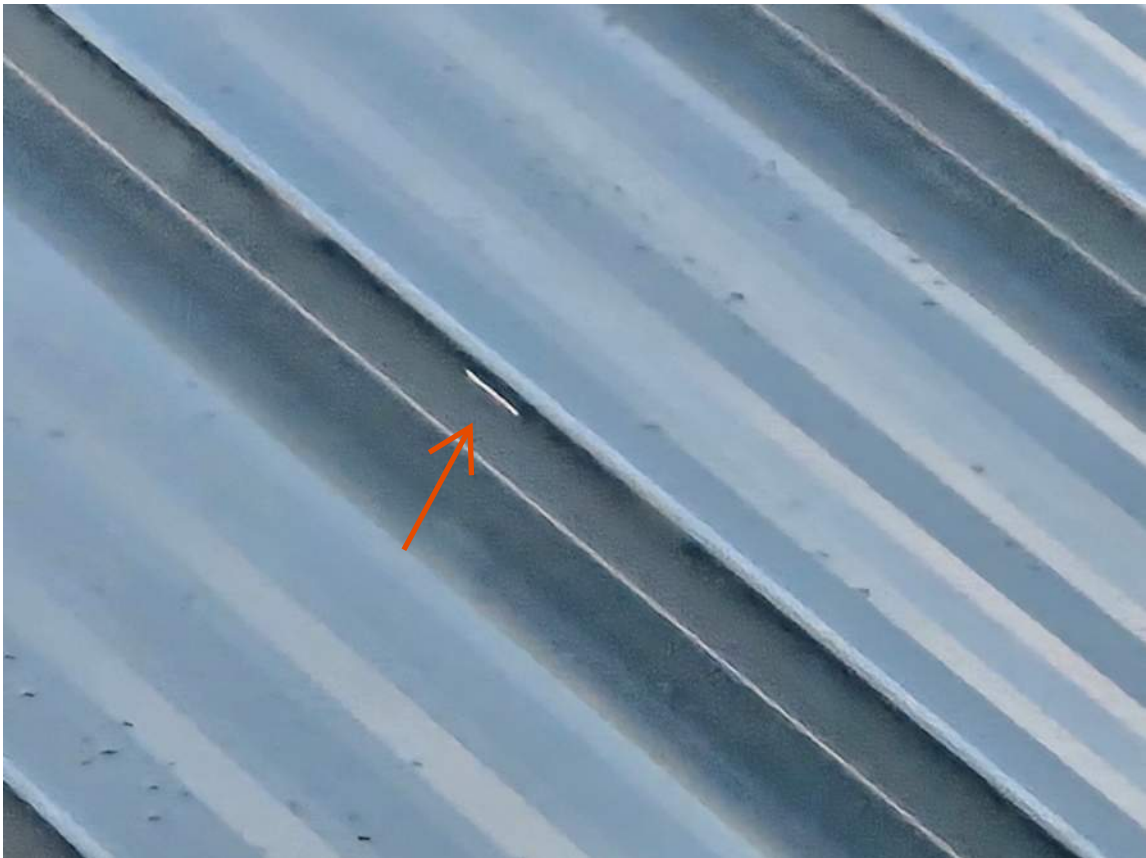
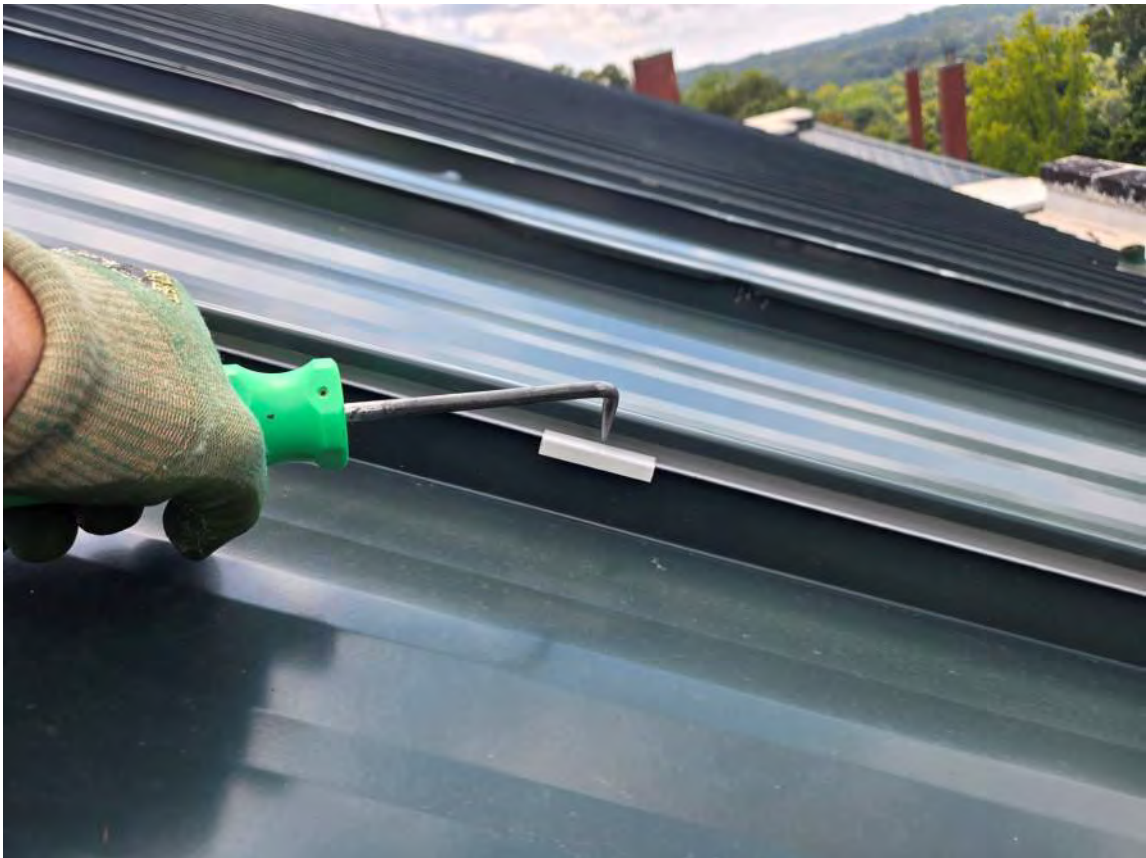
Photos 21 – 24 show that panel seams had not been corrected from our last evaluation and report. The level of seaming observed is consistent with what SMI considered to be Step 2 of 4 of the seaming process. Anchor clips were exposed sporadically across the roof area. These observations were present in areas that Canton reported to have been worked on by the roofer.

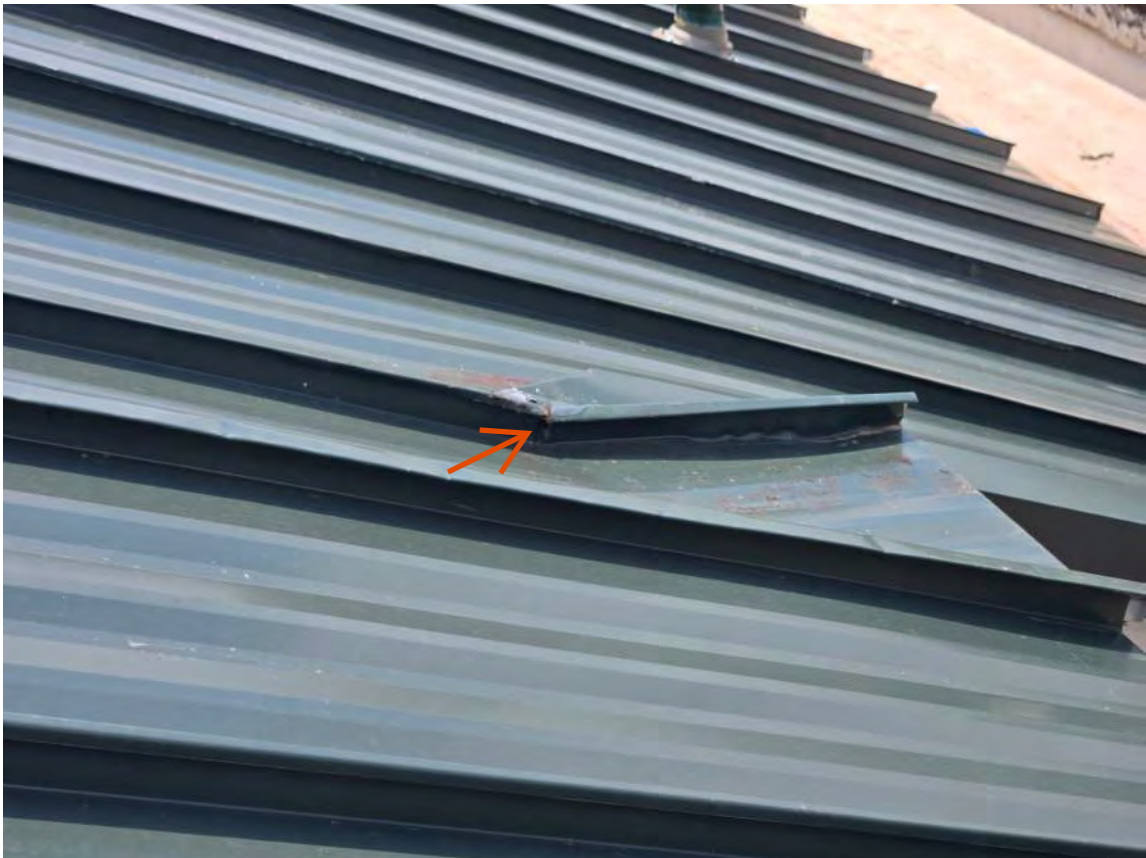
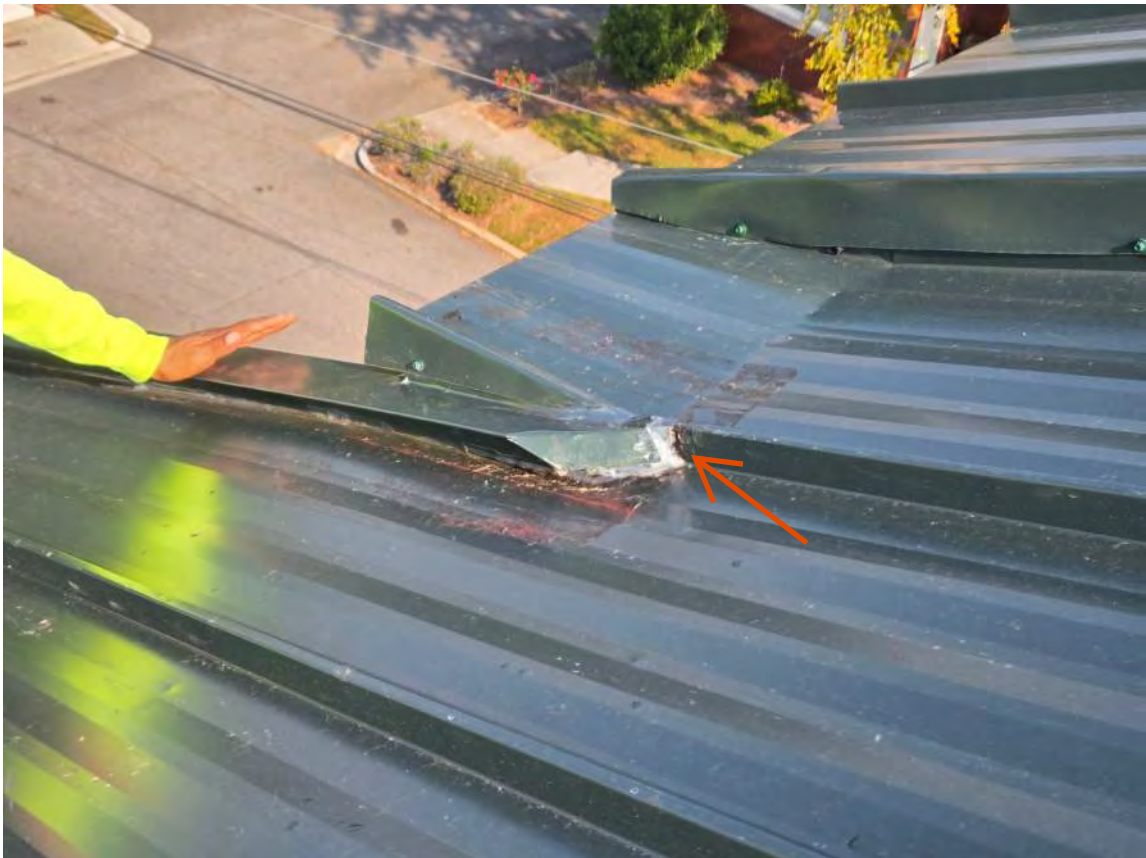
Photos 25 – 28 show a detail area within the reported area of corrective work. Panels were field bent to better follow the contour of the roof deck but the detailing of the bent panel and flashing with clear silicone sealant was improper and contained voids. The method of corrective work in this location does not appear to conform with what we would consider best practices.

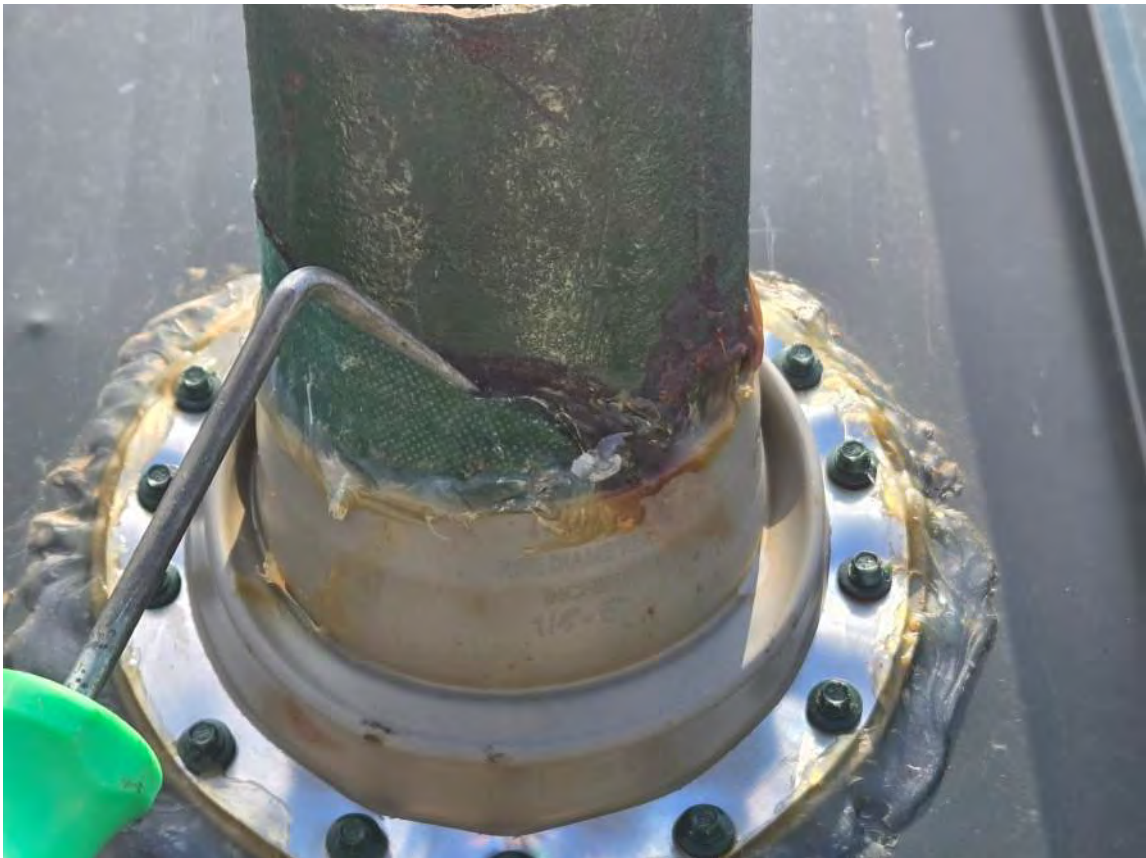
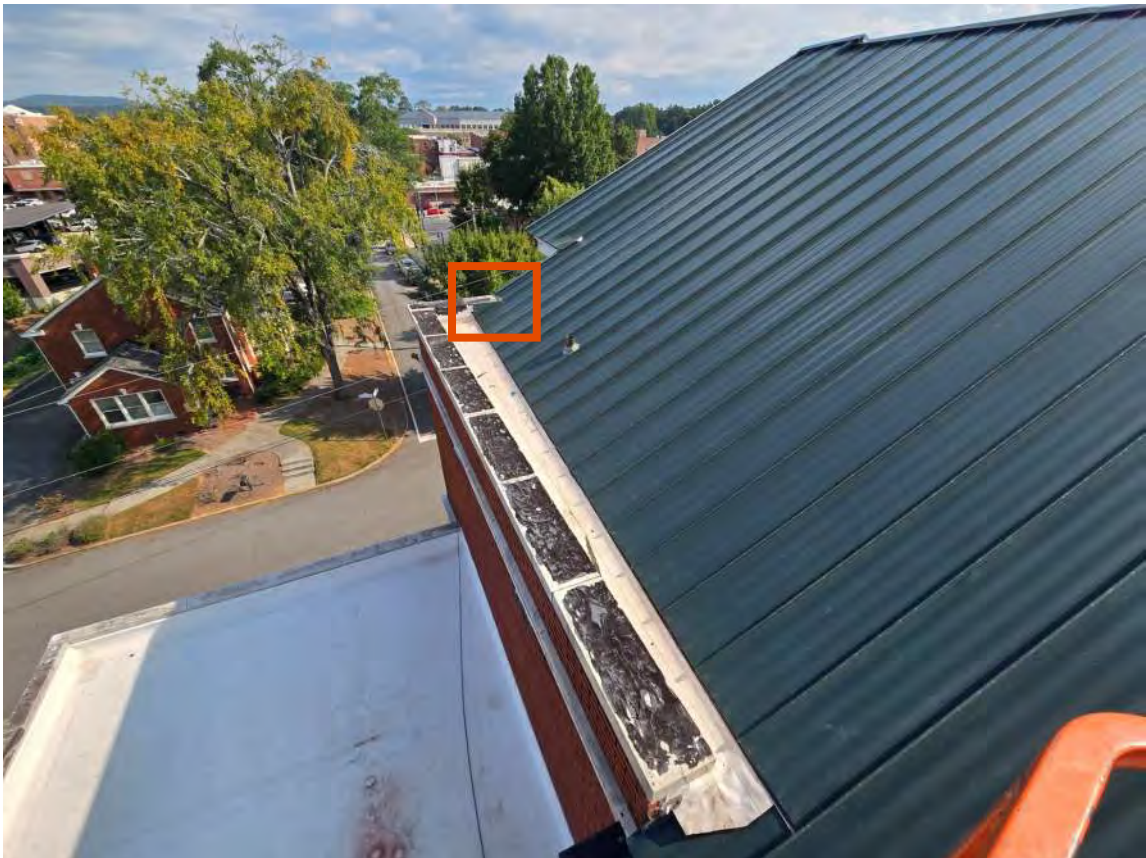
Photos 29 – 31 show an added penetration boot. The previously observed painted underlayment was left exposed and contained voids. The boot was detailed to the metal panel with clear silicone, indicating that butyl tape, as called for by SMI, was not likely underneath the penetration boot. The clear silicone was not well adhered to the panel.

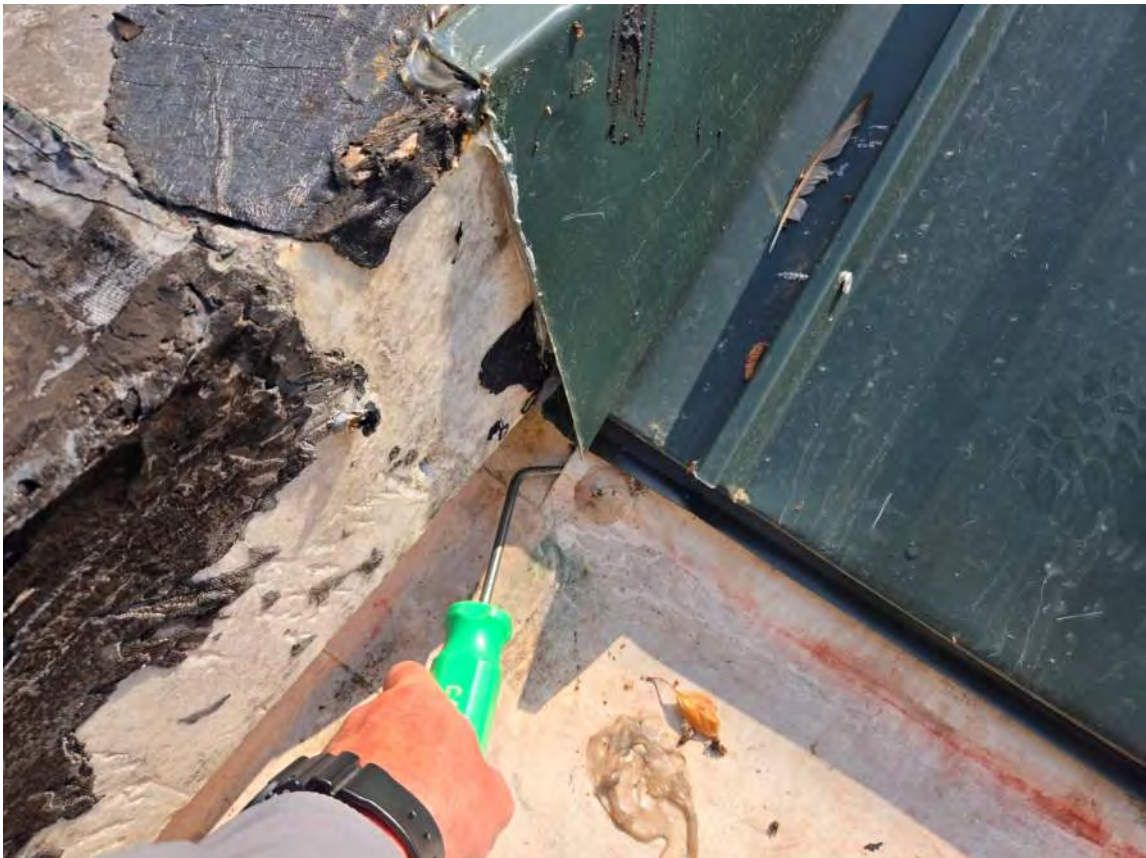
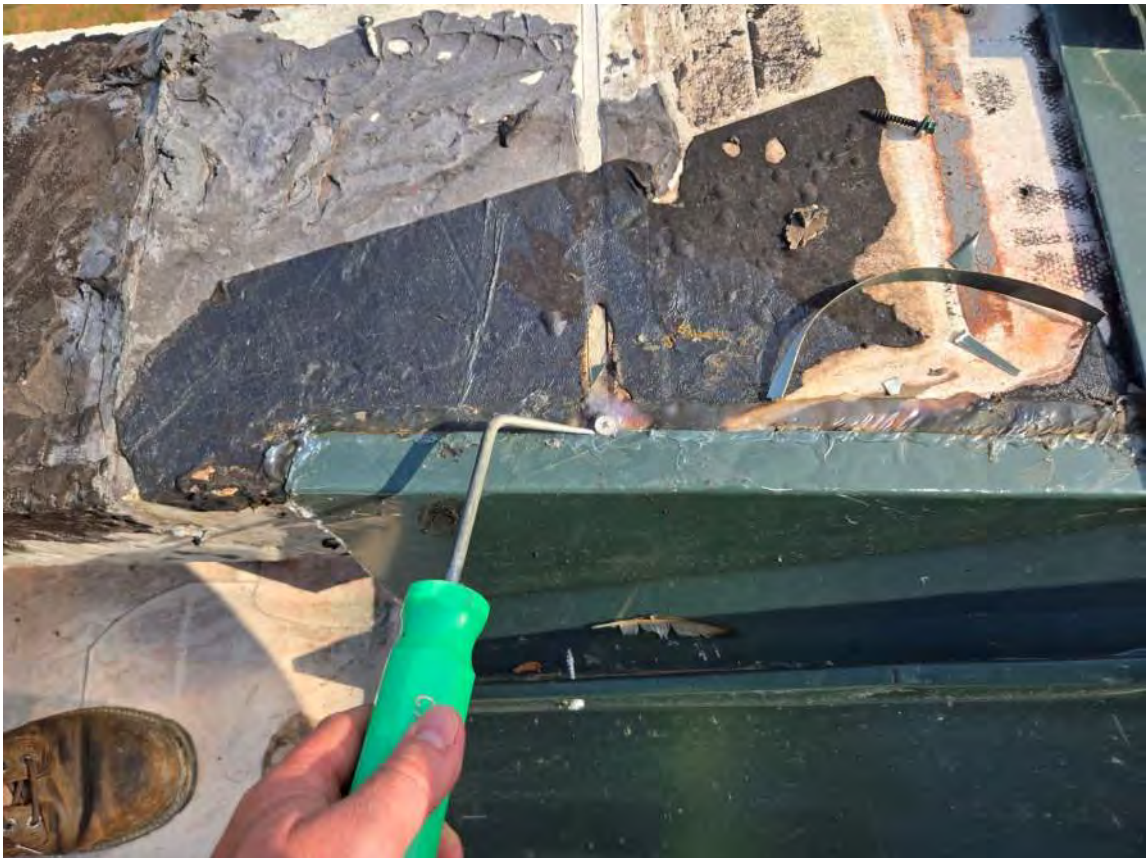
Photos 32 – 36 show that some correct work had been attempted at the north parapet transition area between Areas 3 & 4. Metal flashings were loosely held in place with clear silicone and screws through the stone coping. An open TPO seam was observed in the area. This area appears to be one of several contributing factors to interior leakage.

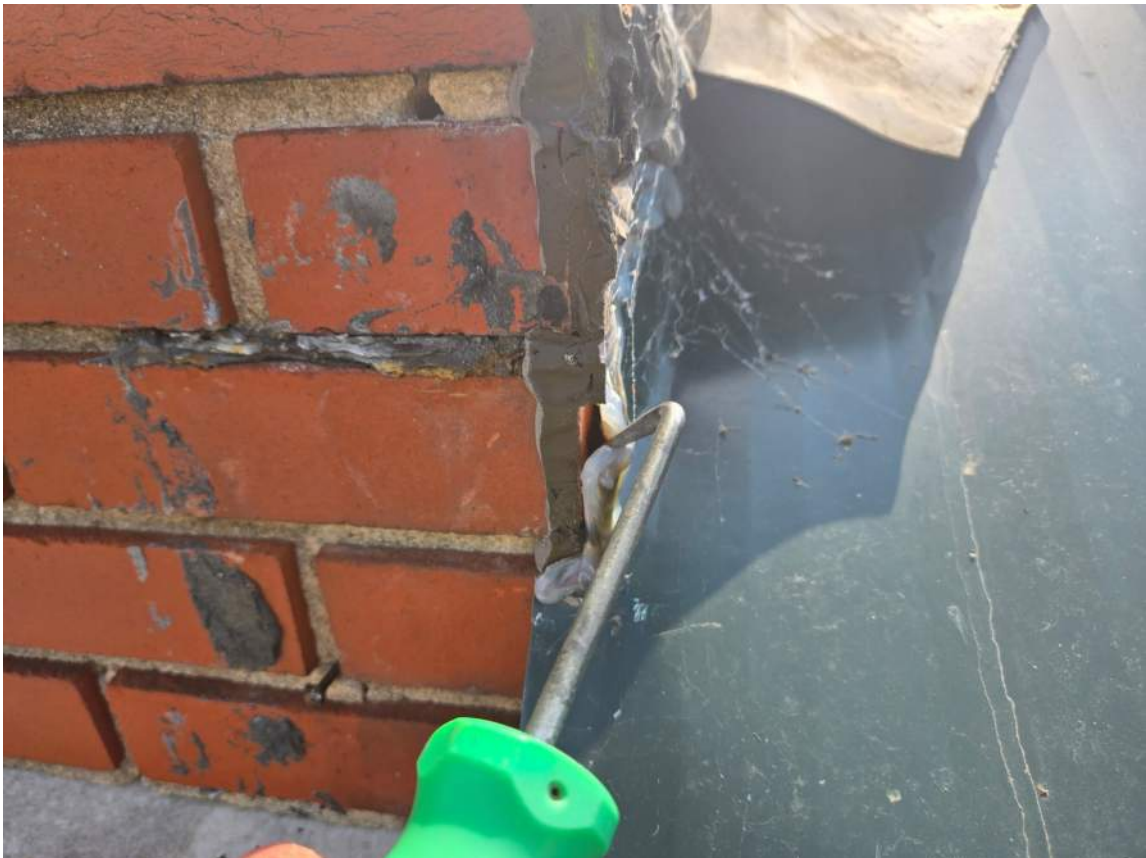
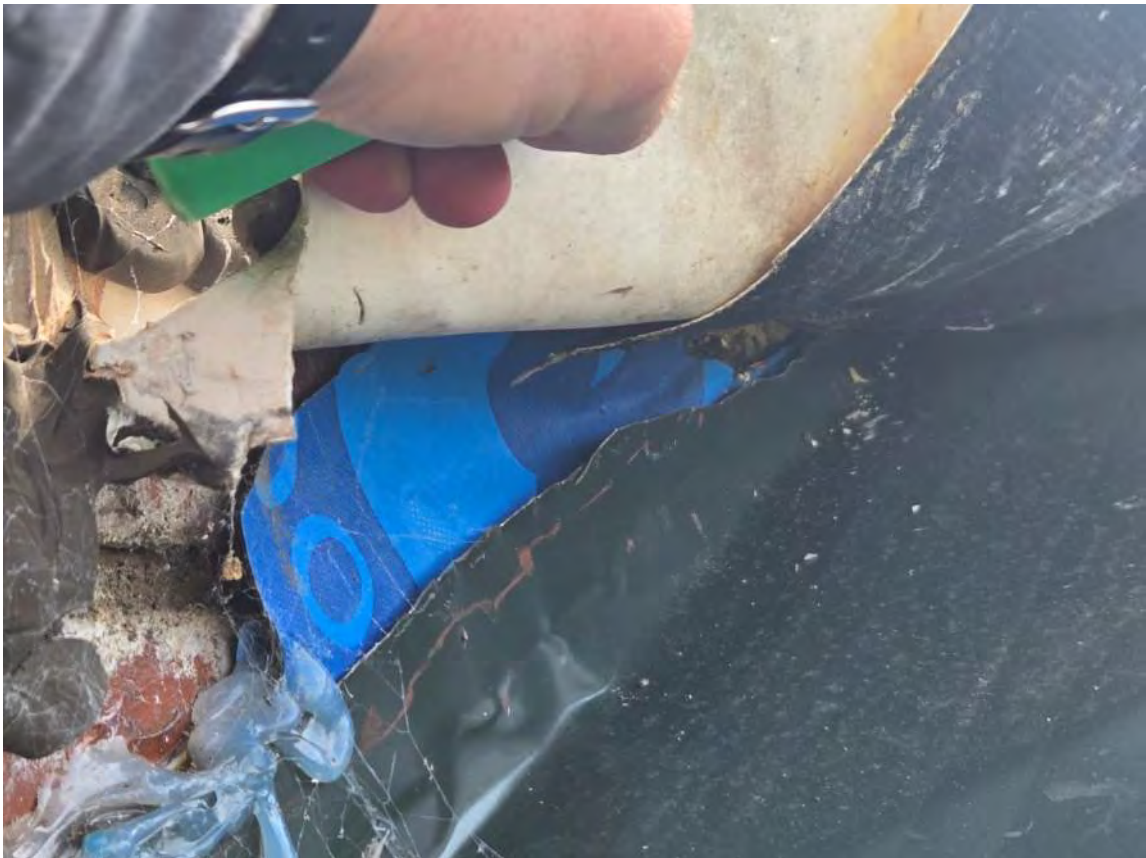
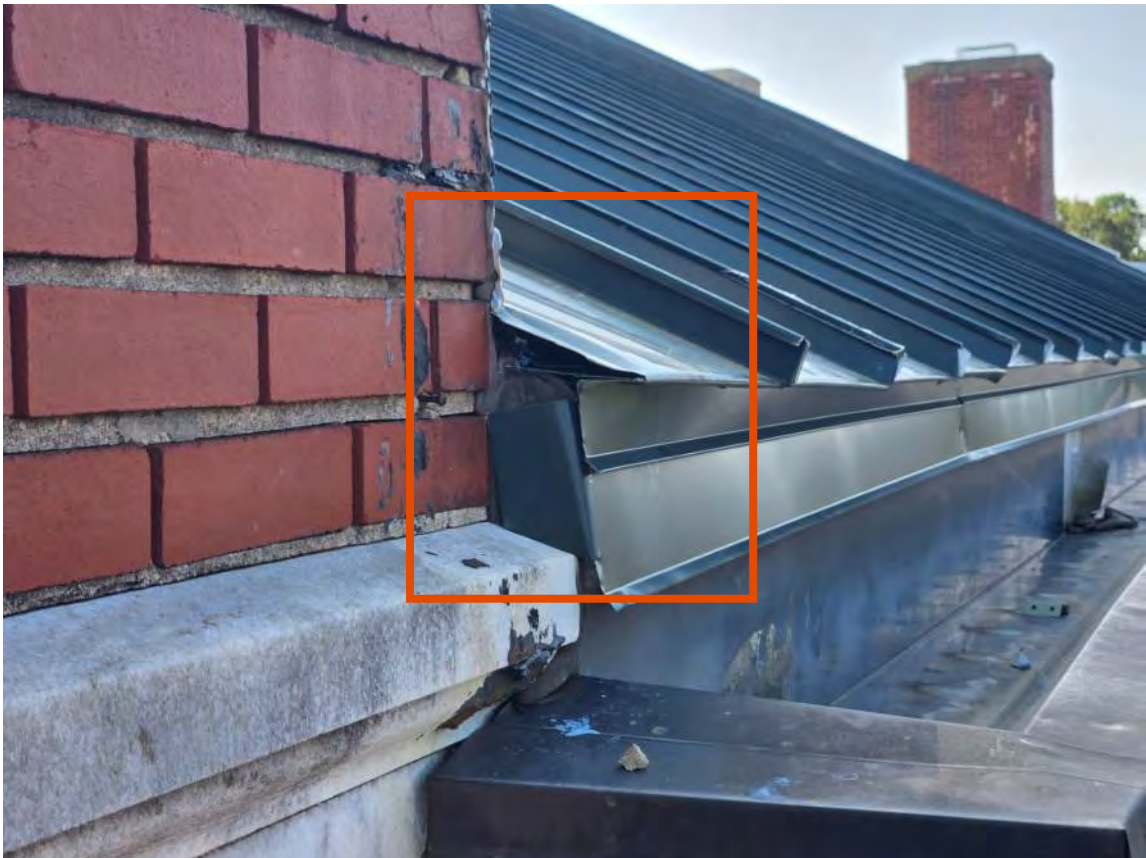
Photos 37 – 41 show that the corrective work performed on the Area 4 to Area 3 transition, in the Area 4 drainage path was limited primarily to clear silicone that was not well applied and was not well adhered. Wind driven rains and high volumes of water drainage are anticipated to be able to bypass the detailing in this location and enter the building.

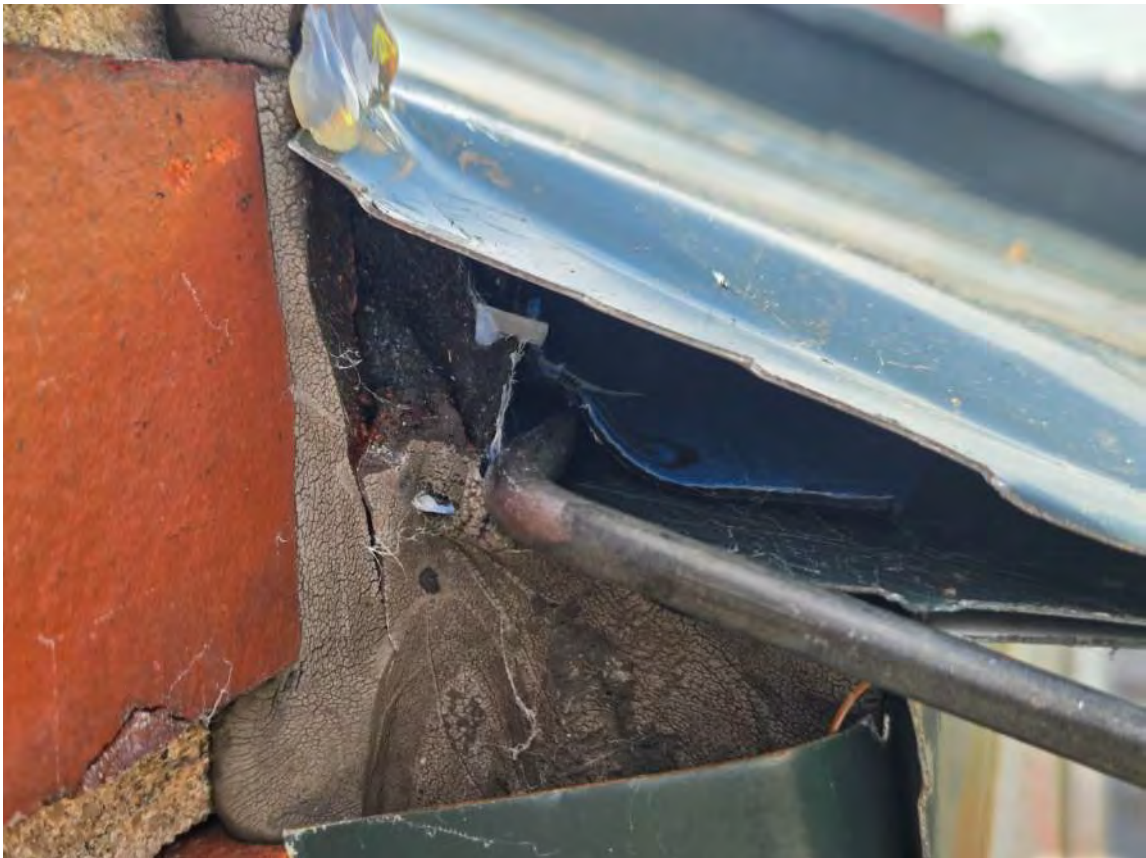
Photos 42 – 44 show that the edge panel bypassing the Area 4 parapet contained a large open void that provided direct access to water. Once water entered the void, it could likely travel and may be able to enter the building. The counter flashing over the gutter was also poorly attached and easily manipulated by hand. Existing sealants had not been replaced with new.
