**CITY OF CANTON POLICE DEPARTMENT
151 ELIZABETH ST
CANTON, GA 30114**

FOLLOW-UP ROOF LEAK EVALUATION REPORT

**Re: Building Exterior Consulting Services
Roof Consulting Services
City of Canton Police Department
Canton, GA 30114
(W&A Project #: 24-01329-2)**

Follow-up Roof Leak Evaluation Report
City of Canton Police Department
Canton, GA
(W&A: 24-01329-2)

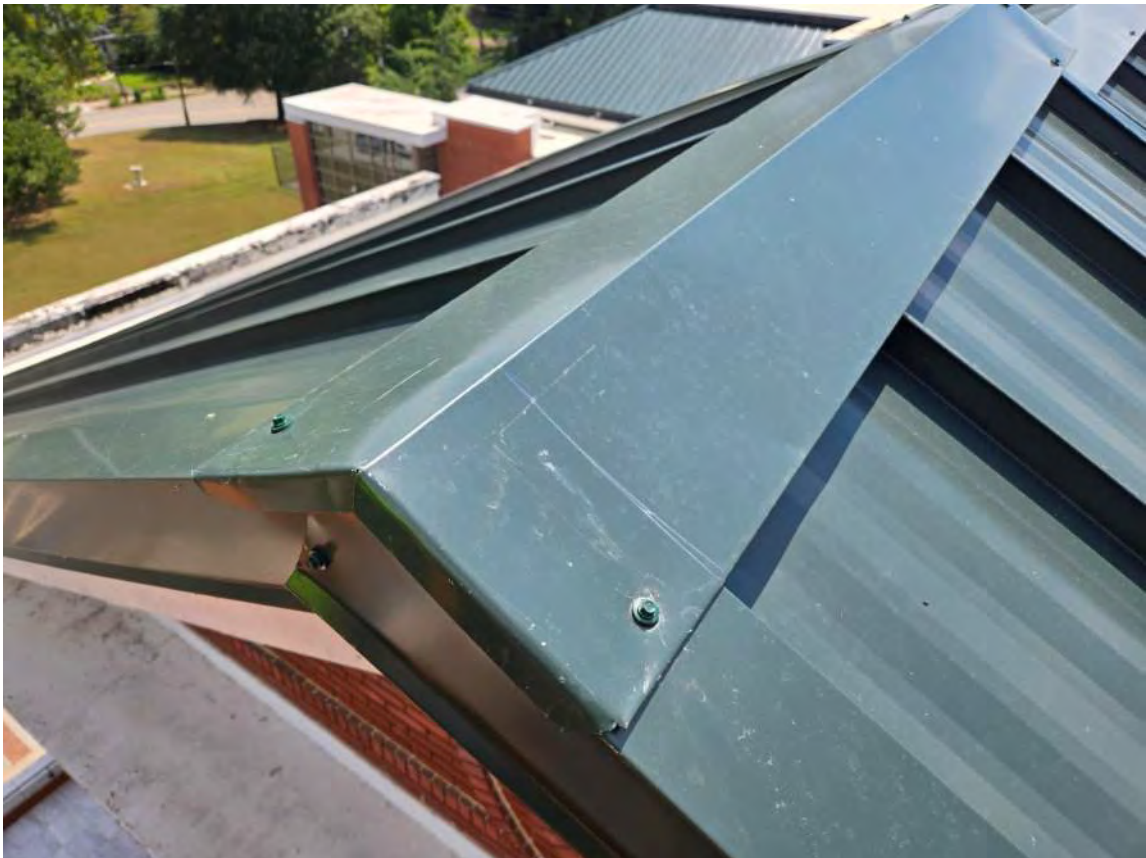
Photo 45 shows that the ridge cap was not well aligned at the ridge and contained sporadically placed fasteners in lieu of pop rivets placed 18" OC as required by SMI.

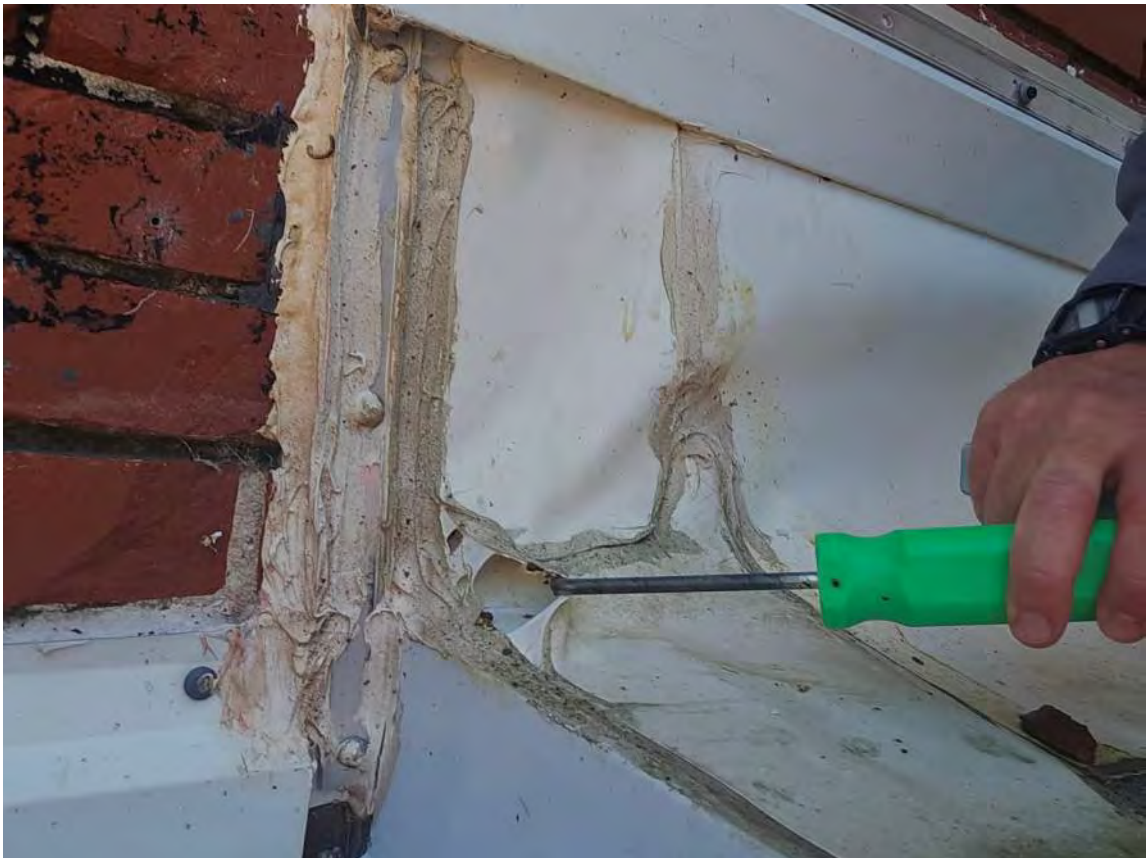
Photo 79

Photos 79 & 80 show that the vertical edge flashing at the outside edge of the roof was not well adhered and contained voids in the flashing.

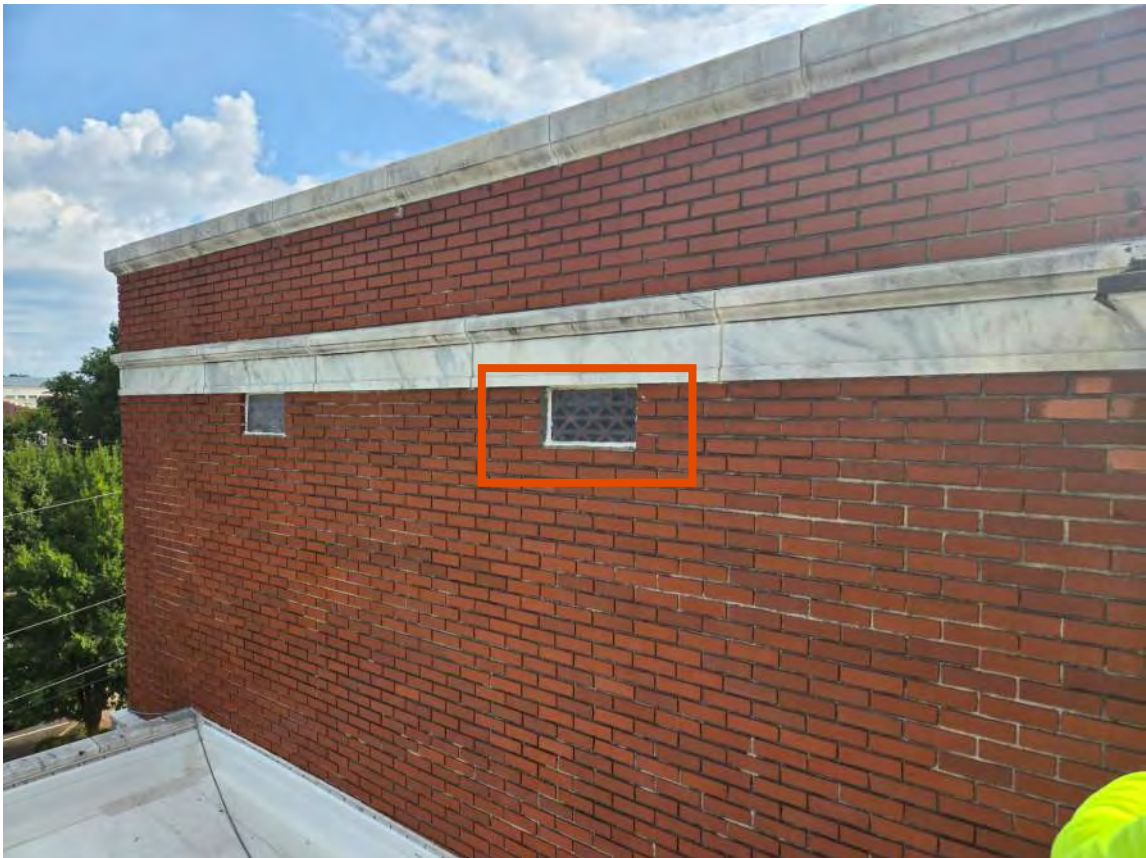
Photo 95 shows additional examples of masonry distress, as has been observed elsewhere.

- Tuck point areas of wall with missing/degraded mortar above roofing terminations and within areas of exterior wall above leakage. See **Photos 71 – 73, 92, 93, 123, 124, 126 – 128** as examples.
- Repair areas of cracked masonry/masonry distress. See **Photos 95, 101** as examples.
- At rising masonry walls, consider the application of a clear silicone coating after the tuck pointing has been completed. Clear silicone coatings, such as GE Optic, allow the wall system to continue to function as originally intended while limiting bulk water entry into the wall system.
- Remediate cementitious panels at gable ends of roof. See **Photos 52 – 54** for example areas.
- Re-solder copper gutters

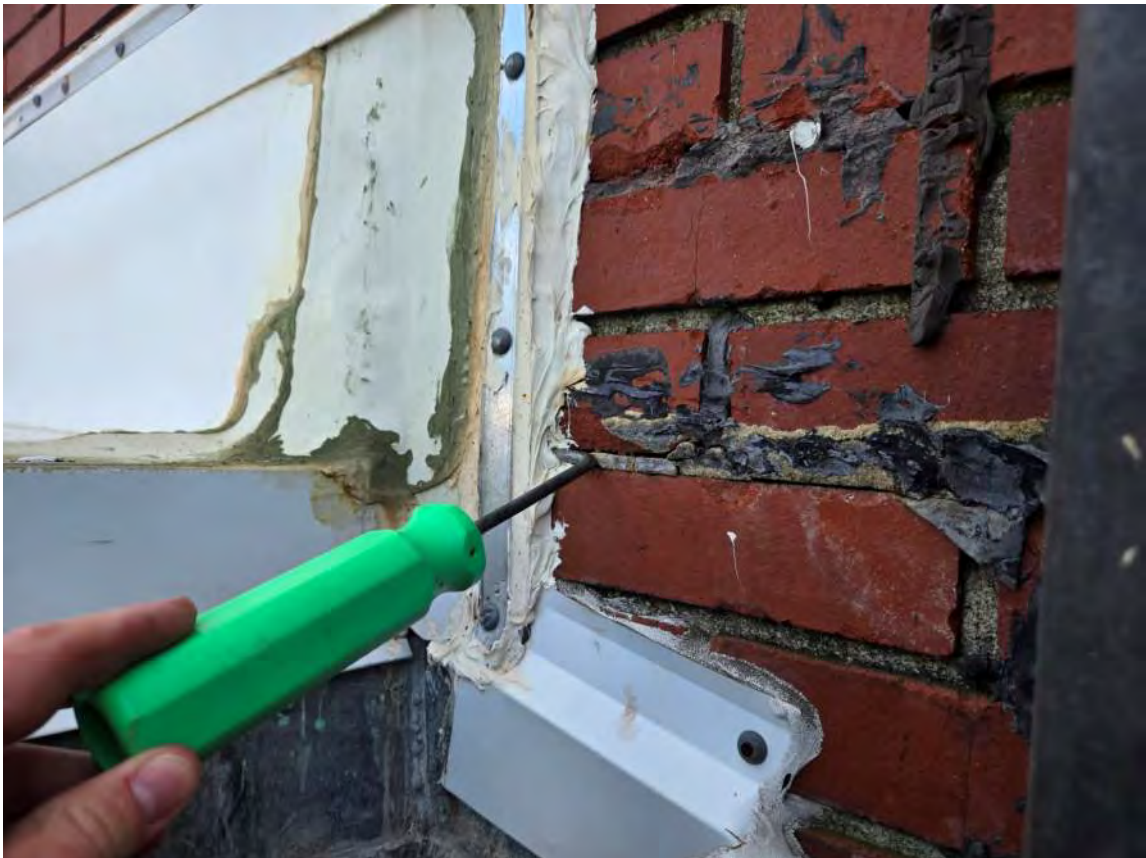
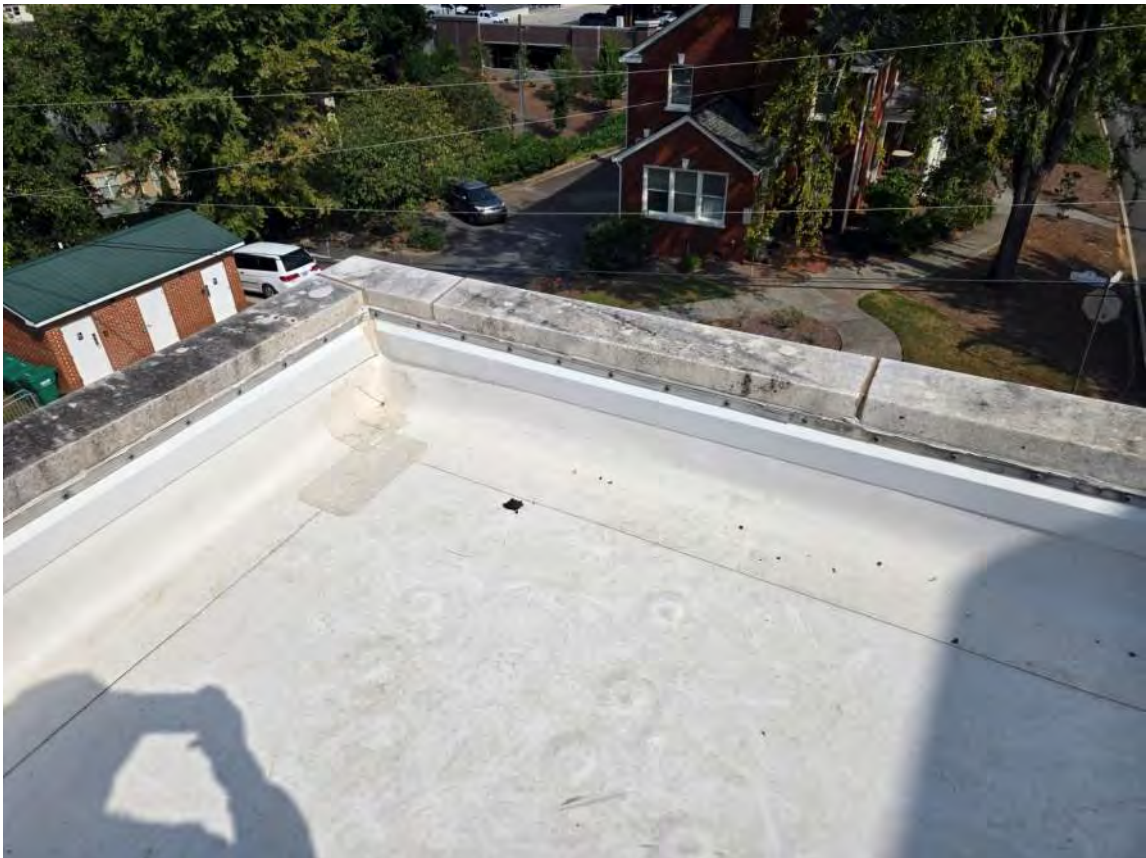
Photos 98 – 101 show perimeter flashing termination deficiencies that may allow water to enter the building.

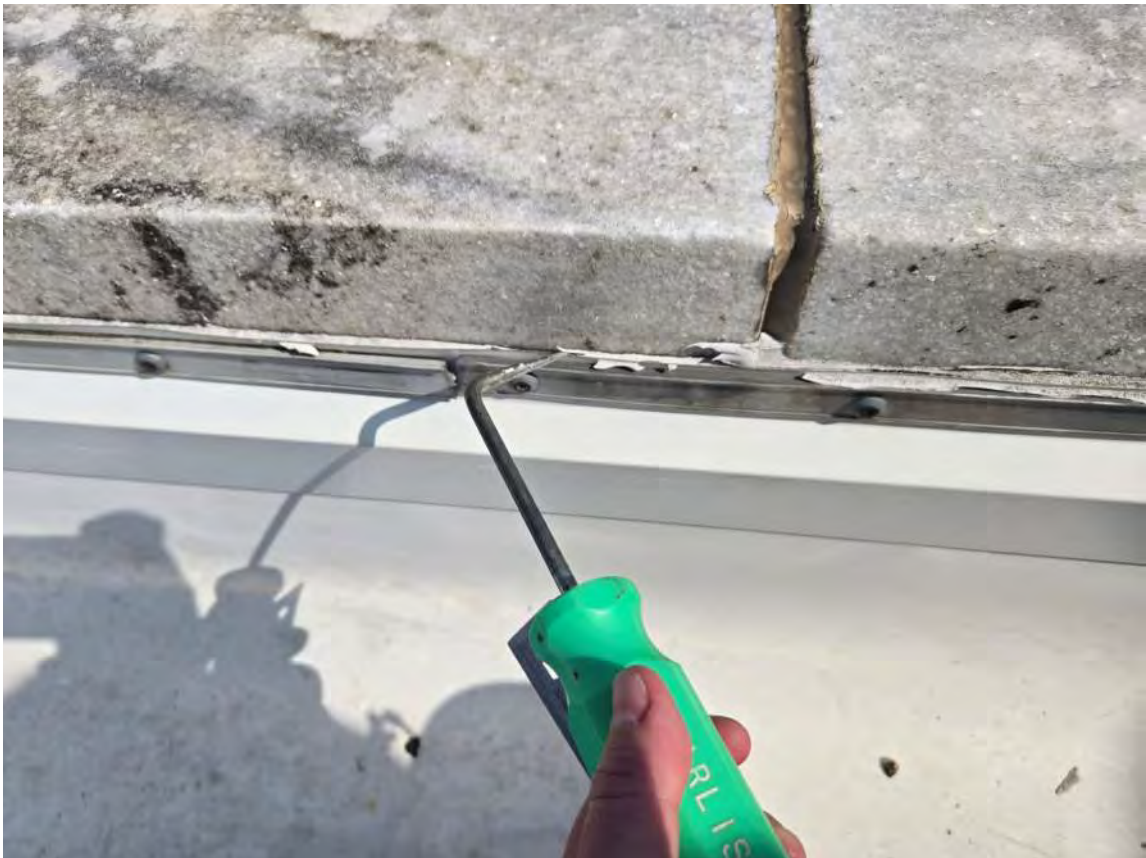
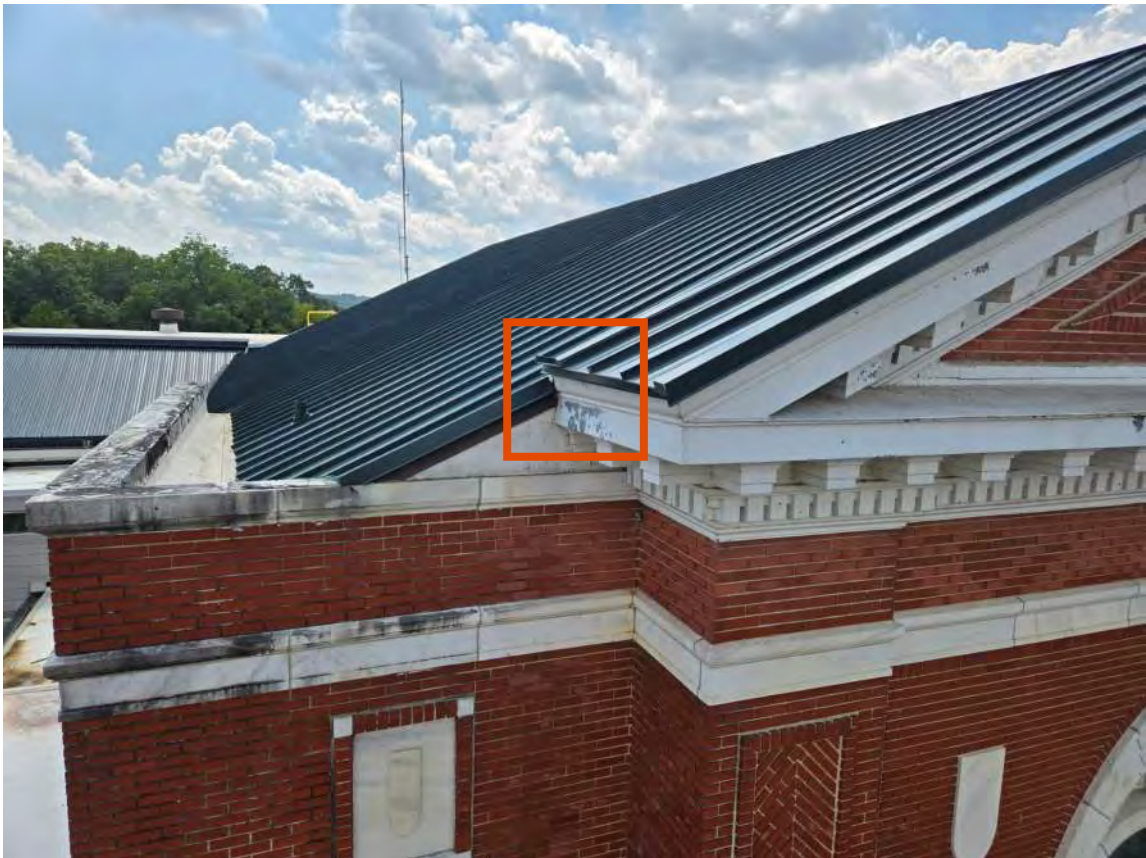
Photos 102 – 105 show additional views of degraded sealant at the older/reused surface mounted counter flashing and coping stone to rising wall termination.

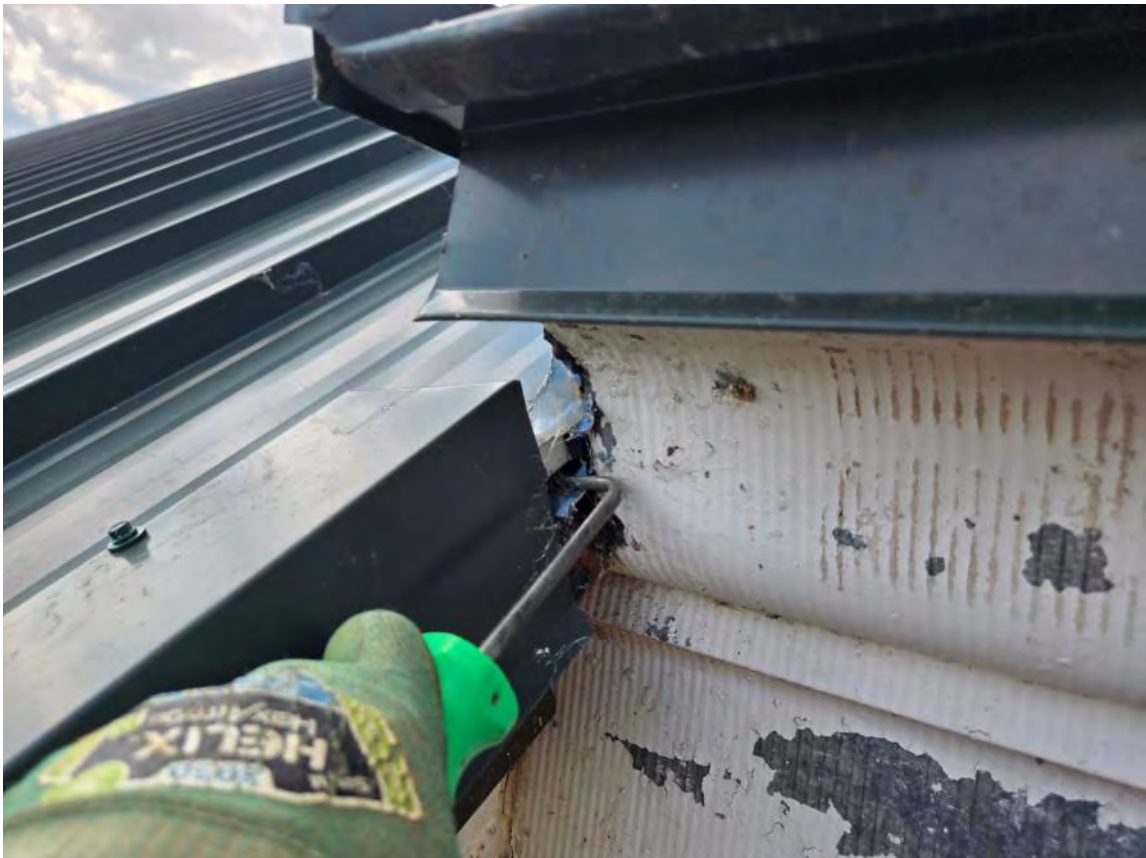
Photo 107

Photos 106 & 107 show the general condition of the roofing system during our evaluation. A lesser amount of leakage was reported on the east side of the gable, compared to the west side of the gable. Some exterior wall concerns were observed, similar to what was observed on the west side.

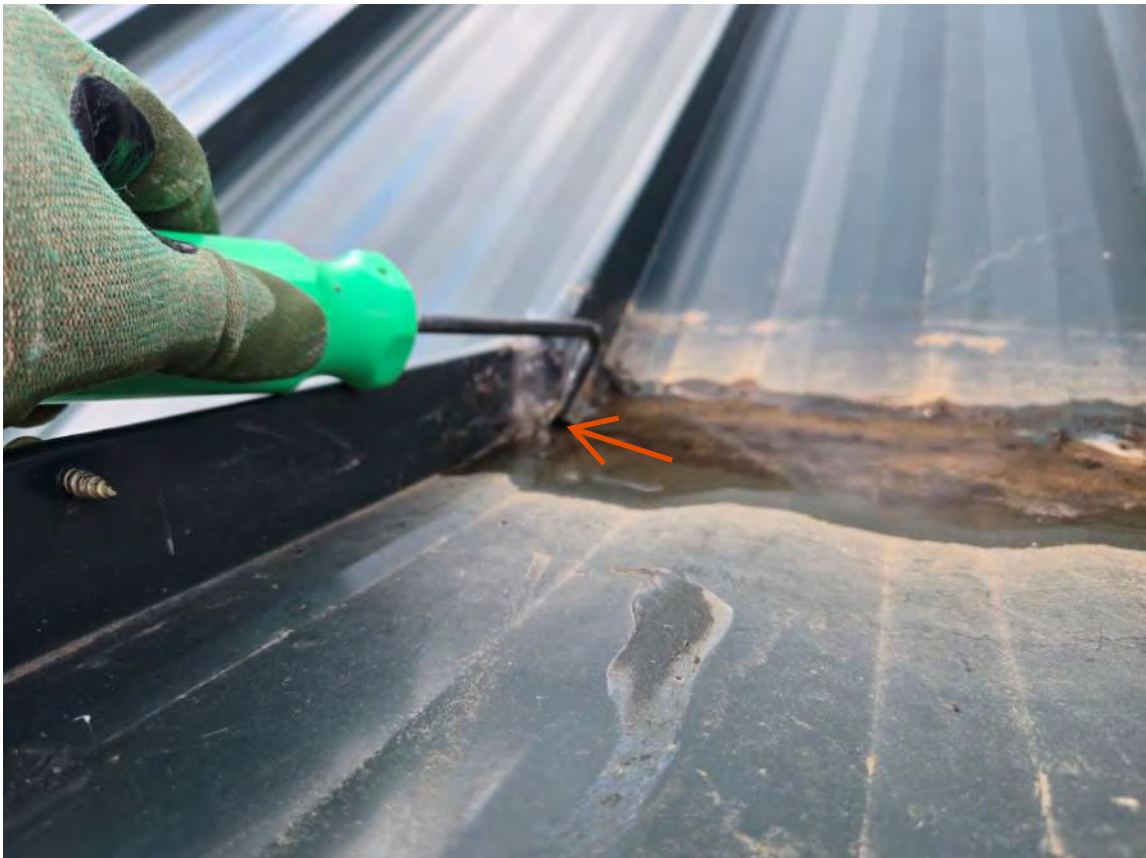
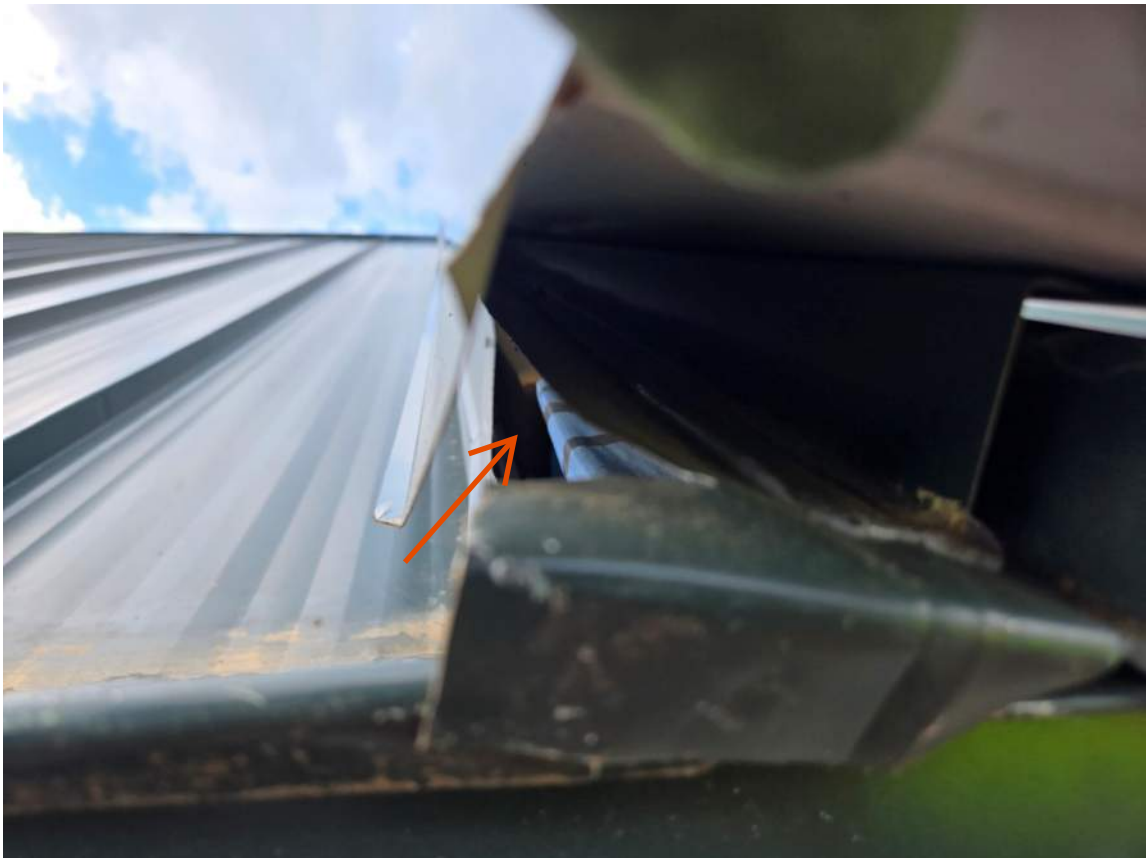
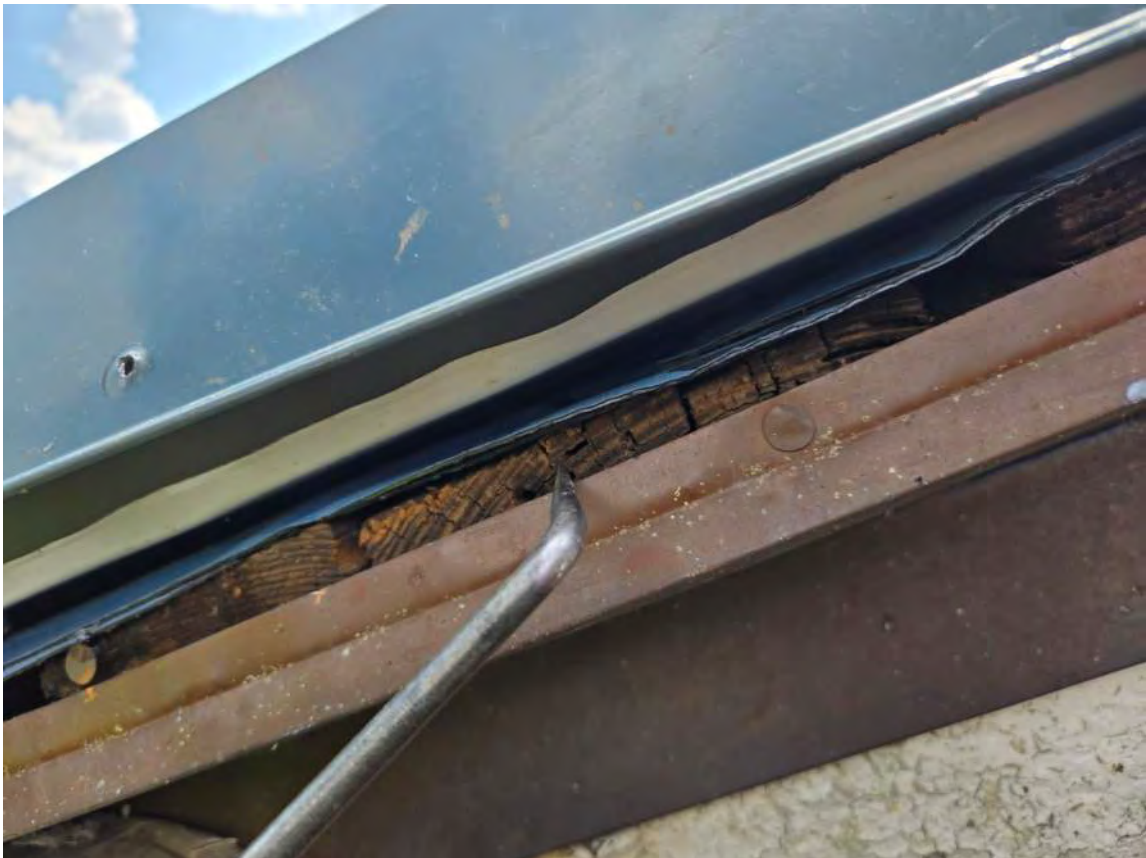
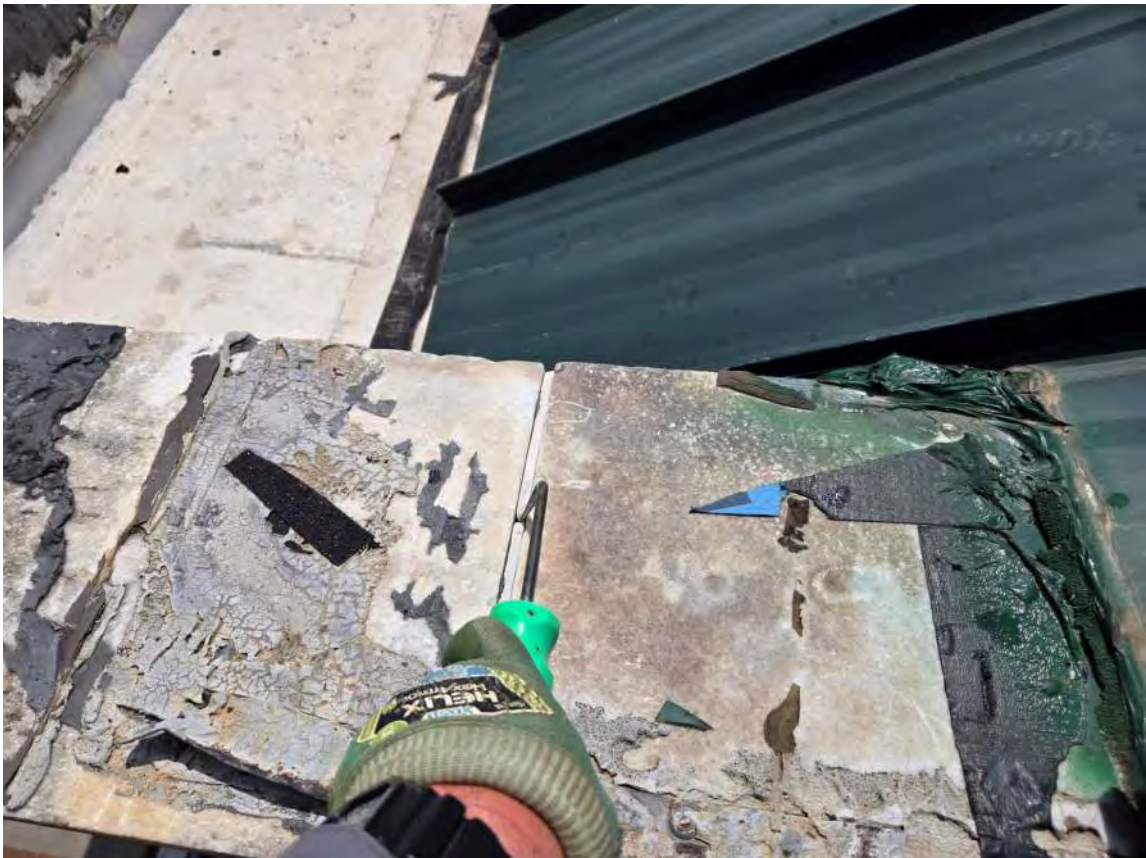
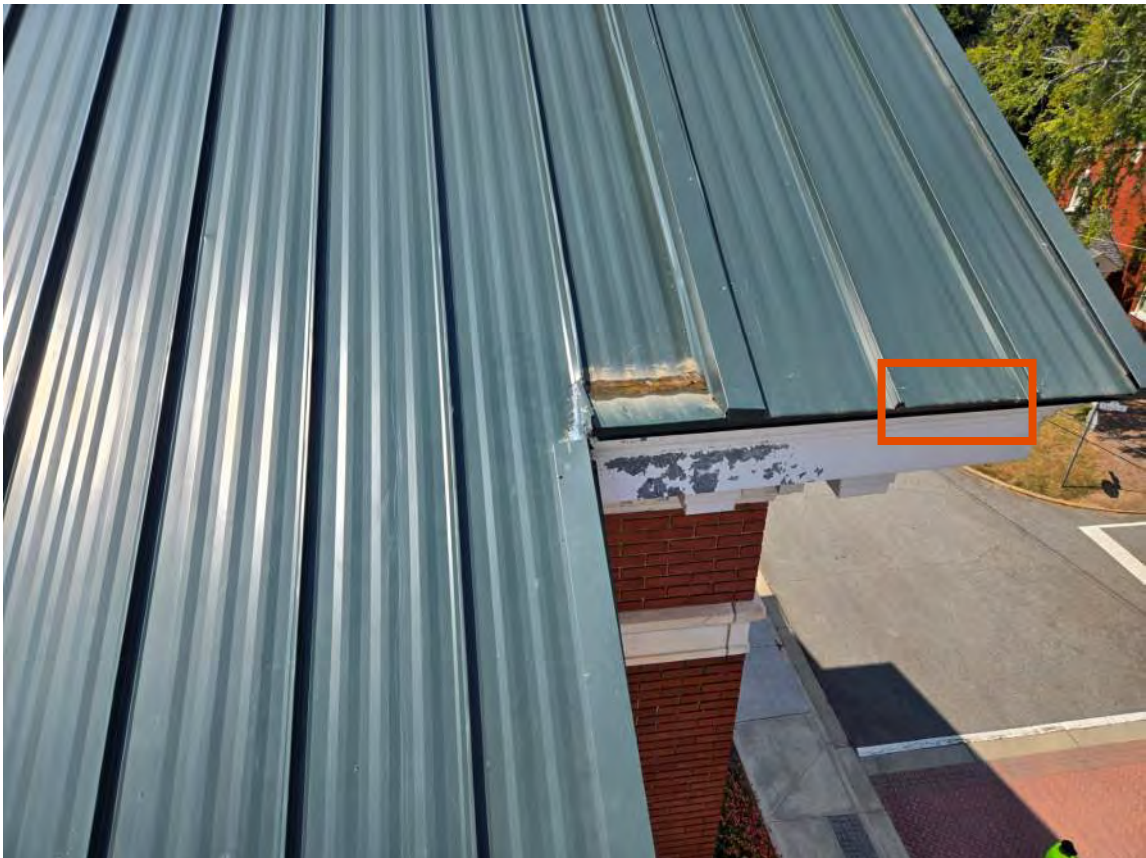
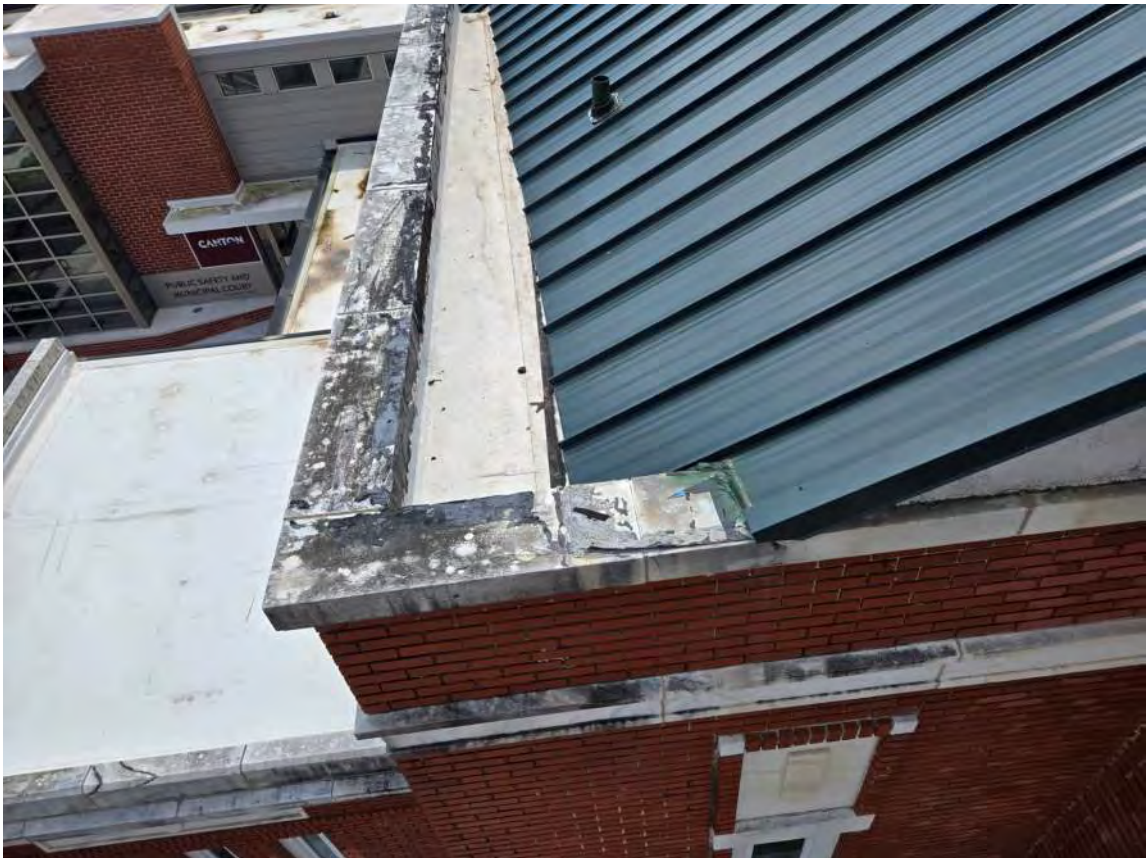
Photos 108 – 119 show similar level of detailing to what was observed on the west side of the roof. Voids had been left at transition areas and changes of plane. Sealant voids were present in new and older sealants. Flashings were not well secured to the roof.

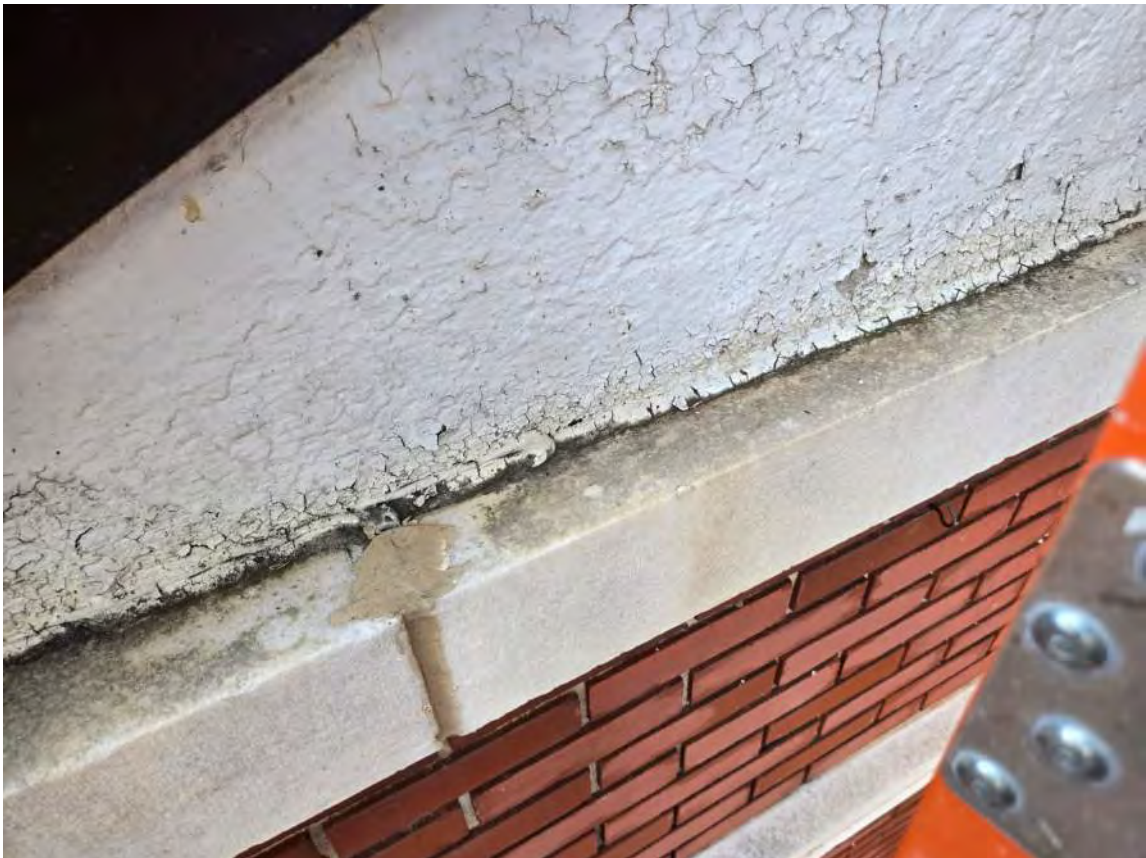
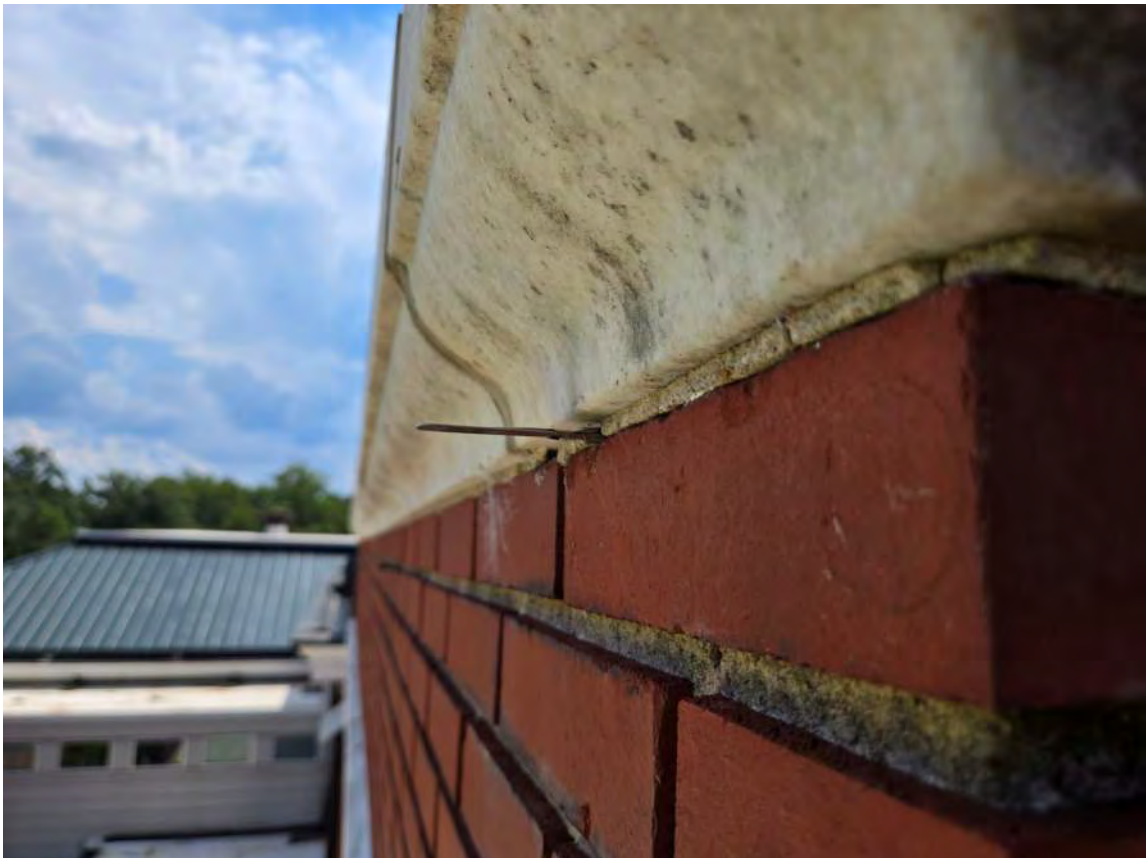
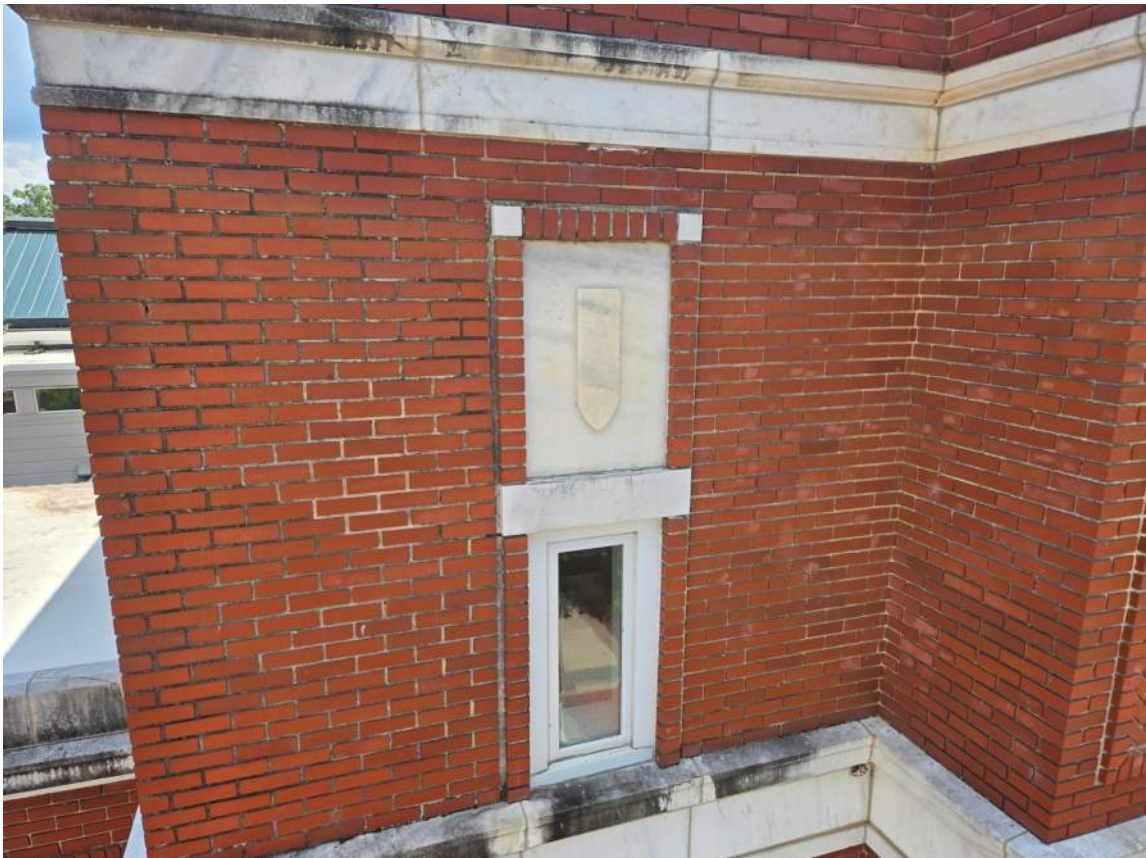
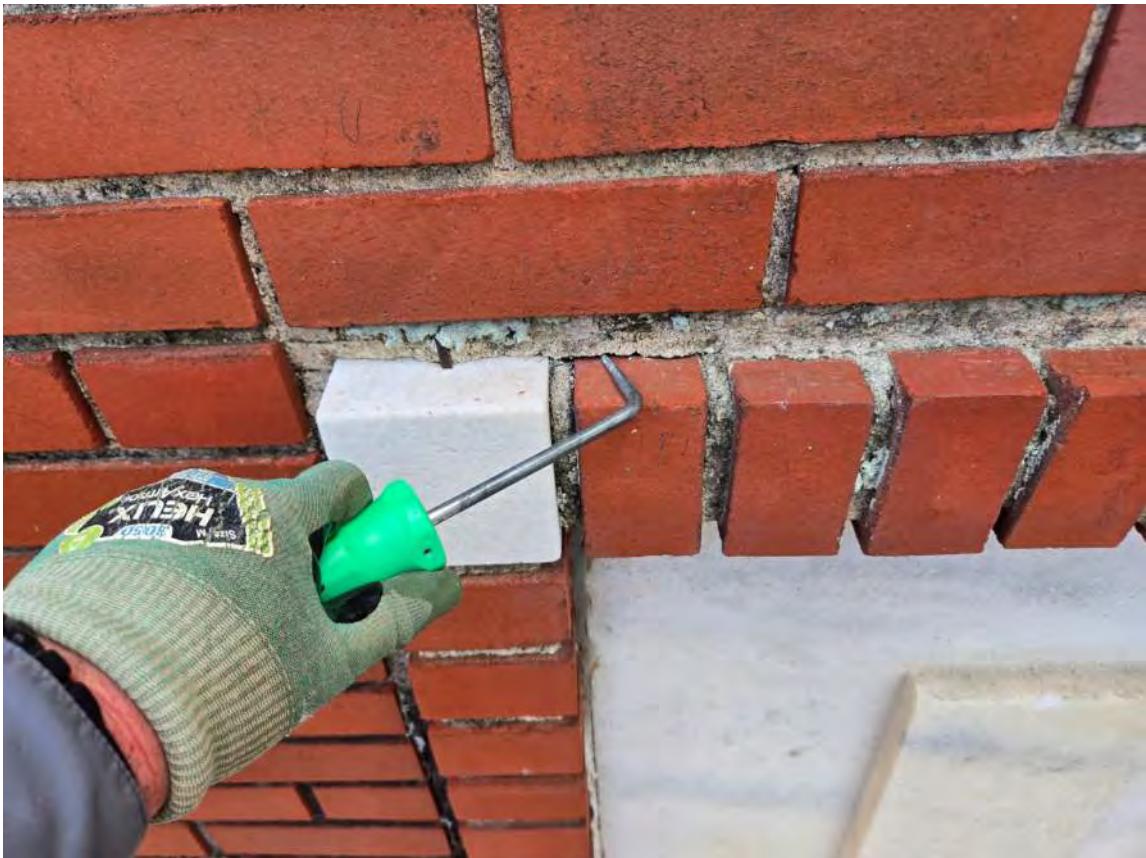
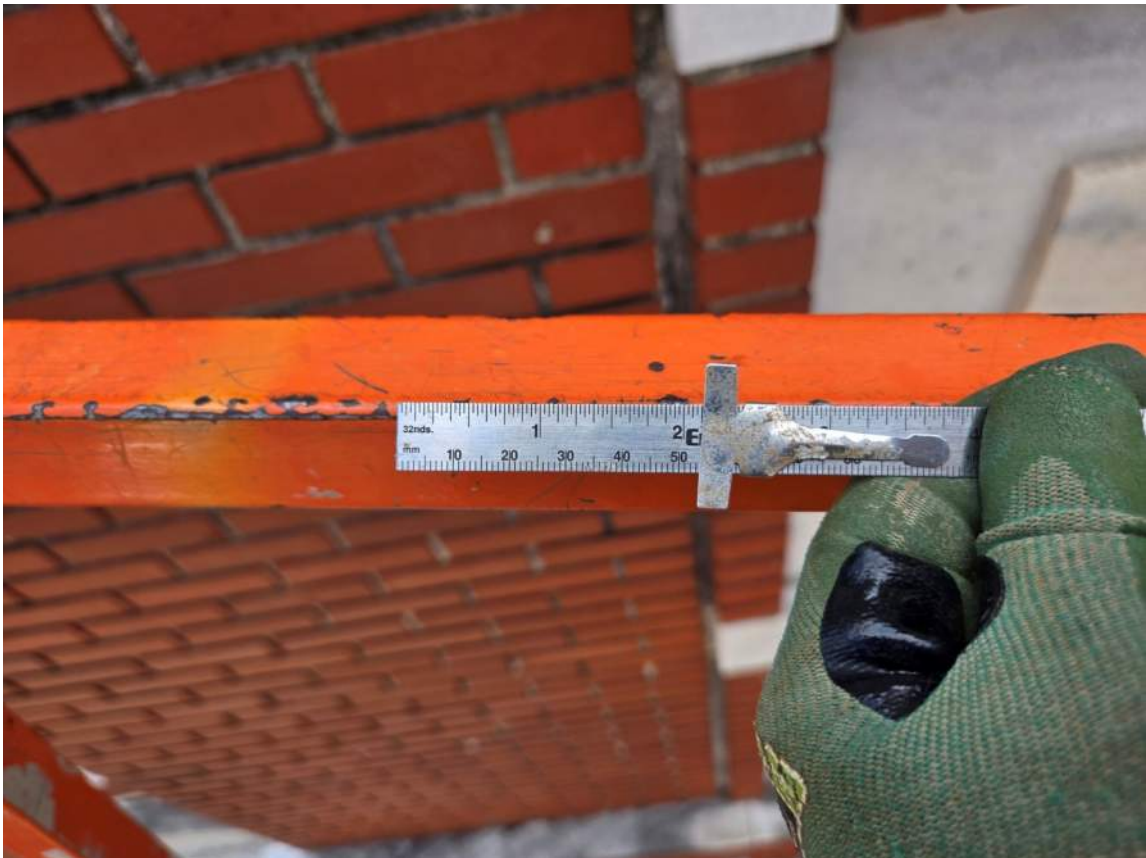
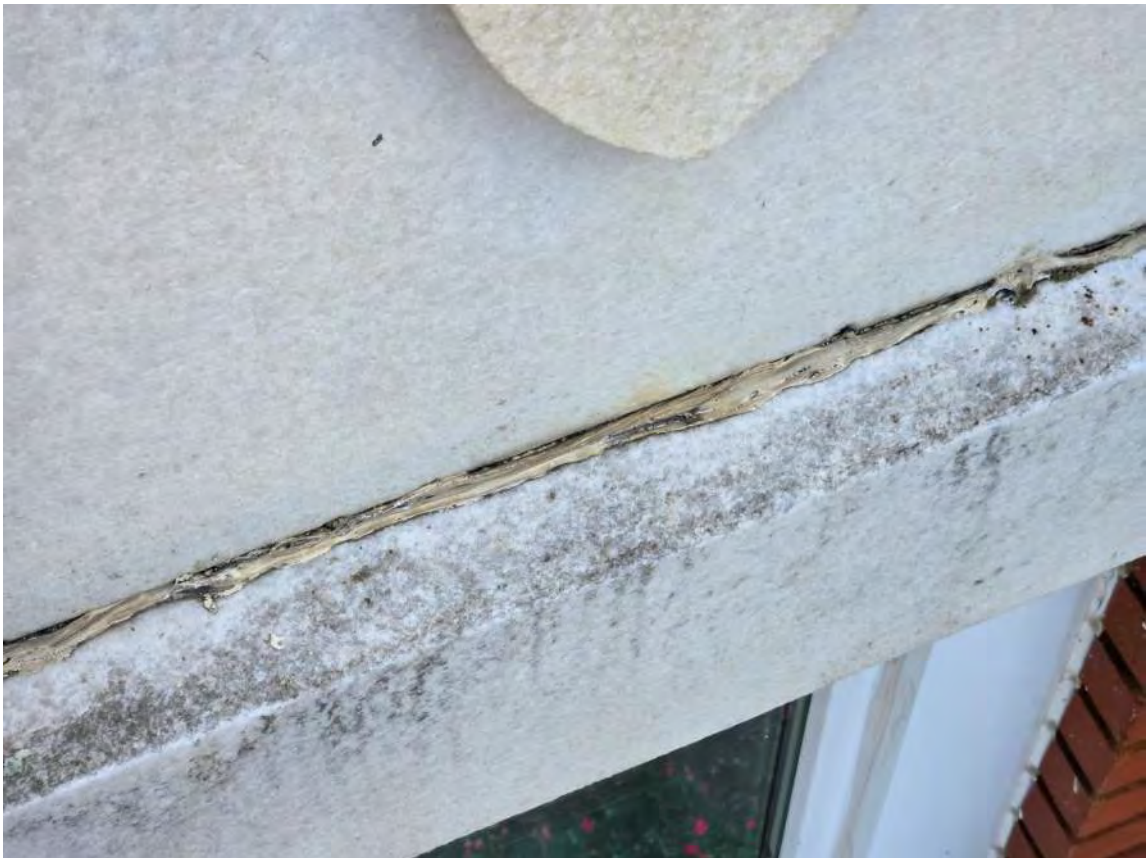
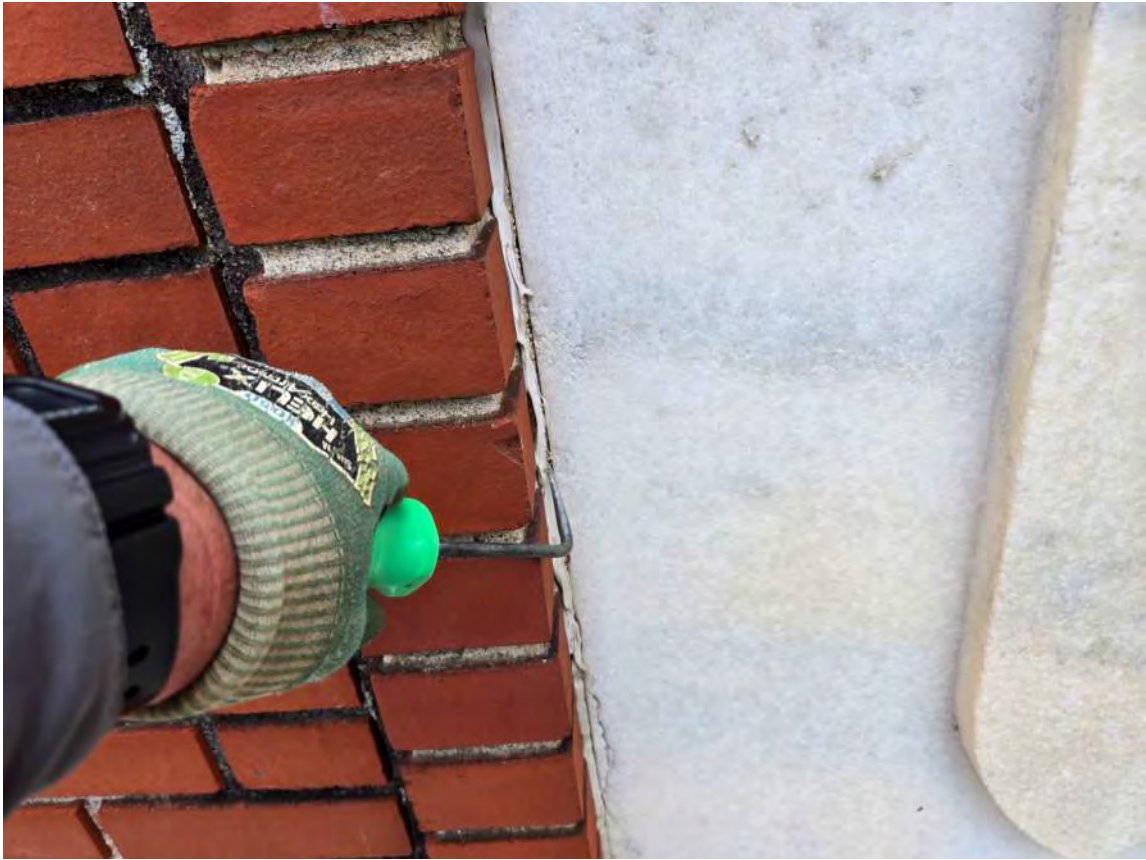
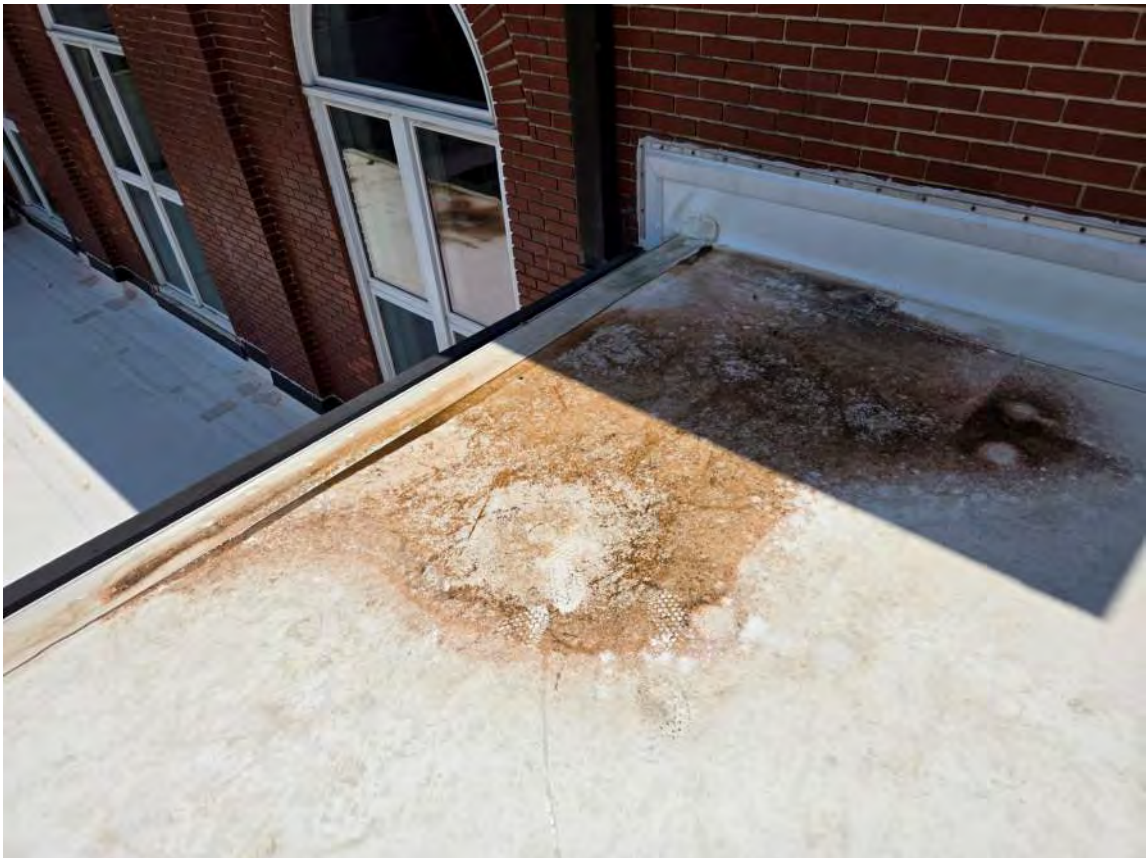
Photos 121 – 133 show failing and missing sealants and mortar on the exterior wall of the roof area, above the window. Reported leakage by the City of Canton and observed by W&A indicate some level of leakage to the interior in this general area.

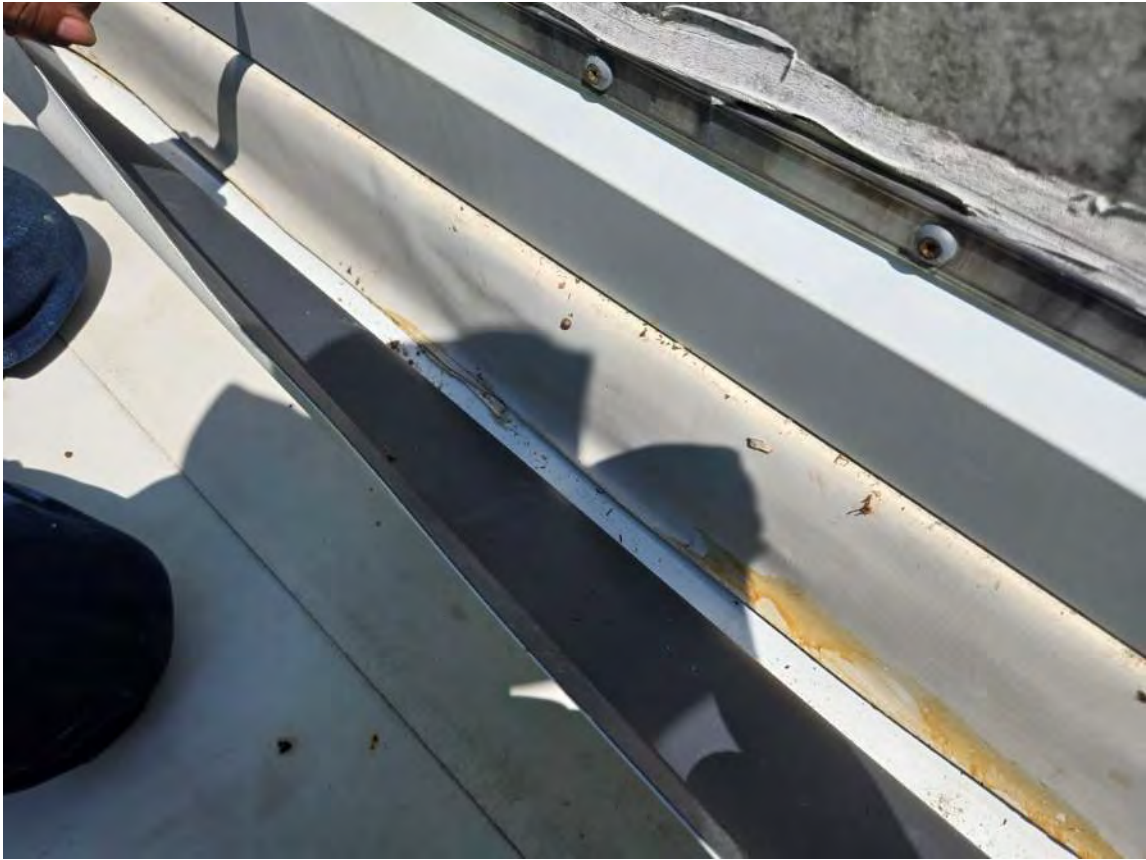
Photo 134 shows the general condition of the roof area. Similar observations regarding flashing and coping sealant degradation were made on this roof area as Roof Area 7 and similar areas.
