**CITY OF CANTON POLICE DEPARTMENT
151 ELIZABETH ST
CANTON, GA 30114**

FOLLOW-UP ROOF LEAK EVALUATION REPORT

**Re: Building Exterior Consulting Services
Roof Consulting Services
City of Canton Police Department
Canton, GA 30114
(W&A Project #: 24-01329-2)**

Follow-up Roof Leak Evaluation Report
City of Canton Police Department
Canton, GA
(W&A: 24-01329-2)

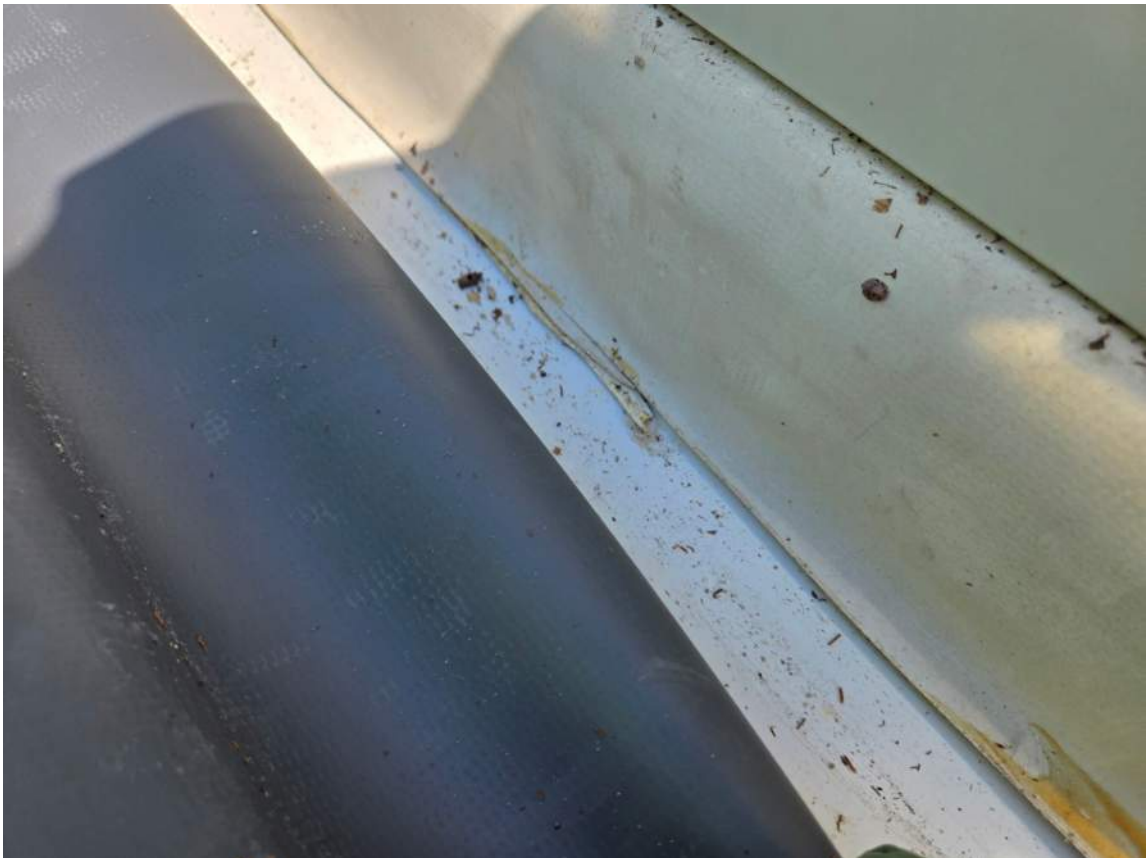
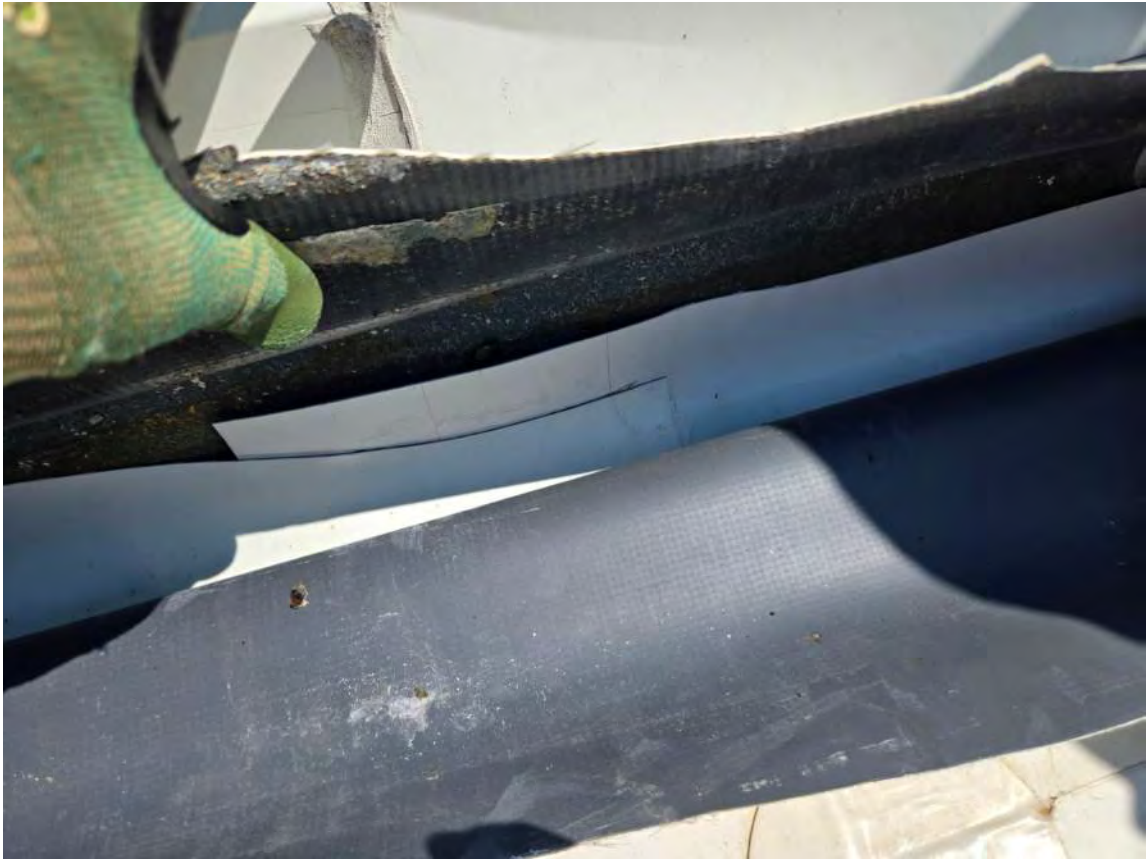
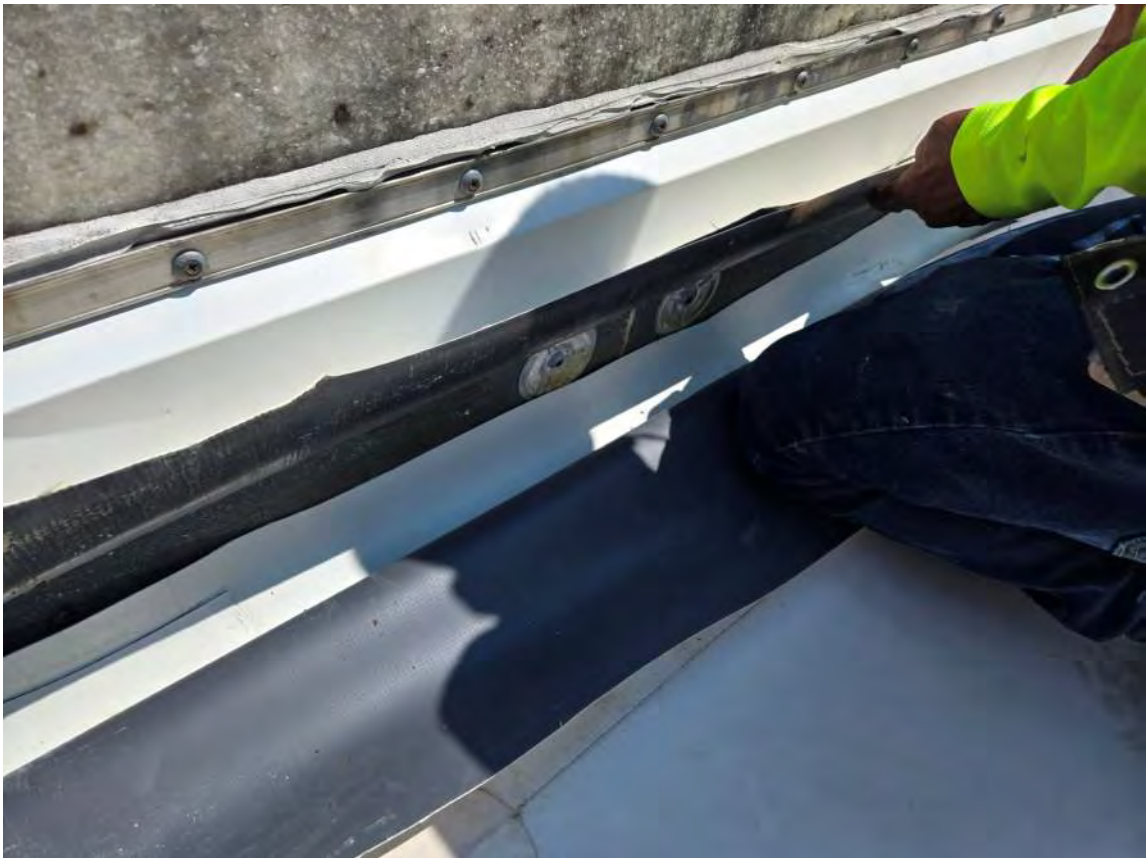
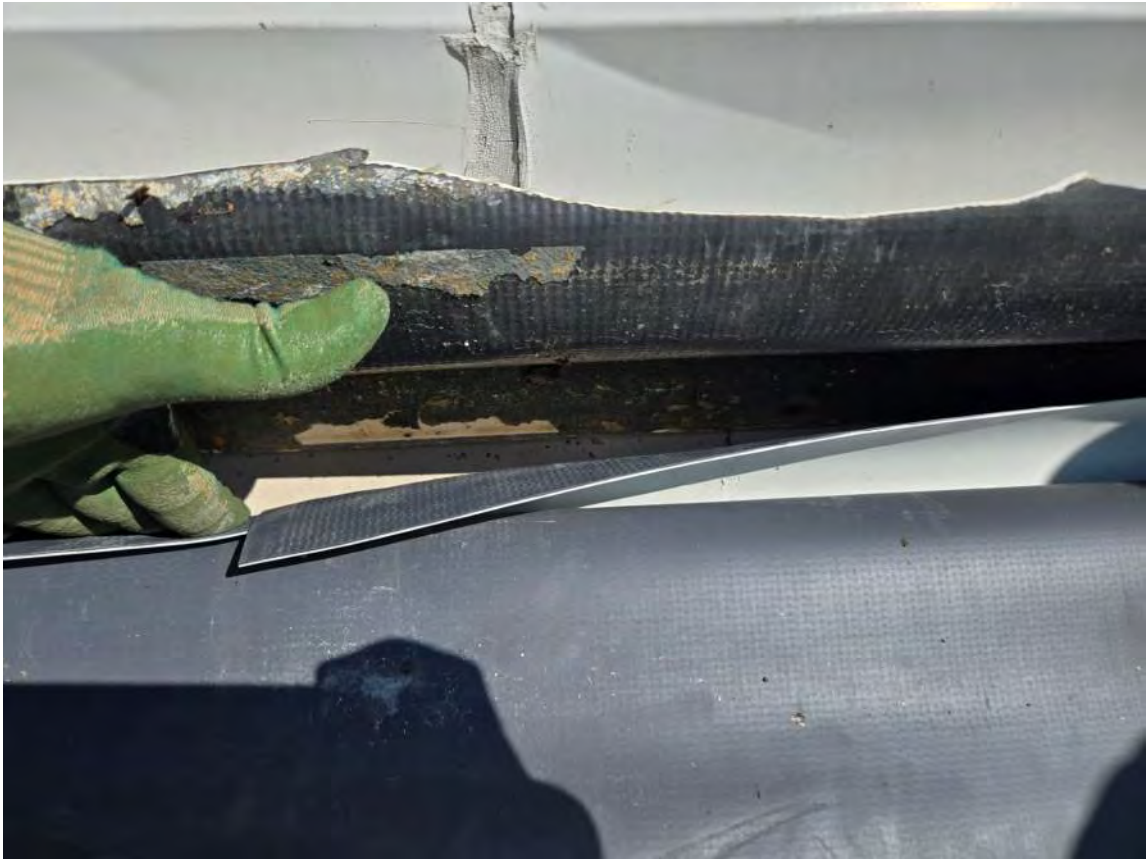
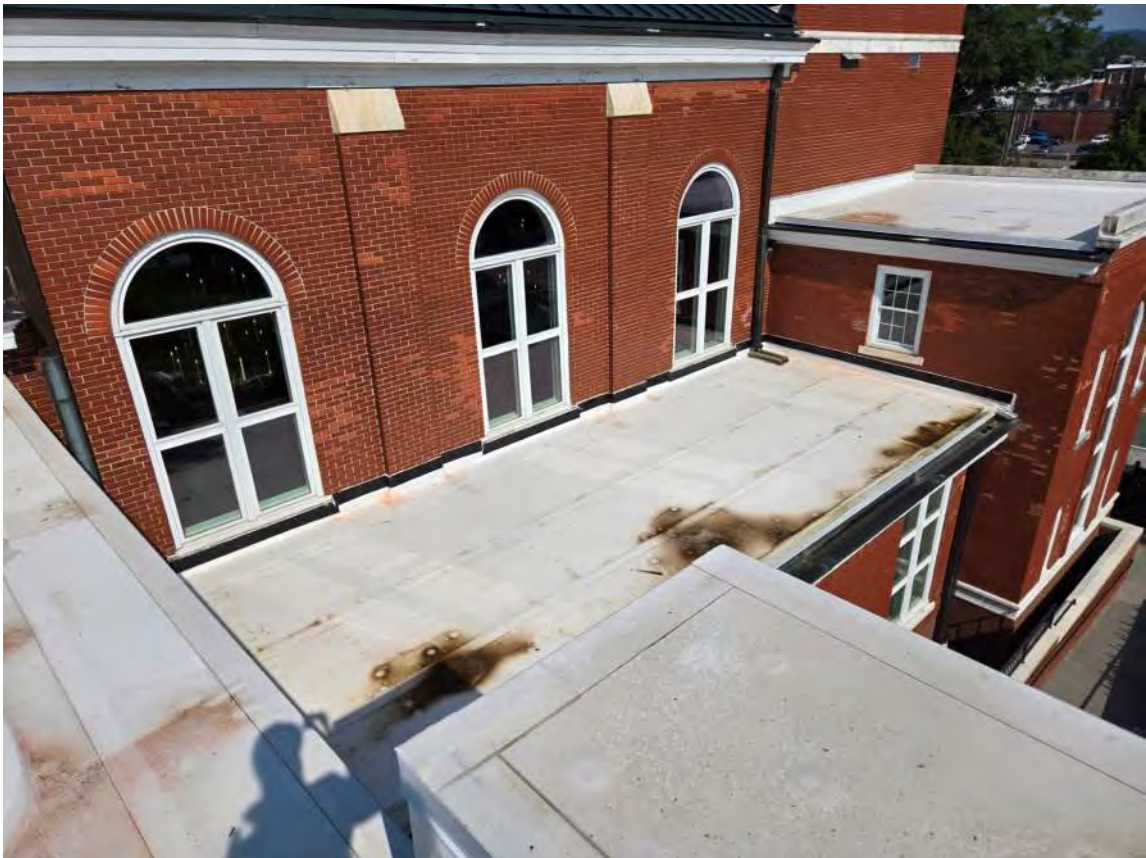
Photos 135 – 139 show the as-built perimeter flashing construction was similar in this area as was found in Area 6. This indicates that single-ply systems at Roof Areas 5, 6, 7, 10, 11 & 12 have similar levels of detailing.

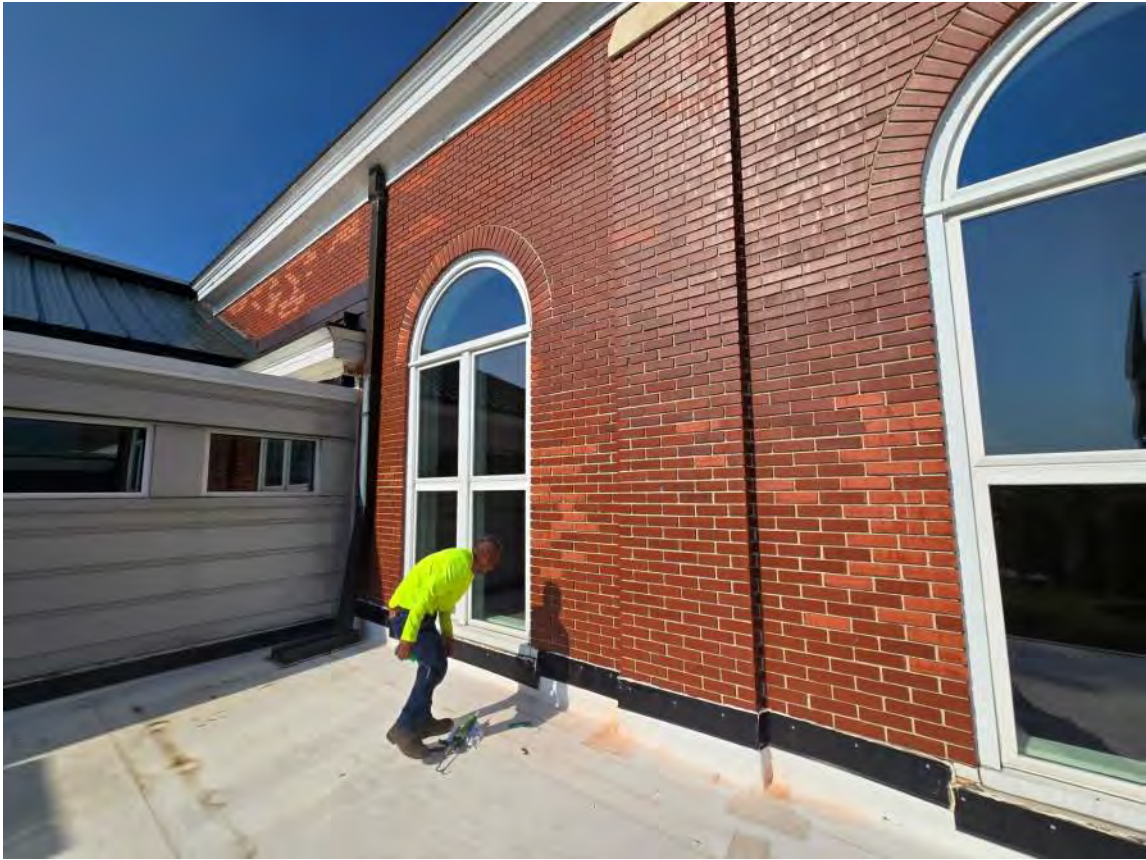
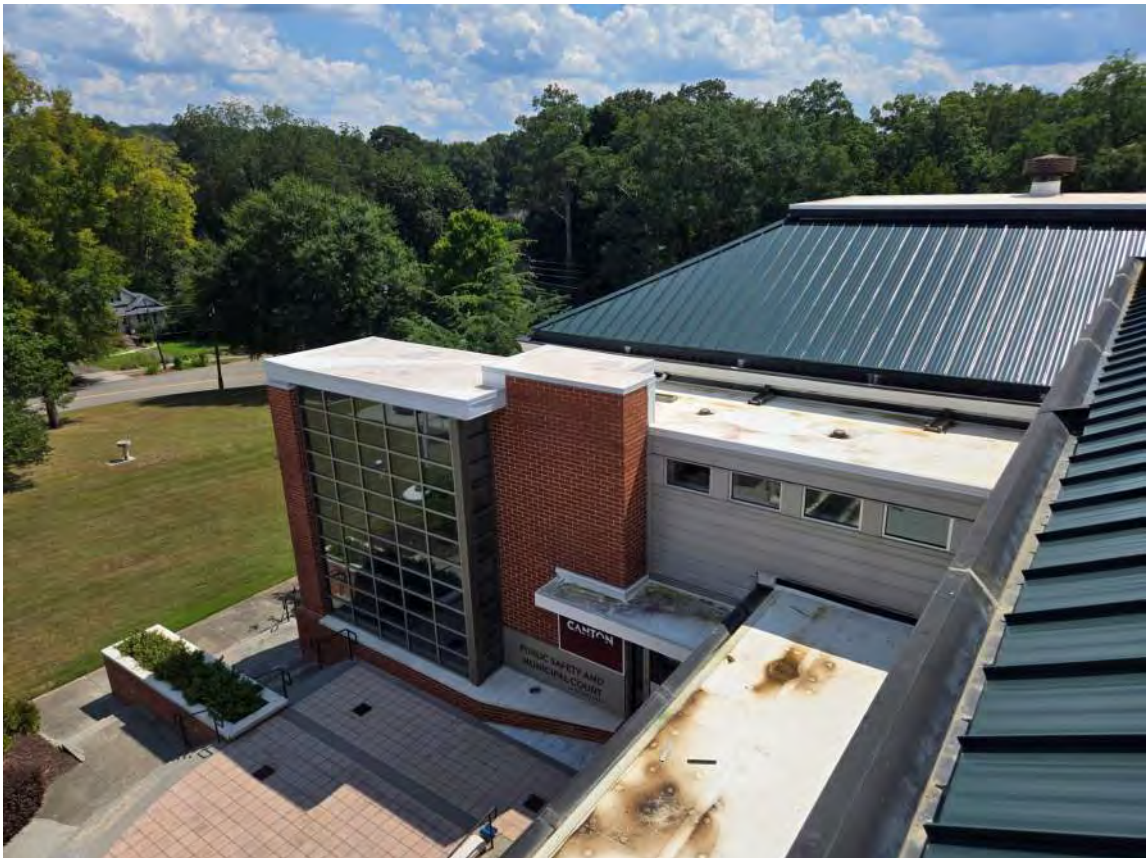
Photos 140 & 141 show the general condition of the roof area during the evaluation. Corrective work was not reported to have taken place in this area. Of note, we did observe that the rising walls above the roof had a clear elastomeric coating applied to them, similar to GE Optic 3101 Translucent Silicone Coating.
